LICENSEE EVENT REPORT (LER)

FACILITY NAME (1) Callaway Plant Unit 1										DOCKET NUMBER (2) 0 5 0 0 0 4 8 3 1 OF 0 8										PAGE (3) 1 OF 0 8	
TITLE (4) Inoperable Control Room Emergency Ventilation System: 1) Personnel Error Caused Pressure Boundary Breach 2) Misposition of Flow Balancing Damper - Cause Unknown																					
EVENT DATE (5) MONTH DAY YEAR 0 6 0 8 8 7 8 7				LER NUMBER (6) SEQUENTIAL NUMBER REVISION NUMBER 0 1 3 0 1				REPORT DATE (7) MONTH DAY YEAR 1 1 0 4 8 7				OTHER FACILITIES INVOLVED (8) FACILITY NAMES DOCKET NUMBER(S) 0 5 0 0 0 0									
OPERATING MODE (9) 1		THIS REPORT IS SUBMITTED PURSUANT TO THE REQUIREMENTS OF 10 CFR § (Check one or more of the following) (11)																			
POWER LEVEL (10) 1 0 0		20.402(b)				20.405(c)				50.73(a)(2)(iv)				73.71(b)

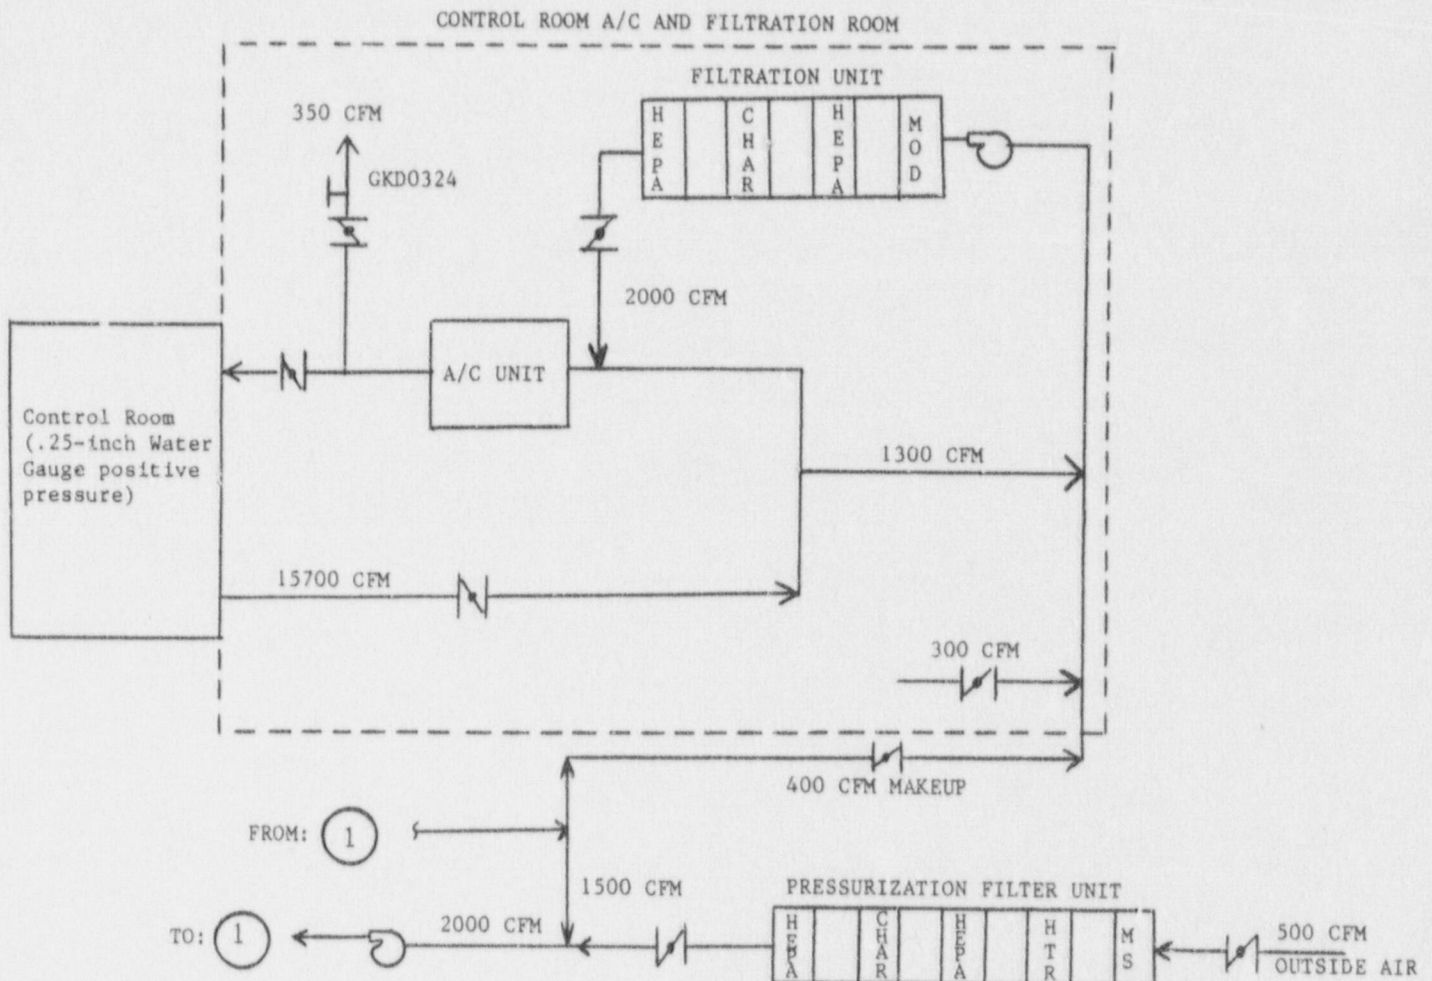
FIGURE 1. CONTROL ROOM EMERGENCY VENTILATION SYSTEM

INTRODUCTION (reference Figure 1 - Control Room Emergency Ventilation System)

During a utility follow-up inspection to LER 87-013-00 on the difference in CR pressure between the CREVS Trains, utility Systems Engineering personnel found GKD0324 throttled closed, producing a flow rate of 160 cubic feet per minute (CFM) into the CR A/C and Filtration room. Due to concerns that restoring the flow to design values could result in decreasing the pressurization of the CR, and an initial assessment by engineering personnel that CR operability was not affected by this damper, GKD0324 was left in its as-found condition.
