LICENSEE: Tennessee Valley Authority
FACILITY: Sequoyah Nuclear Plant, Units 1 and 2
SUBJECT: SEQUOYAH 2 CIRCUIT BREAKER POLE SHAFT
WELD FAILURE (TACs 65955/65956)
Reference: Memorandum from D. Hood dated October 23, 1987
"Record of Telephone Conversation Regarding
Sequoyah 2 Circuit Breaker Pole Shaft Weld
Failure," Docket Nos. 50-327 and 50-328

DATE OF REPORT: 10/3/87

SUBJECT: CONTROL ROD DS-15 BREAKER, SEQUOYAH NUCLEAR PLANT - CUSTOMER

SAMPLE NUMBER 87-33

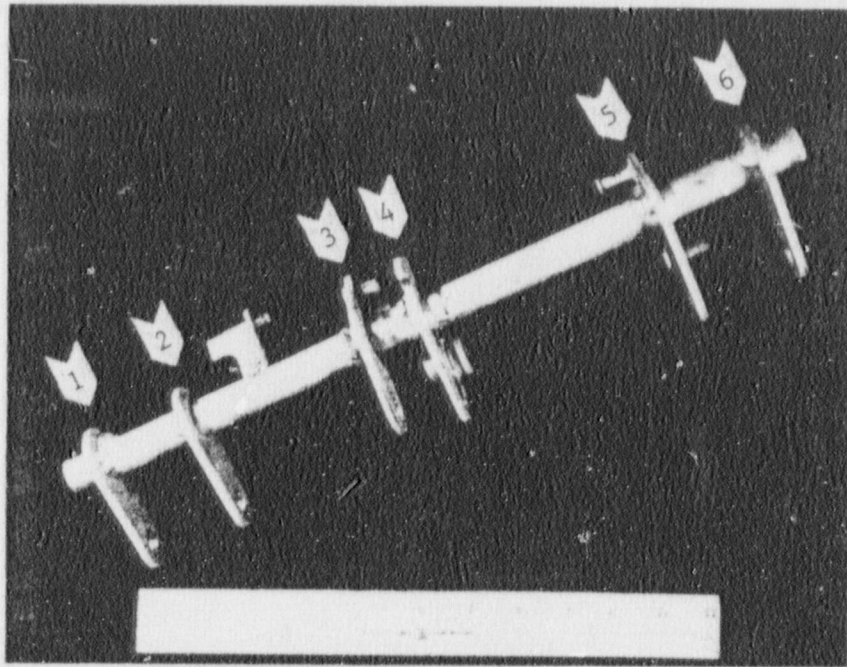
a. Photograph of the sample in the as-received condition.

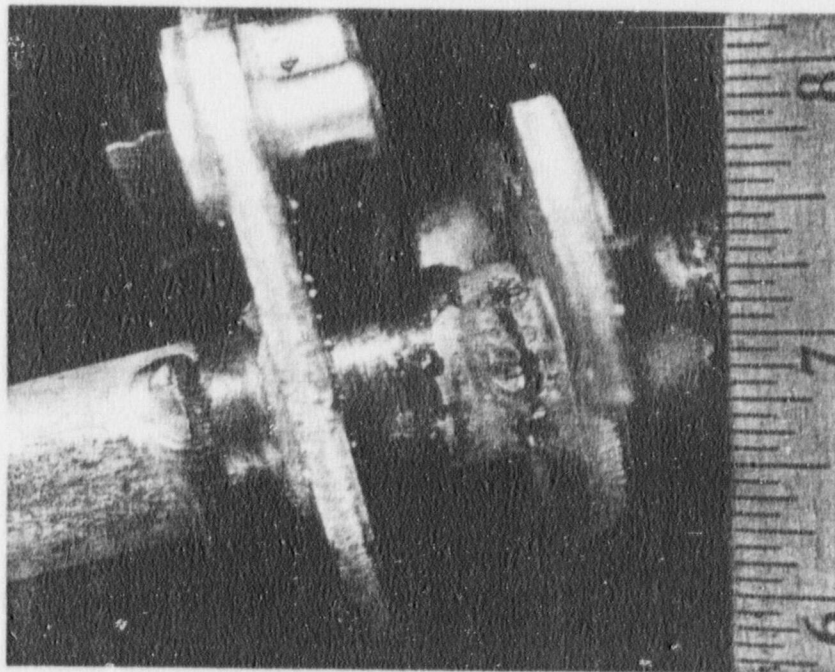
The Metallurgical Laboratory Section received the subject sample (Figure 1a) with a request to determine the fracture mode. Visual examination of the sample showed that the plate in Area 3 had completely separated from the rod at the weld and that cracking was observed at the weld in Area 4 (Figures 1b and 2). Porosity was also observed in the weld of Area 4.

b. Photograph of the area of interest.

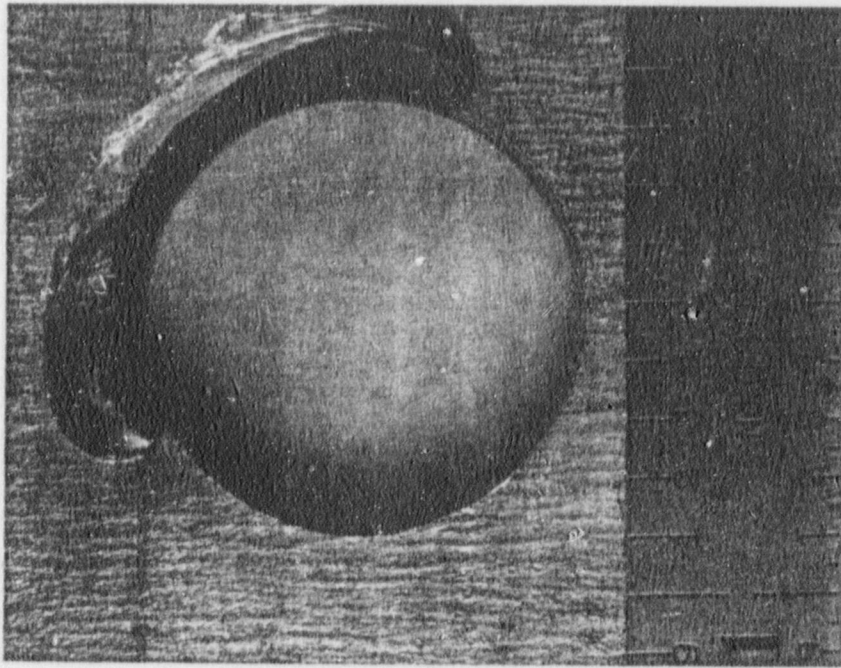
a. Photograph of the fracture in Area 3, ~3X.

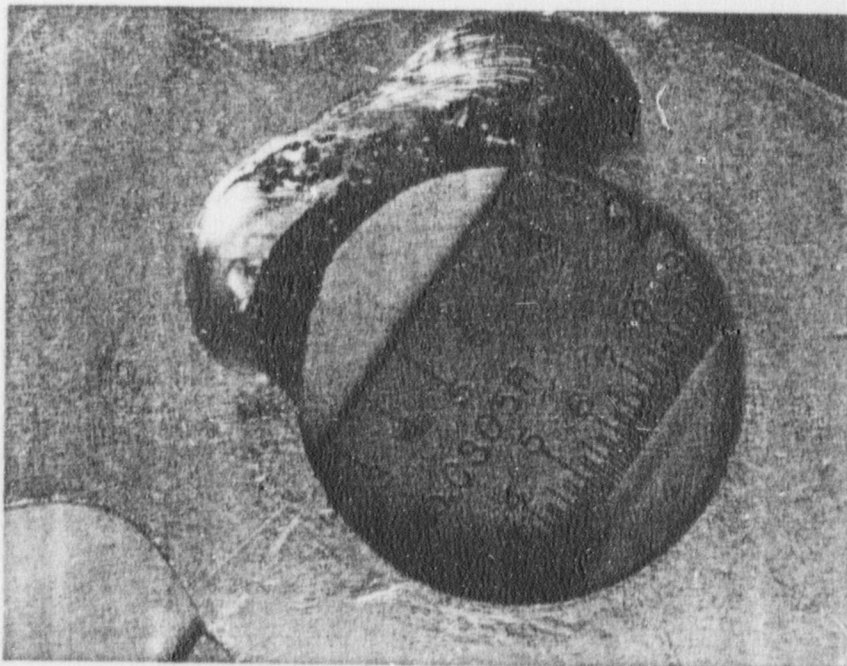
b. Photograph of the fracture in Area 4, ~3X.

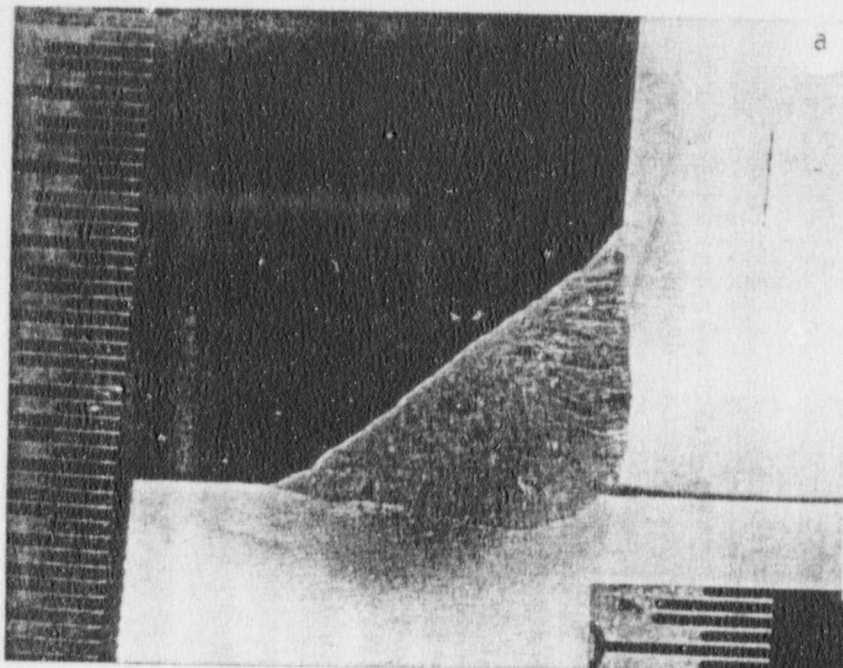
a. Photomicrograph of the weld in Area 1, ~7.5X.

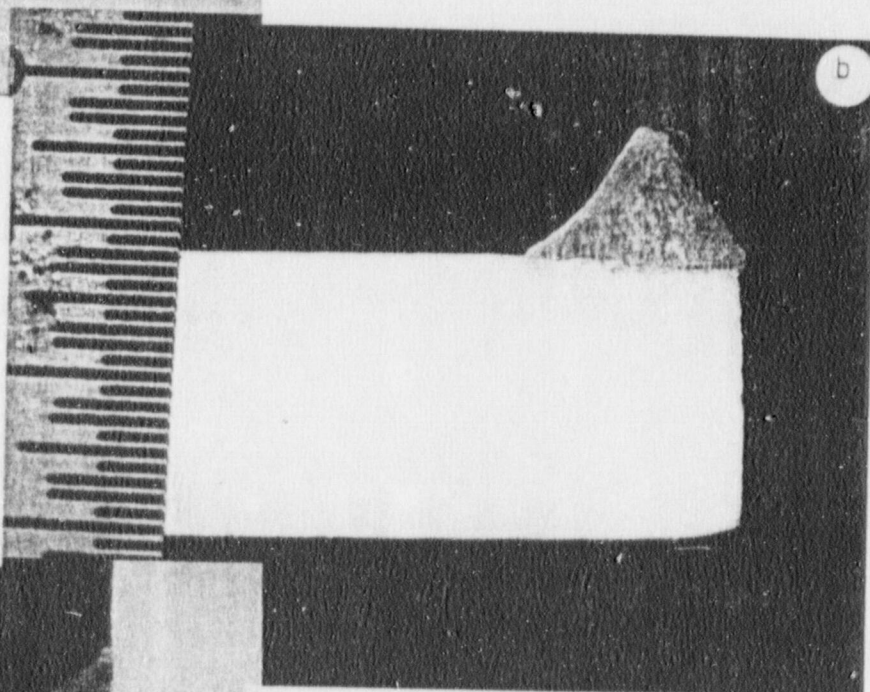
b. Photomicrograph of the weld in Area 3, ~7.5X.

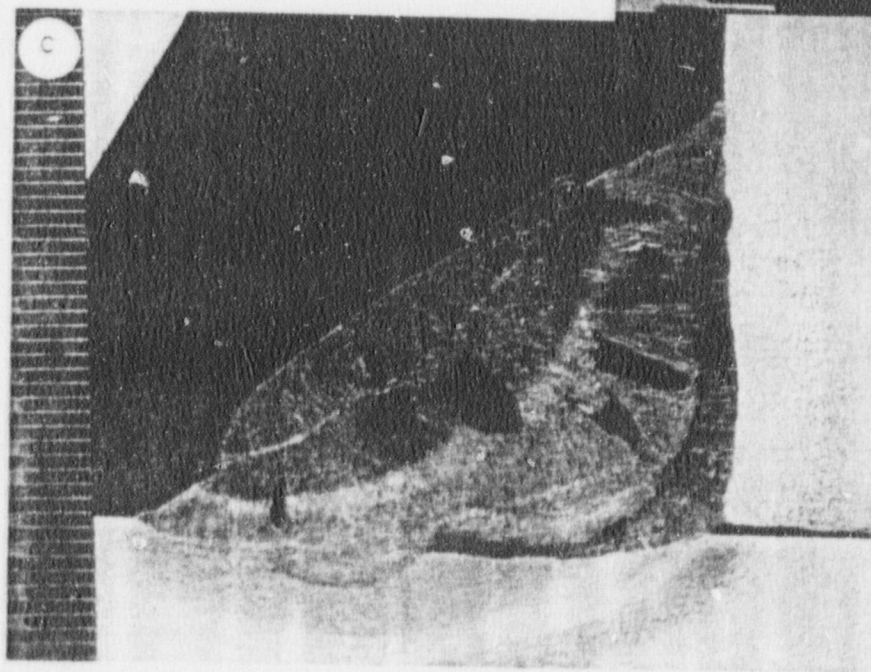
Cross sections through Areas 1, 3, and 4 (Figure 3) showed porosity in the weld in Area 4. Also, the weld in this area did not appear to penetrate into the plate and rod, resulting in a poor bond. Fracture surfaces were ductile (Figure 4a) in Area 3 and Area 4. Poor welding techniques were determined to be the cause of failure.

c. Photomicrograph of the weld in Area 4, ~7.5X.

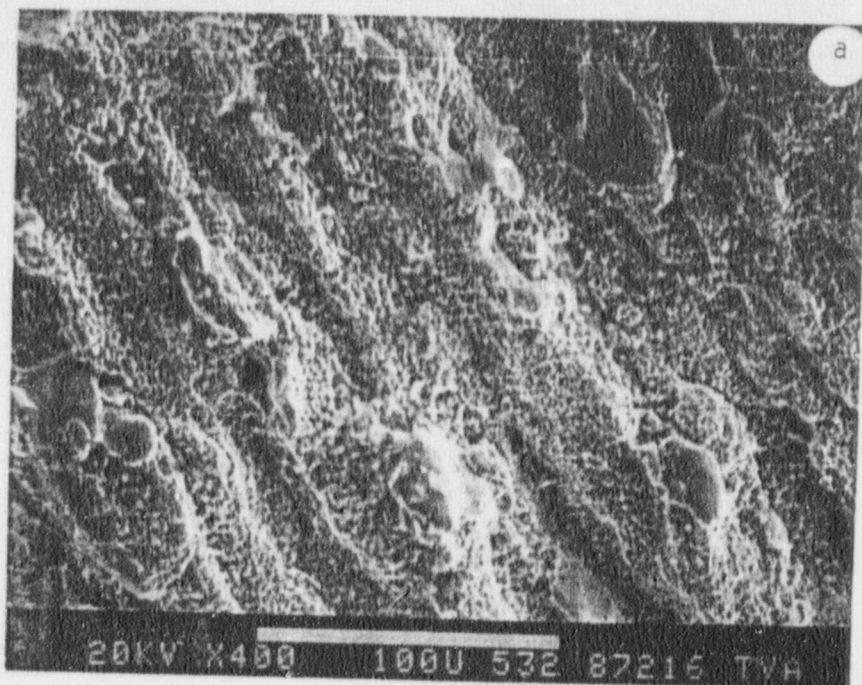
a. SEM micrograph of failed Area 3 and typical of Area 4.

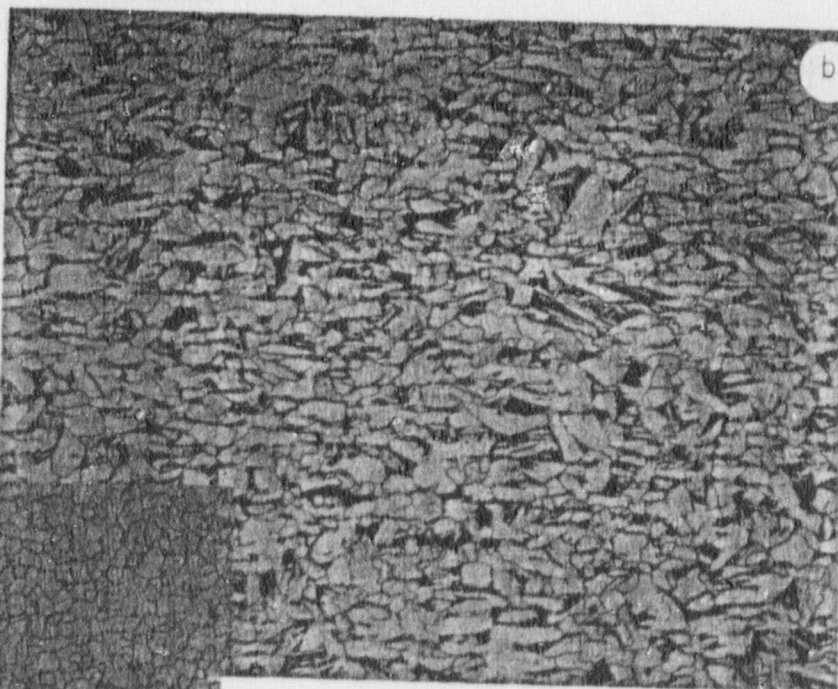
The microstructure of the rod consisted of ferrite and pearlite, while the microstructure of the plate consisted of ferritic grains (Figure 4b and c).

b. Photomicrograph of the microstructure of the rod, 100X.

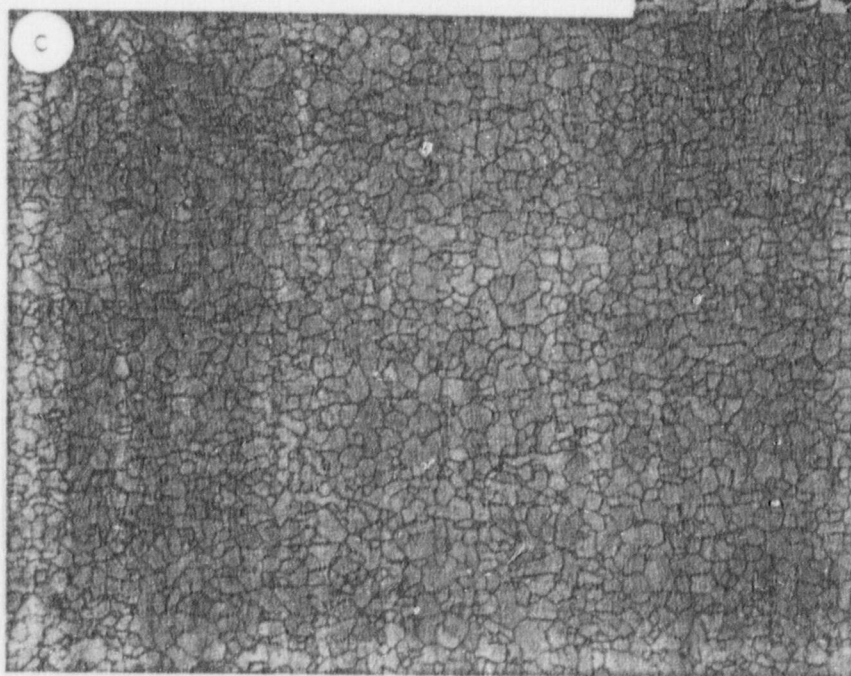
c. Photomicrograph of the microstructure of the plate, 100X.
