NOTICE OF VIOLATION

Duke Power Company
Catawba Unit 1

Docket No. 50-413
License No. NPF-35

ENFORCEMENT CONFERENCE SUMMARY

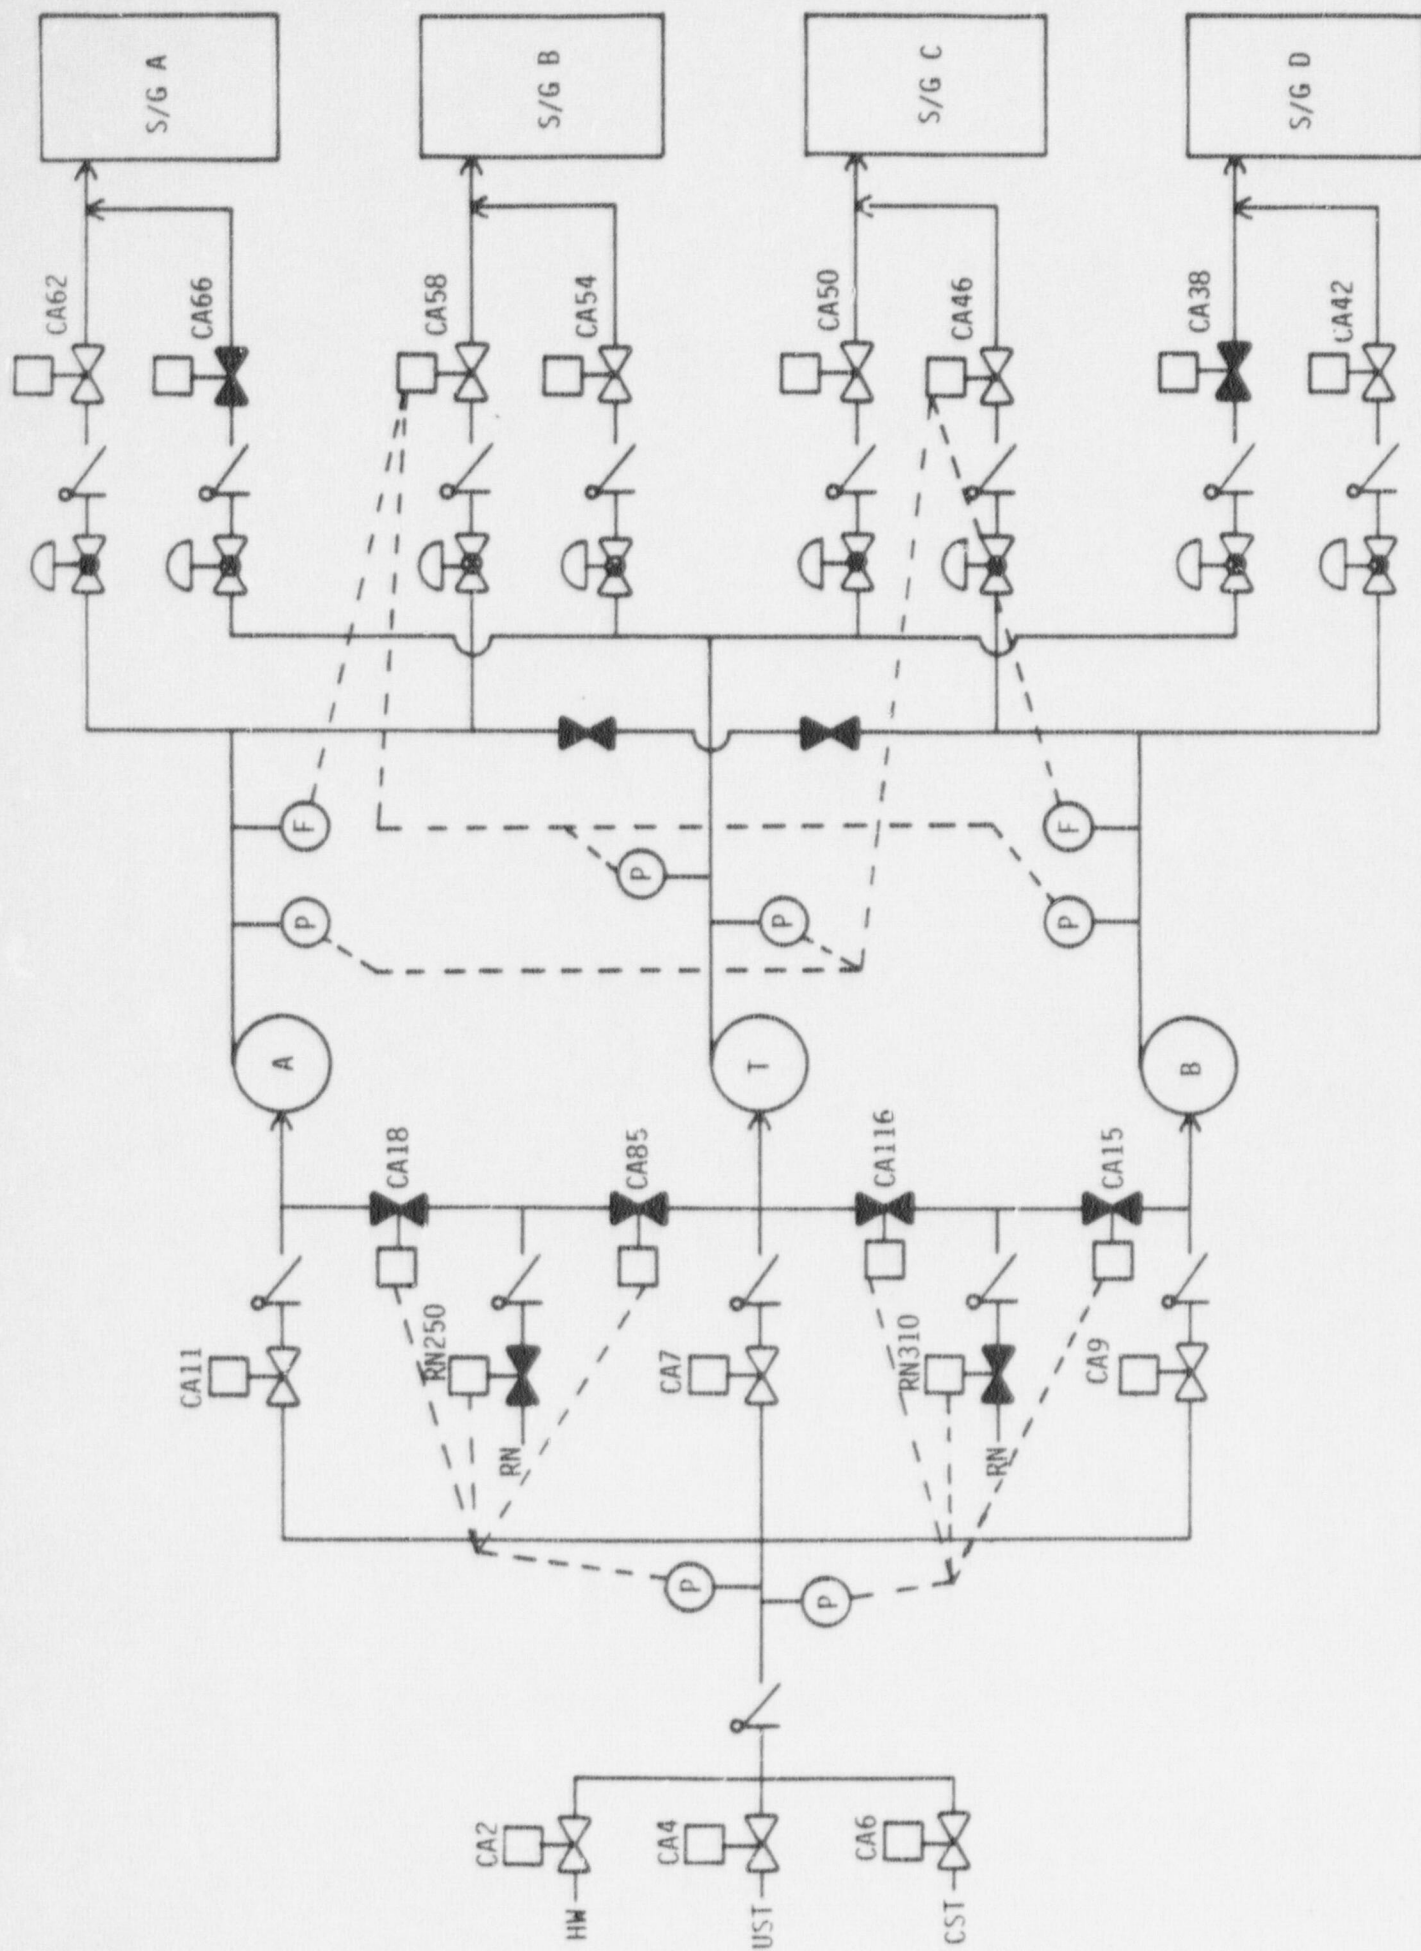
AUXILIARY FEEDWATER SYSTEM

- 1CAPS5131 Isolated.
- Feedwater line rupture at A S/G.
- Turbine Driven pump start and successful run for thirty seconds, then failure.
- Loss of normal feedwater.

- Immediate operator action available.
- 433 gpm supplied to 1D S/G at 1210 psig.
- Flows in excess of 491 supplied at lower S/G pressures.
- Capability to remove core and primary system heat without operator action to unisolate intact S/G.

While the auxiliary feedwater system would have been operating in a configuration different from that described in the FSAR, i.e. supplying only one S/G and flowrate lower than assumed at 1210 psig, the isolation of pressure switch 1CA5131 would not have prevented the system from performing its intended function under any postulated conditions.

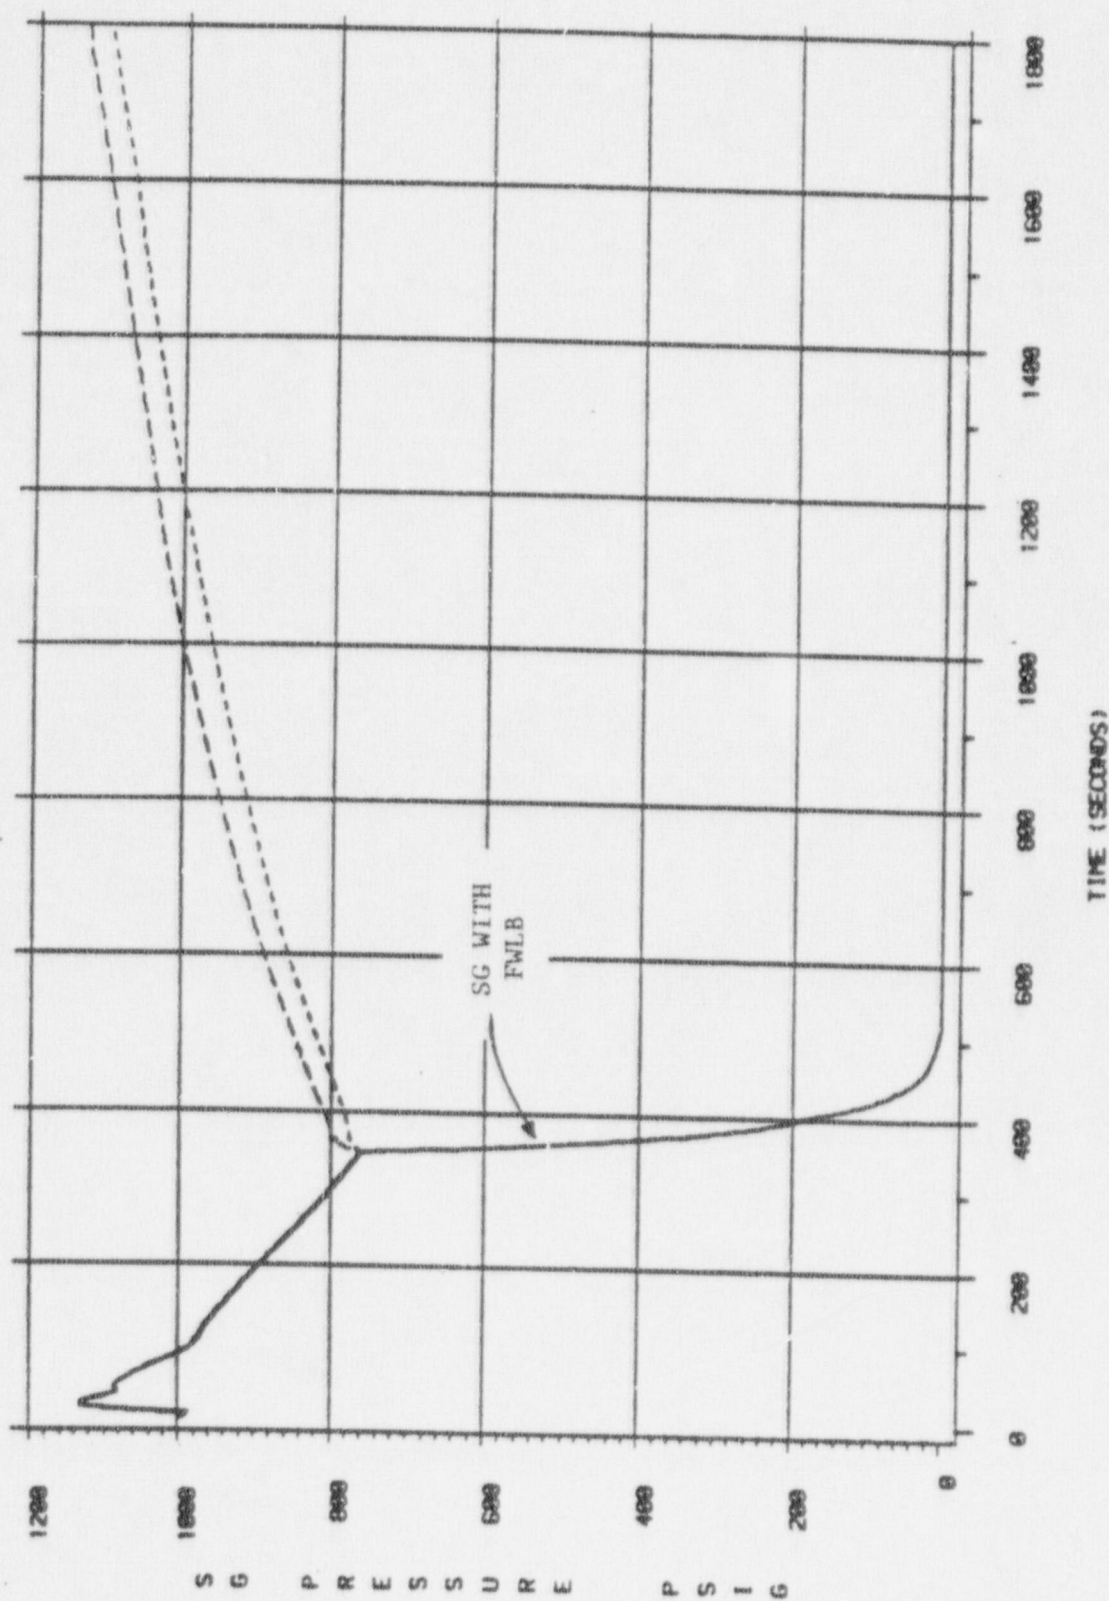
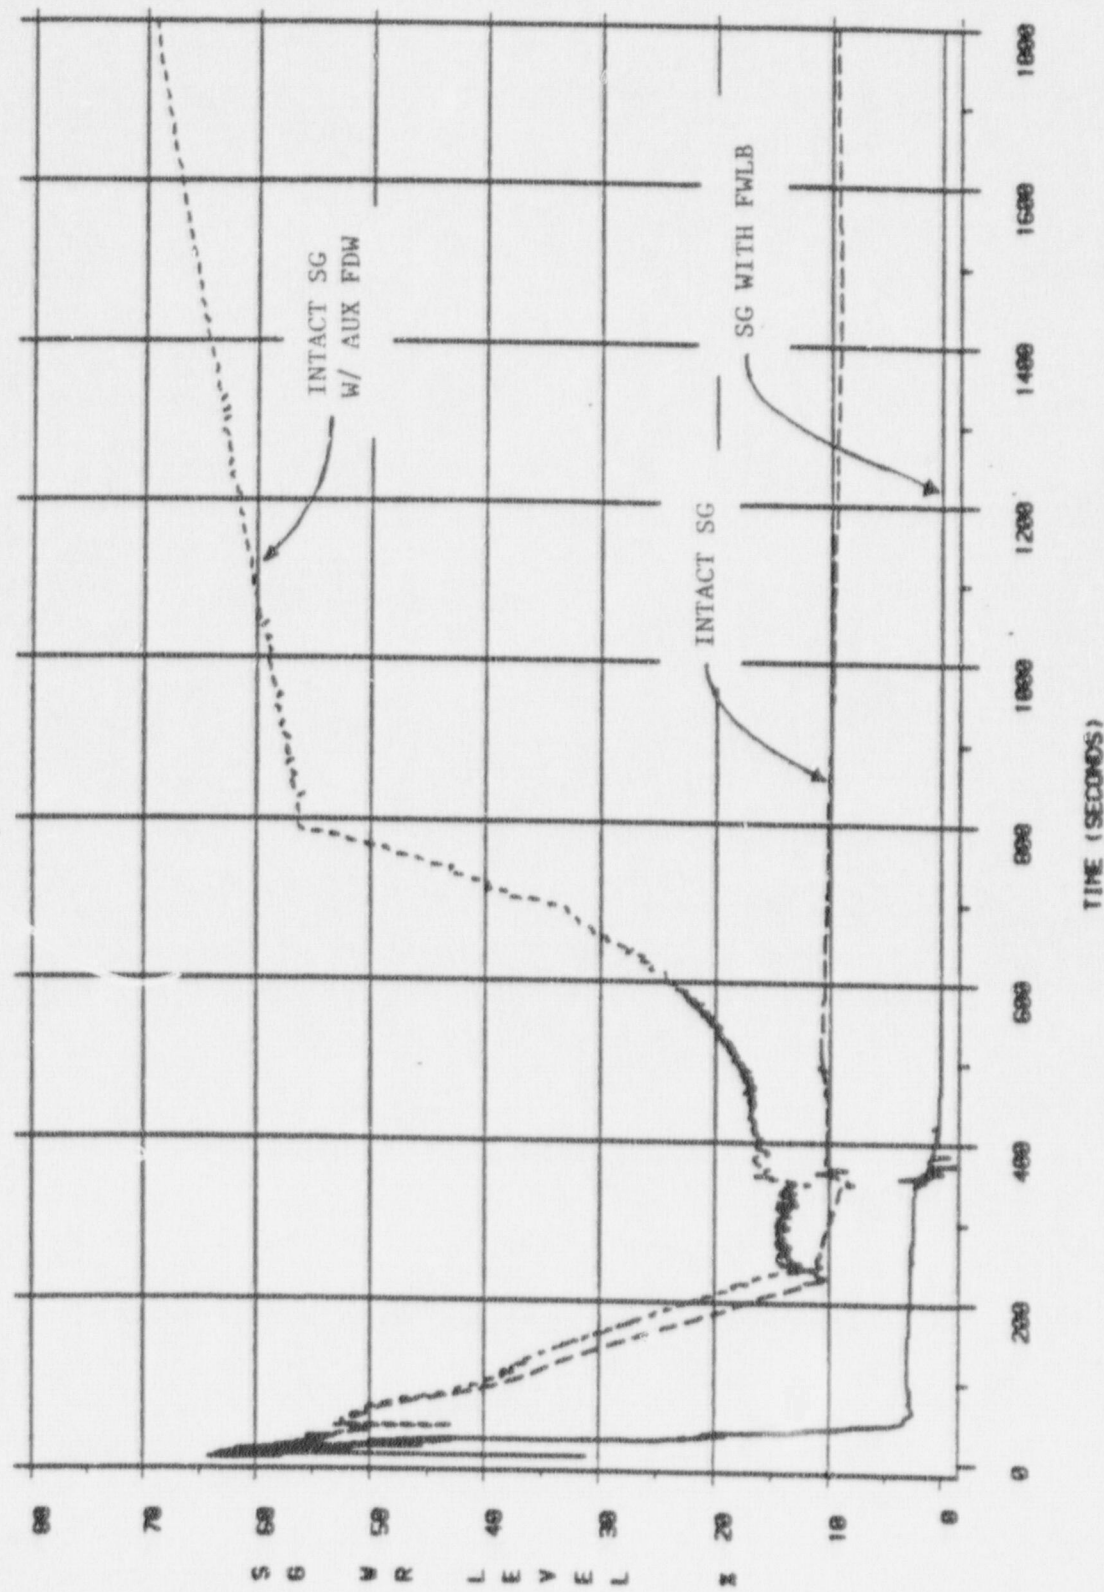
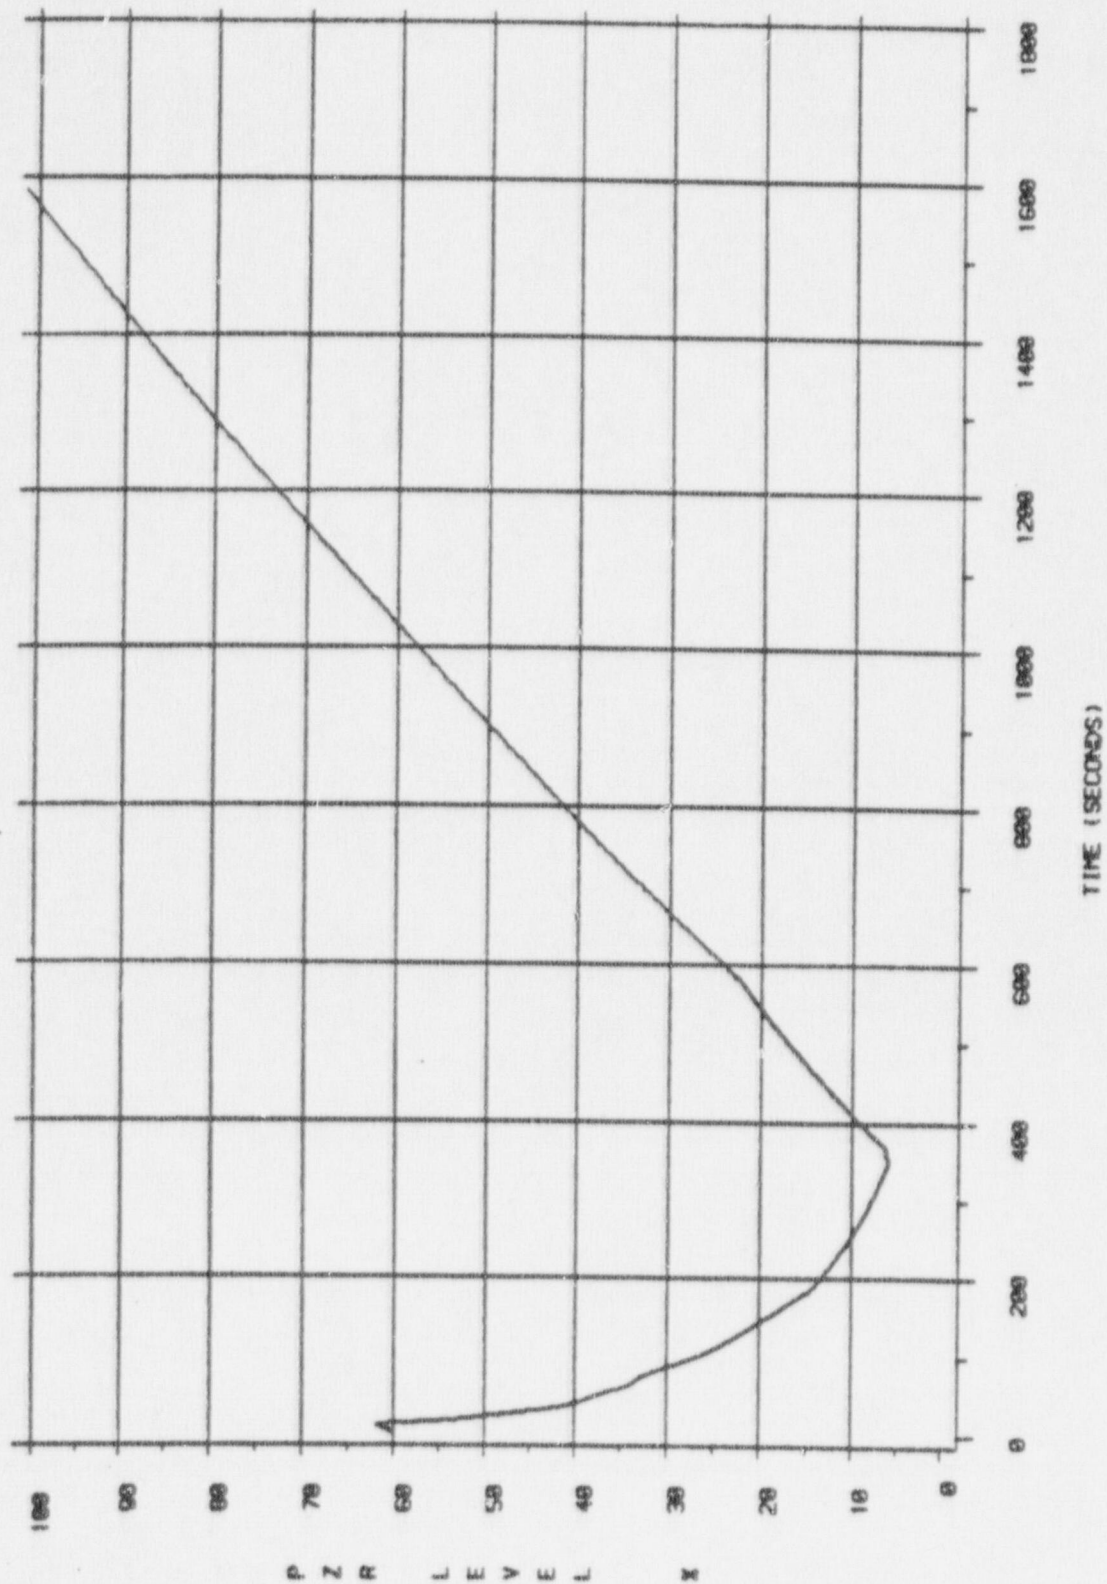
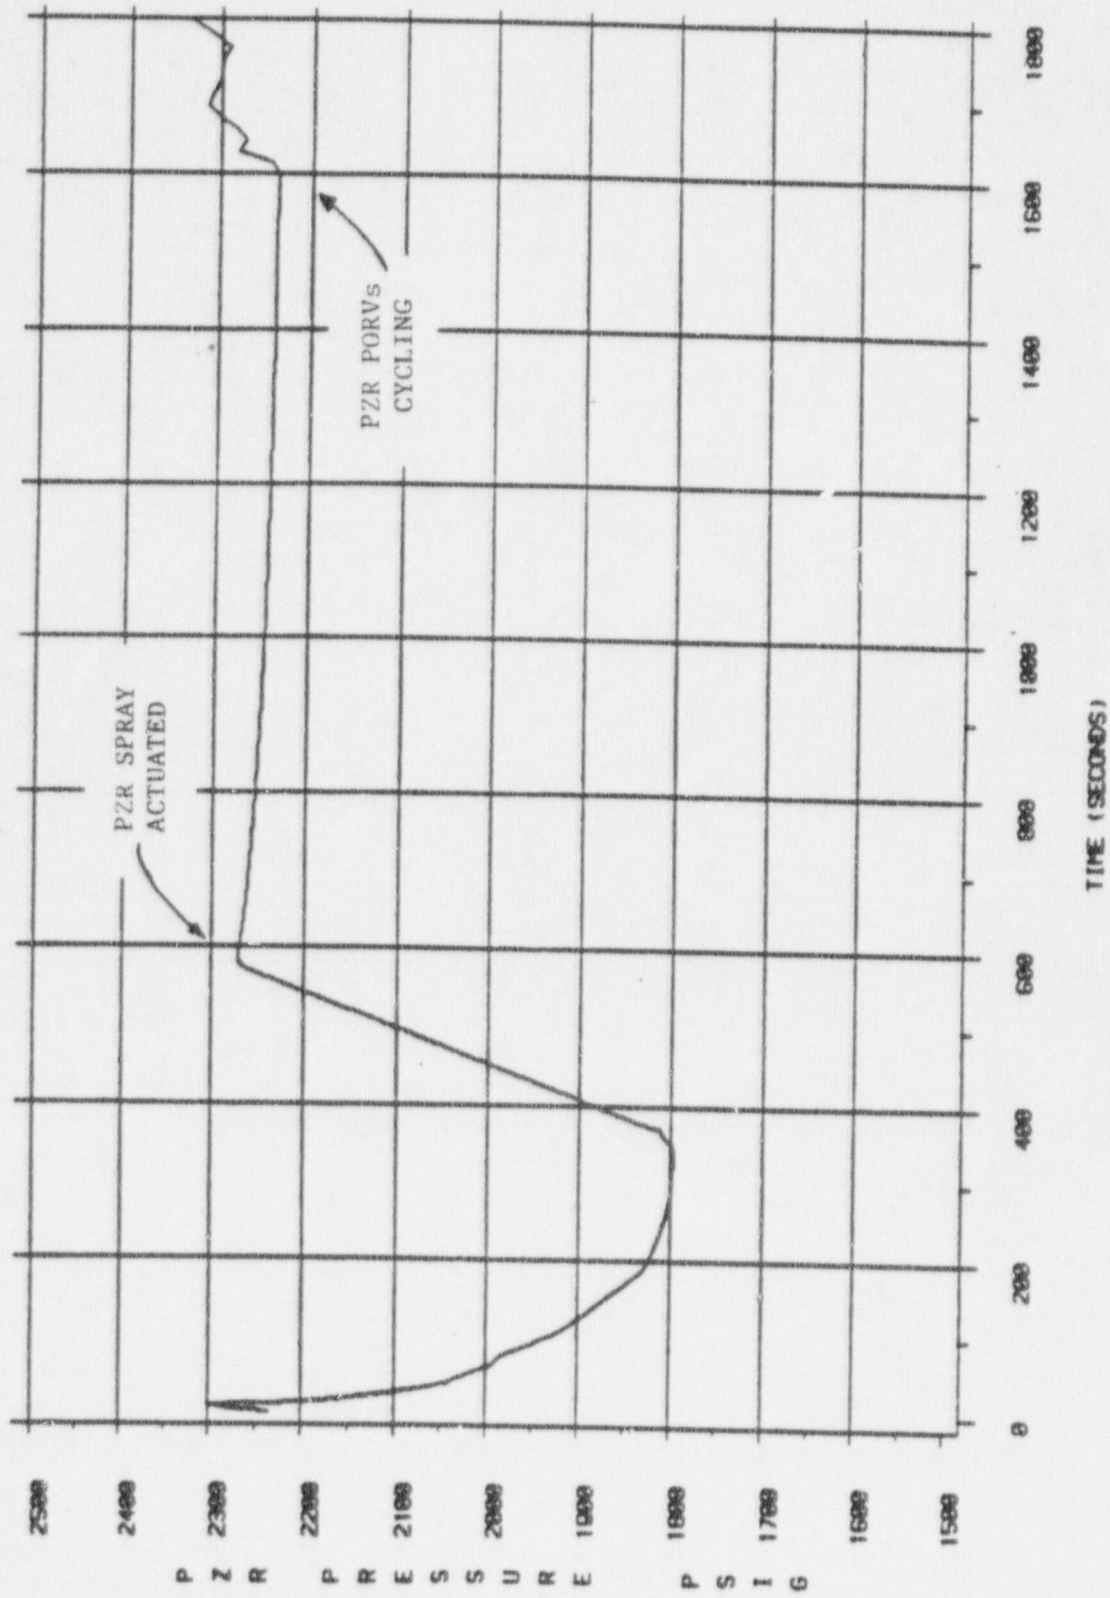
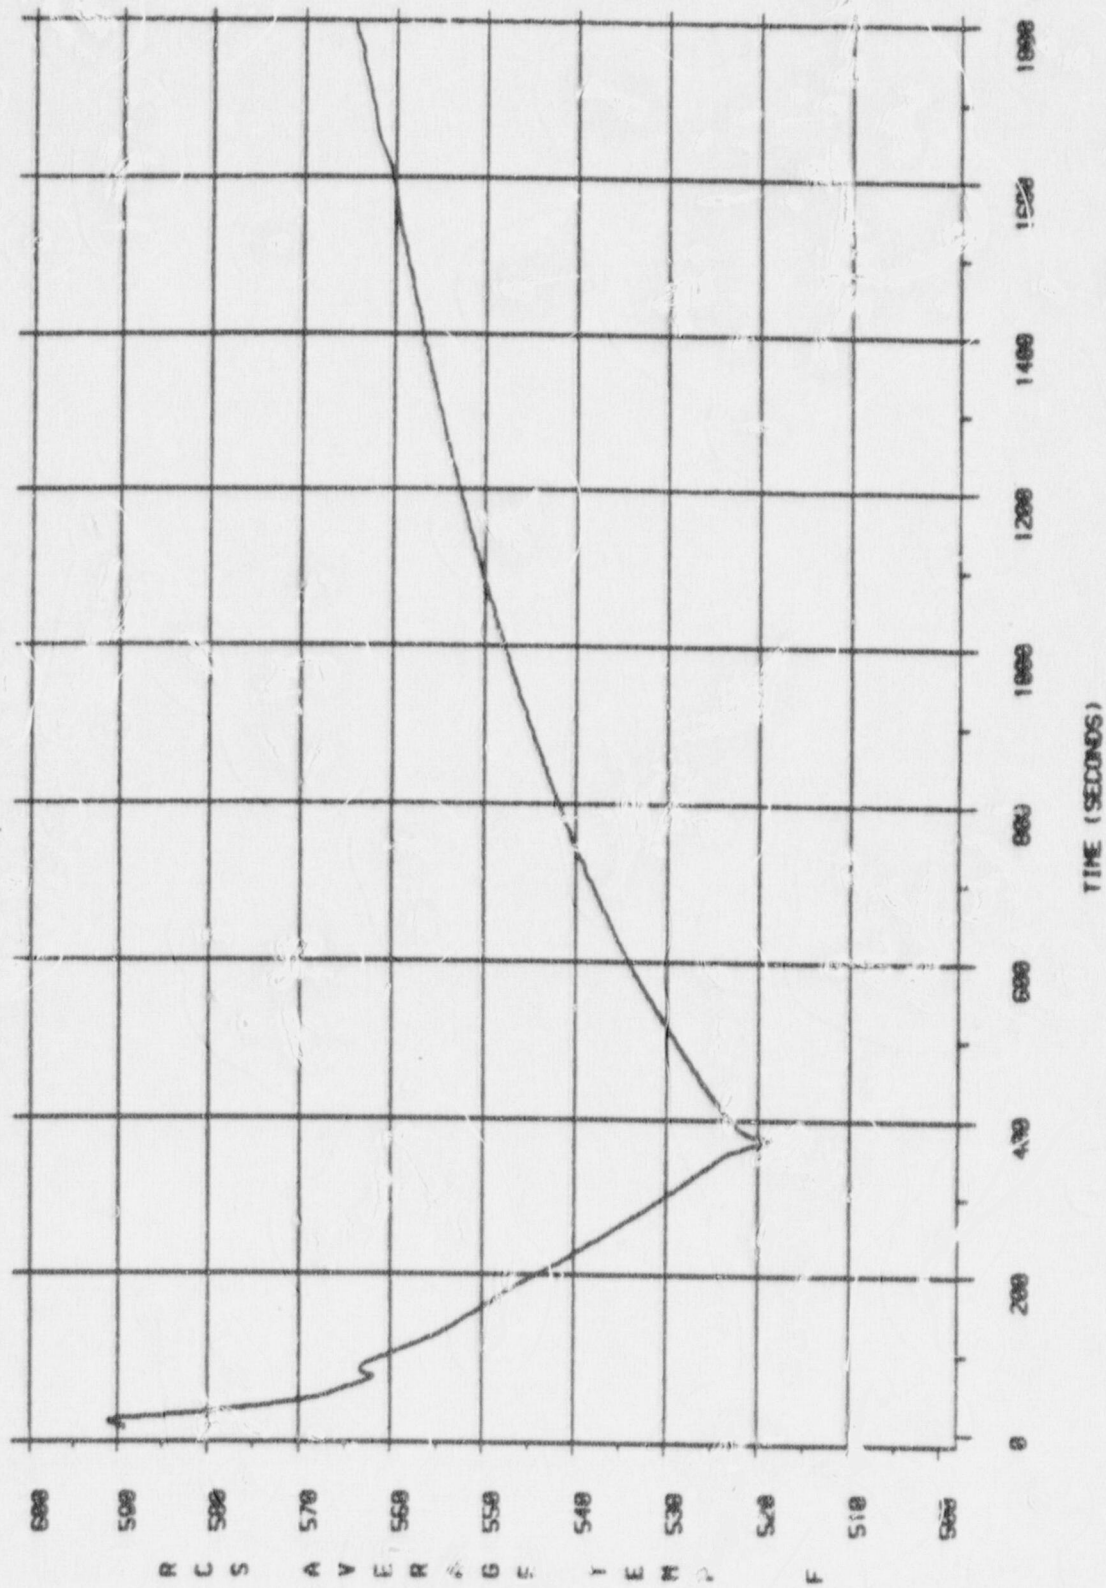
CNS FEEDWATER LINE BREAK WITH DEGRADED AUX FDW

<u>TIME (SEC)</u>	<u>EVENT</u>
0	FEEDWATER LINE BREAK TO SG A
2.7	PZR SPRAY ON
* 5.9	RX TRIP ON LOW-LOW SG LEVEL
6.0	TURBINE TRIP/STEAM DUMP OPENS
10.4	PZR SPRAY OFF
10.9	MOTOR-DRIVEN CA PUMP STARTS
12	PZR HEATERS ENERGIZE
14	ALL SG PORVs OPEN
15	STEAM DUMP BANK 3 CLOSED
26	STEAM DUMP BANK 2 CLOSED
29	ALL SG PORVs CLOSE
46	STEAM DUMP BANK 1 CLOSED
* 55	SG A BOILED DRY
* 173	SAFETY INJECTION ON LOW PZR PRESSURE
183	NV AND NI PUMPS STARTED
310	MINIMUM RCS PRESSURE = 1797 PSIG
* 344	STEAM LINE ISOLATION SIGNAL ON LOW SG PRESSURE
350	MINIMUM PZR LEVEL = 6%
370	MINIMUM T-AVE = 517 ⁰ F
559	PZR HEATERS OFF
571	PZR SPRAY ON
* 1615	PZR WATER SOLID
1624	PZR PORVs BEGIN CYCLING
1800	END OF SIMULATION

- UNIT STATUS AT 30 MINUTES IS NOT SERIOUSLY DEGRADED
 - RCS IS WATER SOLID WITH CHARGING AND SAFETY INJECTION PUMPS ON
 - RCS T-AVE IS 565°F (557°F IS NORMAL POST-TRIP) AND IS INCREASING ~1.5°F/MIN
 - AUX FDW REQUIREMENT TO MATCH DECAY HEAT AND REACTOR COOLANT PUMP HEAT IS 484 GPM
- OPERATOR INTERVENTION AT 30 MINUTES
 - REALIGN AUX FDW
 - MINIMUM AUX FDW FLOW AVAILABLE IS 499 GPM
 - TERMINATE SAFETY INJECTION
- UNIT RECOVERY AND STABILIZATION WITH OPERATOR ACTION AT 30 MINUTES WAS ASSURED
