## SUBTASK REPORT

ISSUE: Accumulator Fill Line FailureAction Plan Item No. : A.2.iTITLE: Kerotest Valve Flow Test

## KEROTEST VALVE FLOW TEST

CHRONOLOGY OF ACCUMULATOR FILL LINE FAILURE

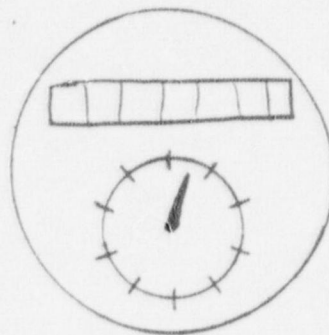
Flowmeter Face

Flowmeter was checked for operation prior to testing by filling two 55 gal drums with tops removed.

Drum dimension :  $22\frac{1}{4}$ "  $\phi$  by  $34\frac{1}{4}$ " deep.  
= 57.6 gal each

1<sup>st</sup> test : Flowmeter read about 115 gal.  
2<sup>nd</sup> test : Flowmeter read about 120 gal.

The drums were right at overflow on 2<sup>nd</sup> test. On first test, they were slightly below the top. I consider the readings to be essentially the same for both tests, considering the difficulties in reading down to 1 or 2 gal and the small differences in drum level between the two tests.

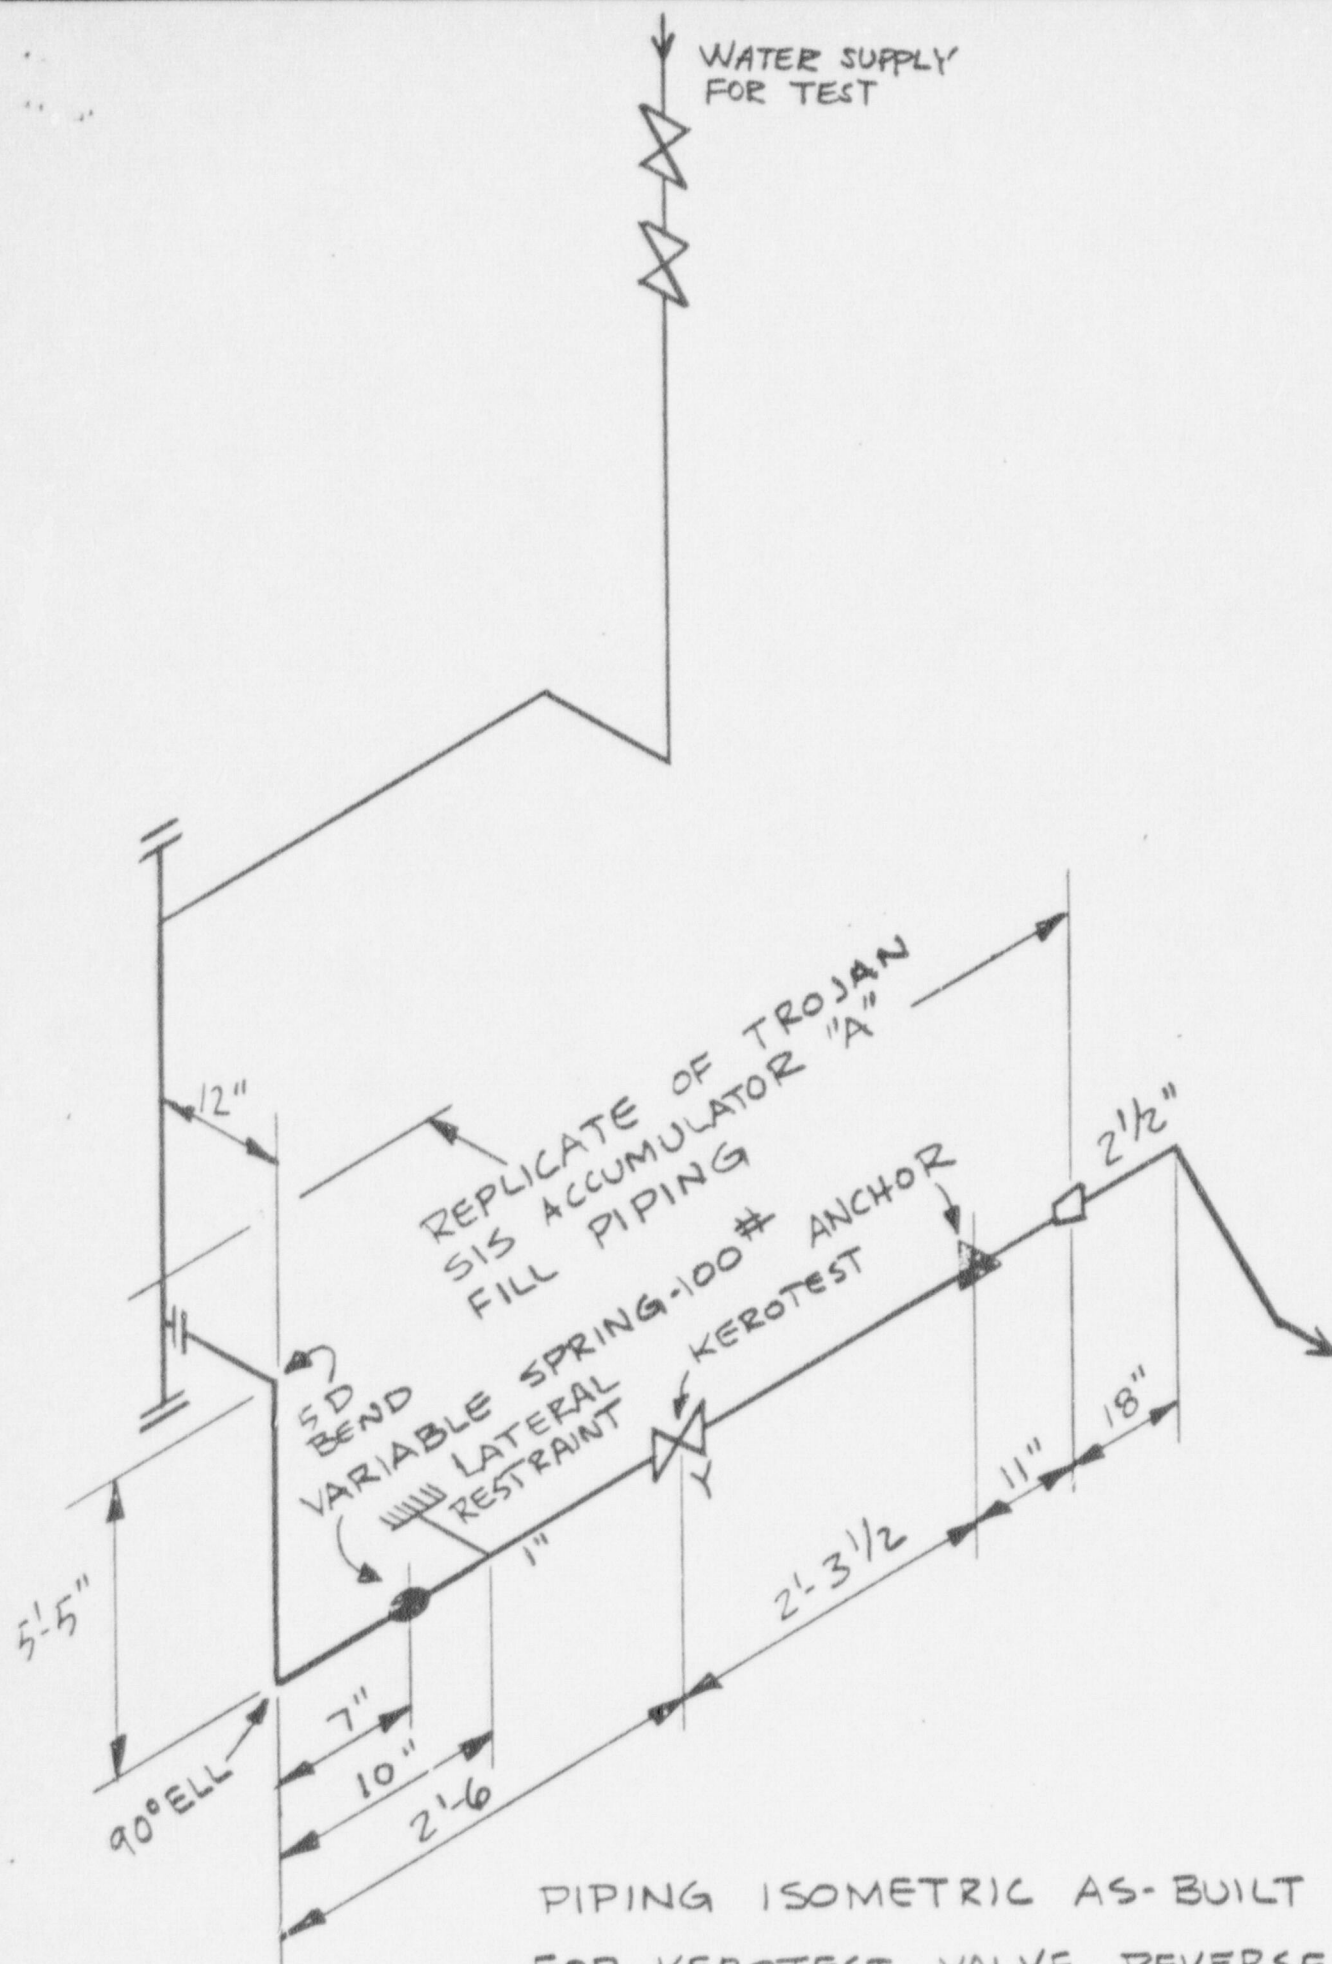
PIPING ISOMETRIC AS-BUILT  
FOR KEROTEST VALVE REVERSE  
FLOW TEST

We established steady state flow conditions at 10, 13, 37, 40 and 63 gpm without valve chatter. We increased flow until chatter started and then reduced flow slightly. We measured a steady state flow of 58 gpm without chatter. When we increased flow again, chatter began and the piping broke, stopping the test, before a measurement could be taken.

Pipe motion during valve chatter was violent, affecting the deslagging system piping about 75 feet away. This piping, however, was very flexible. The noise was loud. The frequency did appear to depend on flow rate as it did sound lower at the threshold than at higher flows. The tabs on the lateral restraint at H-226 location were significantly bent outward. The anchor at location CV8878A did not move.

It is clear to us that the valve chatters violently at high reverse flow rates (about 70 gpm) and that the resulting water hammer can cause rapid failure of the piping at the location corresponding to the accumulator connection. I estimate that the number of cycles to failure was in the vicinity of 100. The piping motion and sound were clearly recorded on videocassette.
