Serving The Best Location in the Nation
PERRY NUCLEAR POWER PLANT

Perry Nuclear Power Plant
Docket No. 50-440
Augmented Inspection Team (AIT)
Status and Commitments

I. Executive Summary

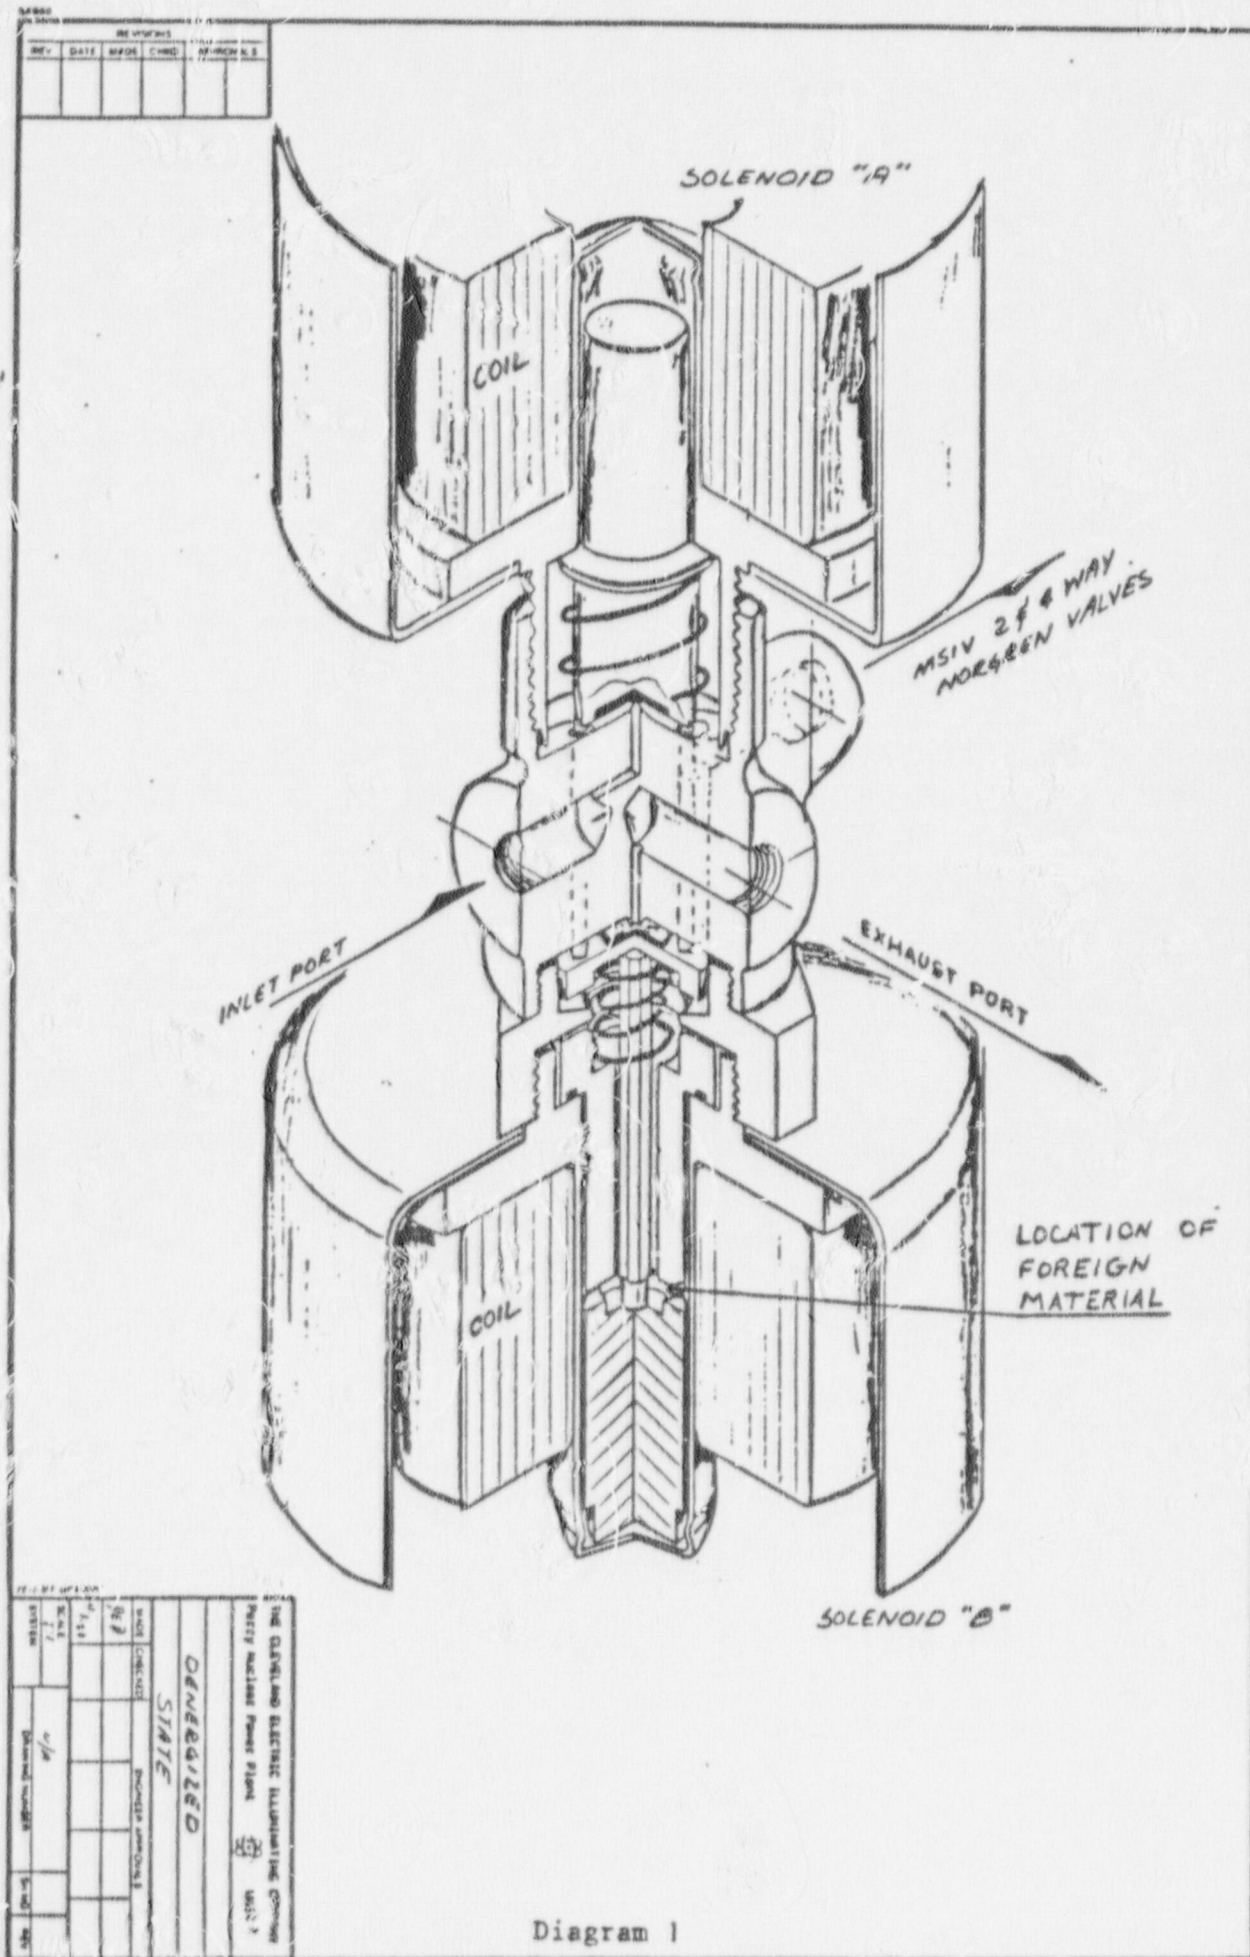
A sliver and two other small segments of foreign material were discovered in solenoid valve body (see Diagram 1).

A detailed root cause analysis was performed and a draft report was provided to the NRC AIT. It concluded that the root cause of the MSIV failure was binding of the "B" solenoid (refer to Diagram 1) due to the presence of foreign material.

During visual examination, a sliver of foreign material (EPDM) was discovered in the 1B21-F022B solenoid valve body core cavity. The material was demonstrated to have come from rebuild activities conducted during the previous MSIV outage (early November 1987). This sliver was inadvertently dropped into the core area of the "B" solenoid and since that portion of the solenoid was not disassembled it was not detected until the current investigation. Inspection of the "B" solenoid core area required removing the "B" coil. However, the leads for the "B" coil would have required cutting to remove the coil. By the time this solenoid valve was being rebuilt, the root cause had already been determined to be heating of EPDM material. Consequently it was decided that the "B" solenoid core area would not require inspection.

The sliver of foreign material caused mechanical binding of the solenoid valve. This binding caused the solenoid to remain in the normally energized position which prevented the air bleed off from the MSIV actuator and thus valve (MSIV) closure.

To prevent recurrence, all MSIV dual solenoid valves have been replaced with new valves and will be cycled 10 times as part of the retest activity prior to reactor startup. In addition, administrative controls will be instituted on future class 1E ASCO solenoid valve work to require the use of new valves or complete disassembly and cleanout to ensure no particles are introduced during the rebuild process.
