SUBJECT: Calvert Cliffs Nuclear Power Plant
Unit Nos. 1 & 2, Docket Nos. 50-317 and 50-318
Failure Analysis Report Summary for Low Pressure Safety Injection
Relief Valve RV-439 Line

CALVERT CLIFFS UNIT 2 SUMMARY OF MATERIALS ANALYSIS OF THE LINE LEADING TO RV-439

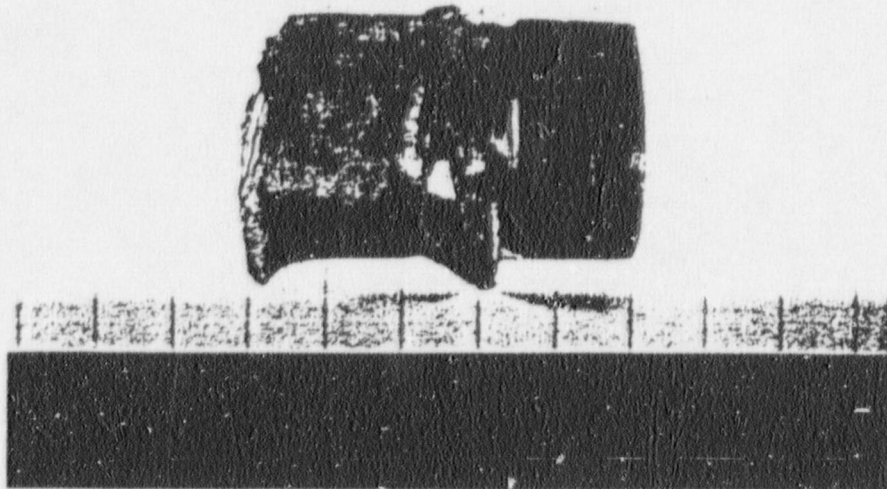
A visual examination of the failed 1/2 inch pipe leading to RV-439 (Low Pressure Safety Injection Relief Valve) revealed a crack on the 1/2 inch pipe that is at an angle of approximately 45° with respect to the fillet weld. The 45° crack intersects the fillet weld and follows the toe of the weld for approximately 3/8 of an inch. The cracked pipe was removed from the line leading to RV-439 for further examination (see Figure No. 1)

Figure No. 1 Section Containing Crack in as Removed Condition

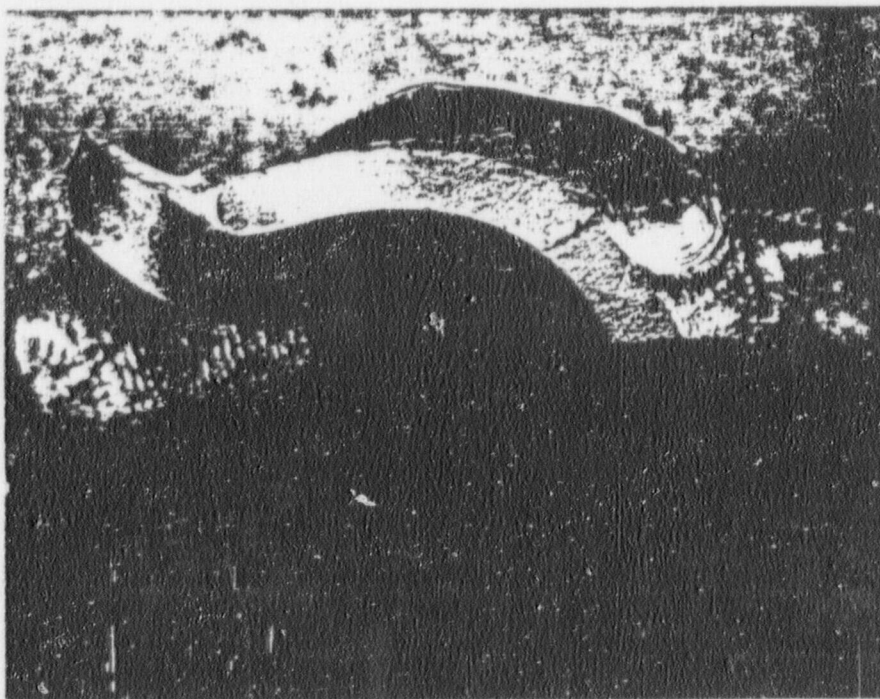
Microscopic examination of the pipe spool fracture surface in the laboratory indicated two cracks initiated at the toe of the fillet weld approximately 1/8 of an inch apart. These cracks grew in slightly different planes creating the step (or ratchet mark) observed at in Figure No. 2. The crack to the right of the step in Figure No. 2 continued to propagate along the toe of the weld while the crack to the left veered off at a 45° angle to the toe of the weld. A schematic is shown in Figure No. 3 that highlights the features discernible on the fracture surface. The radial lines extending from points A and B indicate these were the sites of crack initiation. There was no evidence of beach marks on the fracture surface of the crack that initiated at point B and only faint beach marks near the very end of the crack initiating from point A.

Figure No. 2 Fracture Surface of Cracked Pipe Showing a Ratchet Mark at Point 1

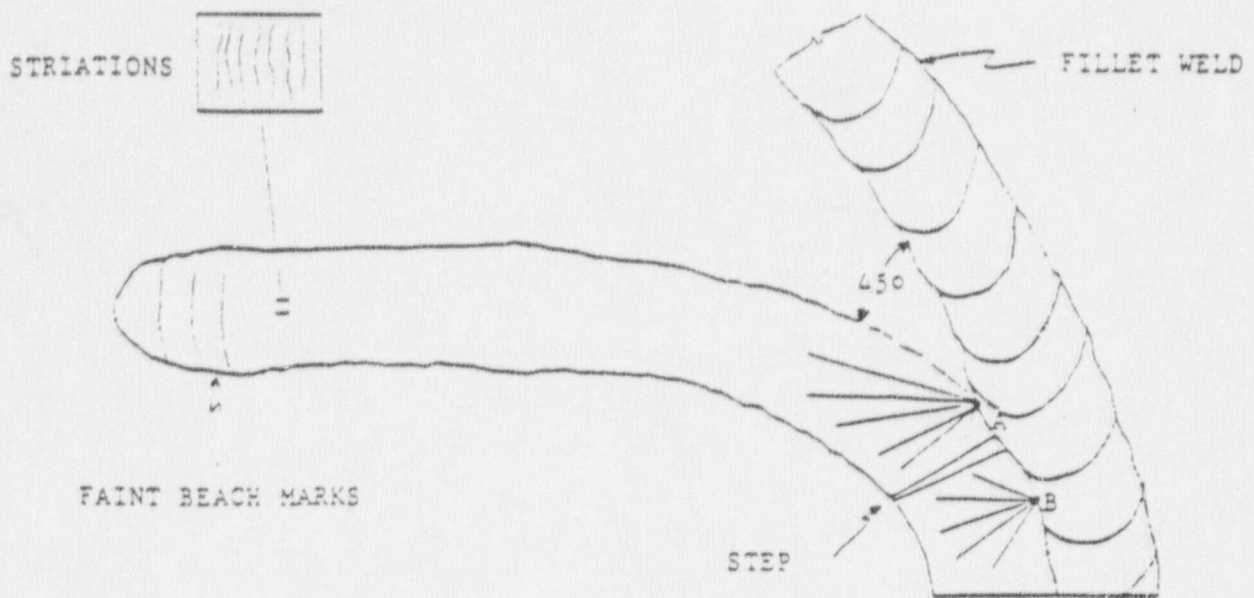
Figure No. 3 A Schematic of the Fracture Surface Highlighting Discernible Features from the Examination

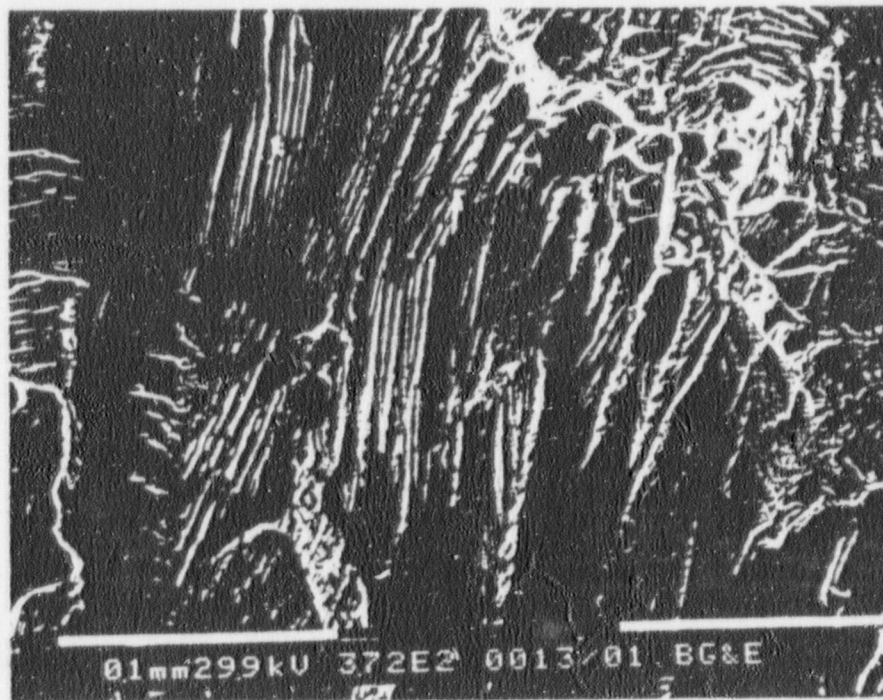
A scanning electron microscope examination of the fracture surface around the initiation sites did not reveal any latent defects that could be responsible for the initiation of these cracks. An interesting area found near initiation site A is shown in Figure No. 4. This area has a faceted appearance and river patterns indicating crack propagation along preferred crystallographic planes. This is typical of stage I fatigue often observed near the point of initiation. No discernible striations were observed in the through wall area near the initiation sites but striations were observed from the middle to the end of the 45° crack (see Figure No. 5). If the spacing for the striations in this area is projected over the entire surface the number of cycles involved in the propagation of the crack would be greater than 6000.

Figure No. 4 Faceted Area Near the Initiation Site

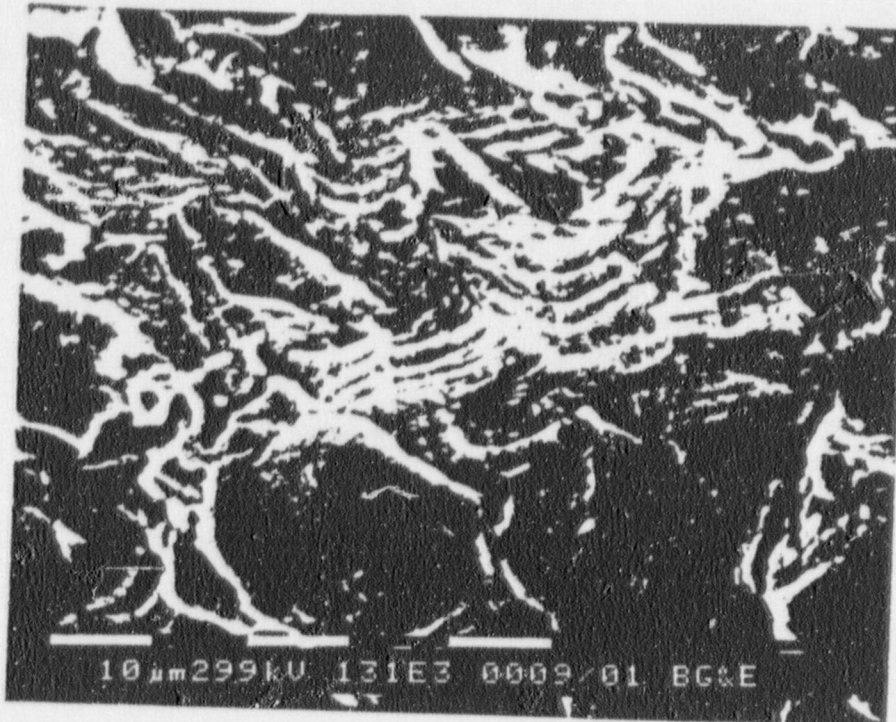
Figure No. 5 Striations Observed on the Fracture Surface Near the
End of the 45° Crack
