DRAFT REV. 0

CPRRG
TASK GROUP 3
REPORT OF
SAFETY SIGNIFICANCE

February 1987

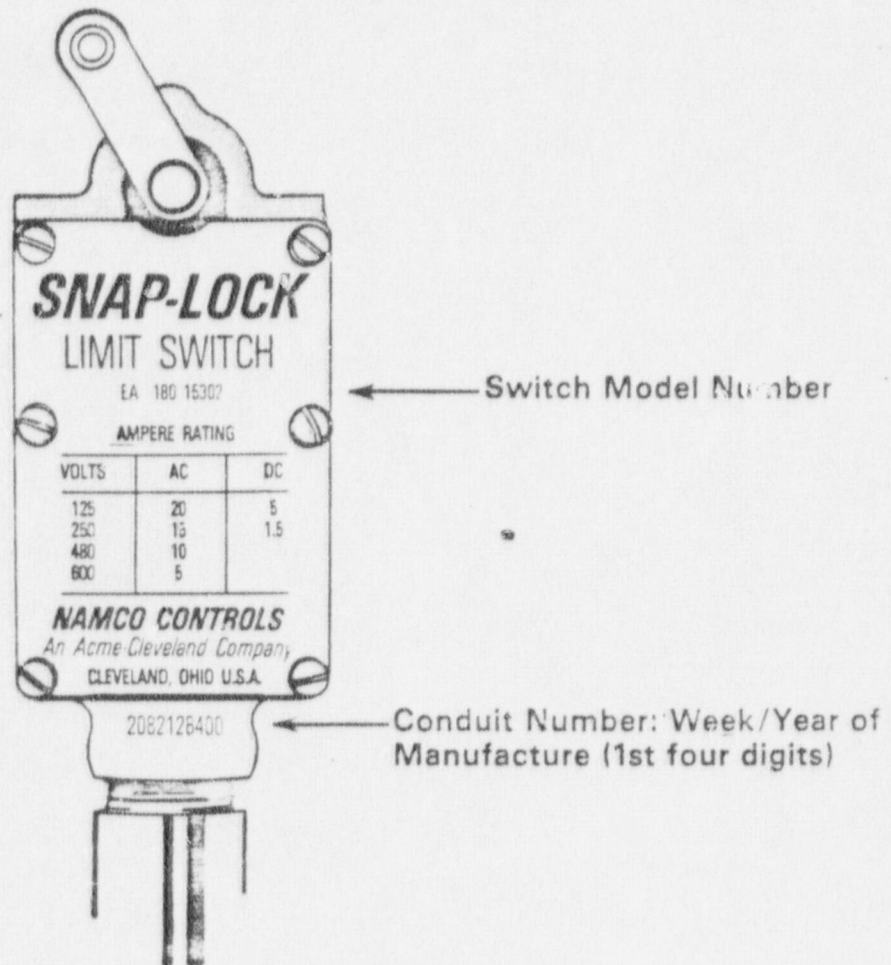
NAMCO Limit Switch

8. NAMCO switches IEB 79-28 were not properly identified on installation travelers.	Unresolved Item 445/8516-U-04 446/8513-U-04	None	Adequate - as installed configuration satisfies the design requirements for the two switches-- EQ CAP complete field verification on Class IE equipment with documentation.	<ol style="list-style-type: none"> 1. Assure applicants understand root cause for traveler mismatch with equipment; 2. Assure records system is structured such that equipment record affected by in-plant equipment changes are identified and tracked to completion; 3. Determine the cause and implication of the apparent breakdown of the development of travelers for the entire NAMCO switch replacement effort; and 4. Monitor the applicants' on-going programs (EQ CAP) to confirm that the correct switches have been installed. 	3.14
