LICENSEE EVENT REPORT (LER)

FACILITY NAME (1): **Nine Mile Point Unit 2** DOCKET NUMBER (2): **05000410** PAGE 3  
 TITLE (4): **Two ESF Actuations Consisting of Standby Gas Treatment Initiations Caused by Inadequate Administrative Policy and Personnel Error**

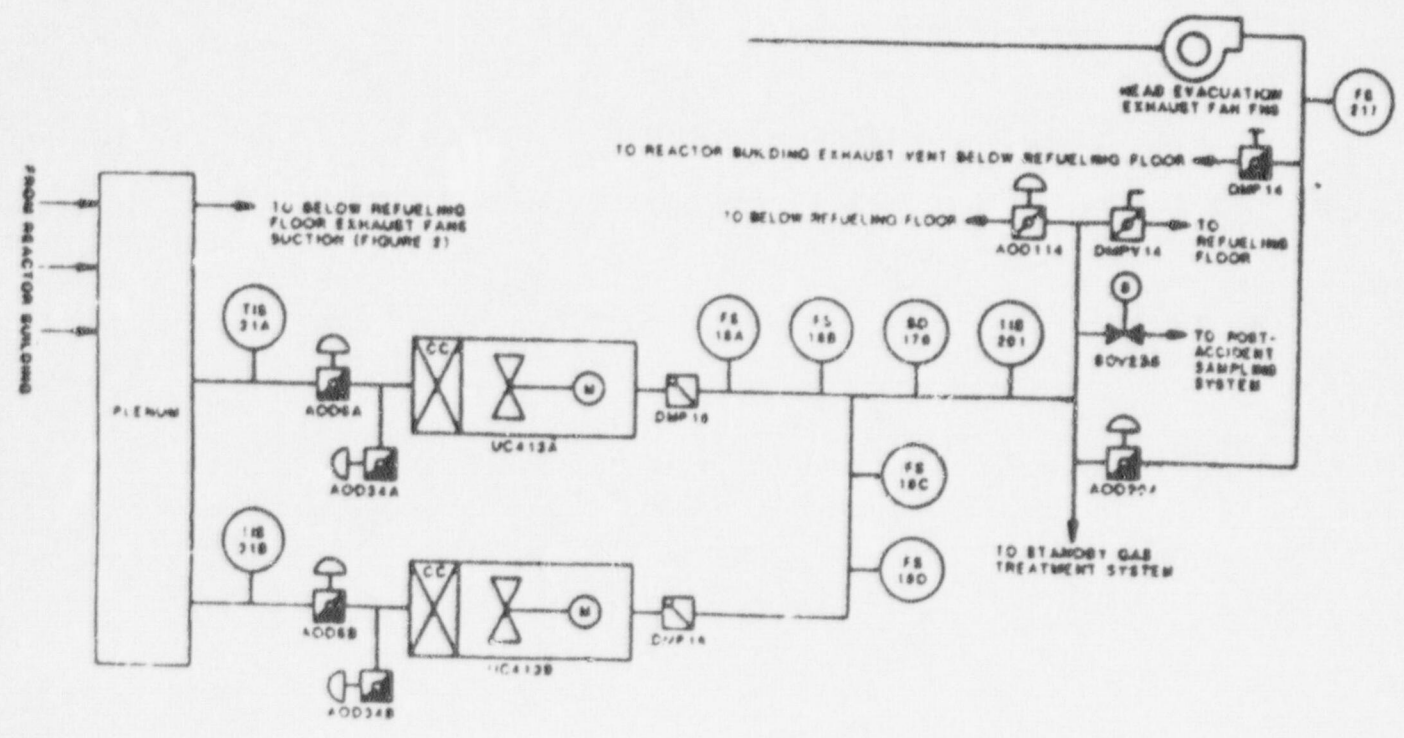
### FIGURE 1

## REACTOR BUILDING VENTILATION - EMERGENCY RECIRCULATION SUBSYSTEM

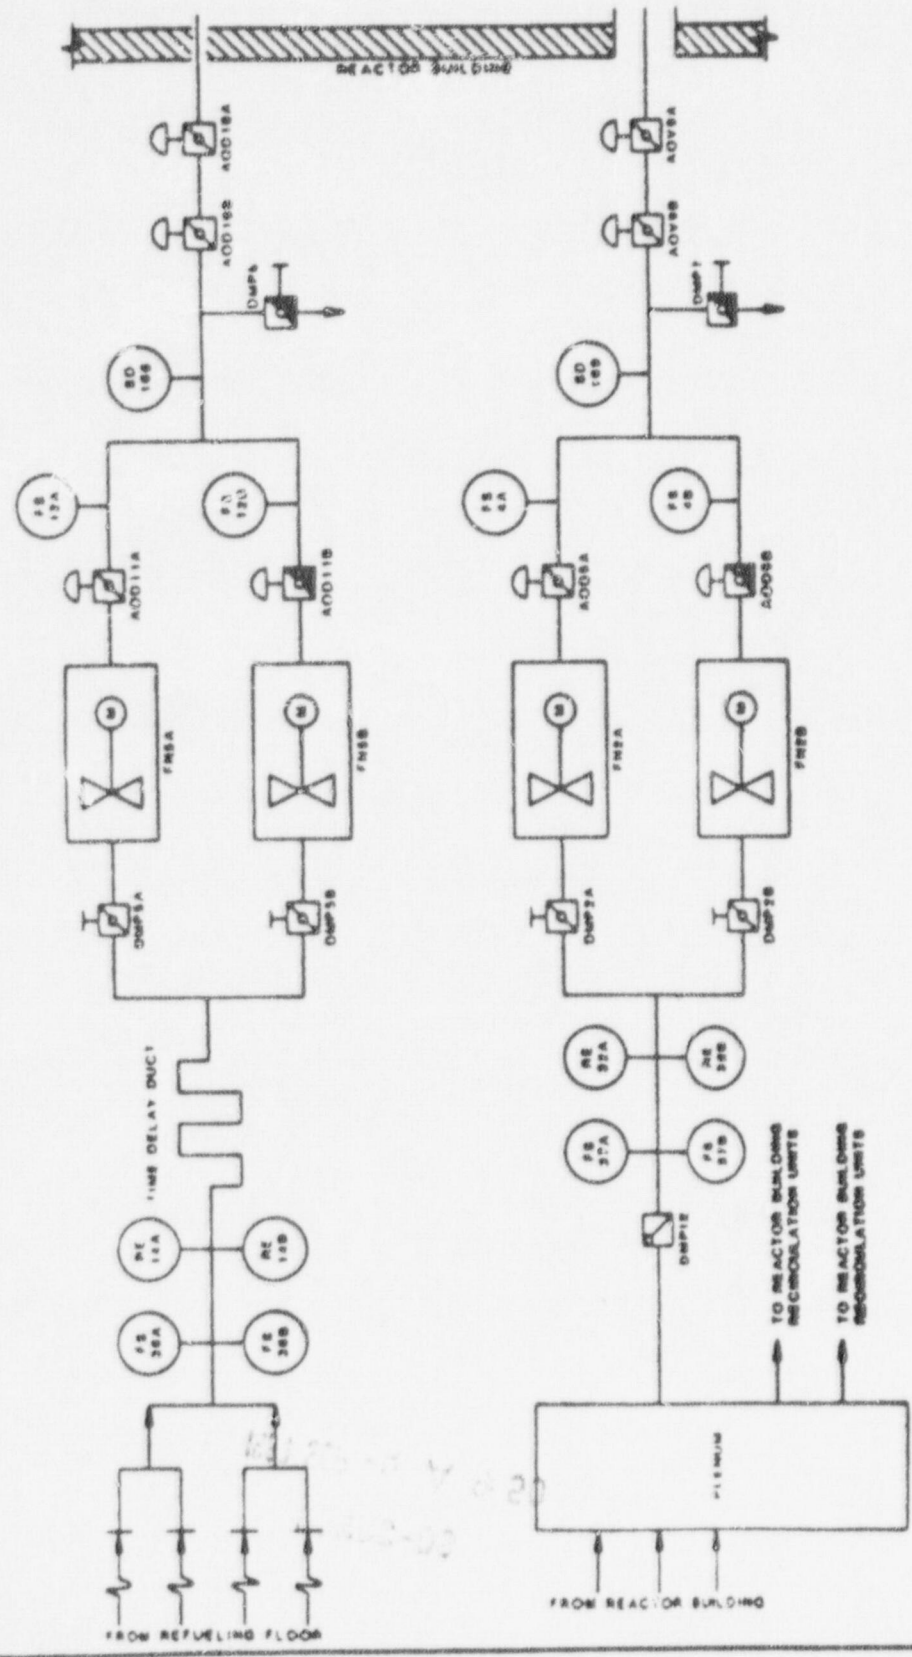
FIGURE 2

REACTOR BUILDING NORMAL EXHAUST VENTILATION
