JUNE 10, 1987
SEISMIC EVENT REPORT

CLINTON POWER STATION
ILLINOS POWER COMPANY

PROJECT NO. 7685-22
DATE: JUNE 12, 1987

Sargent & Lundy
Chicago, Illinois

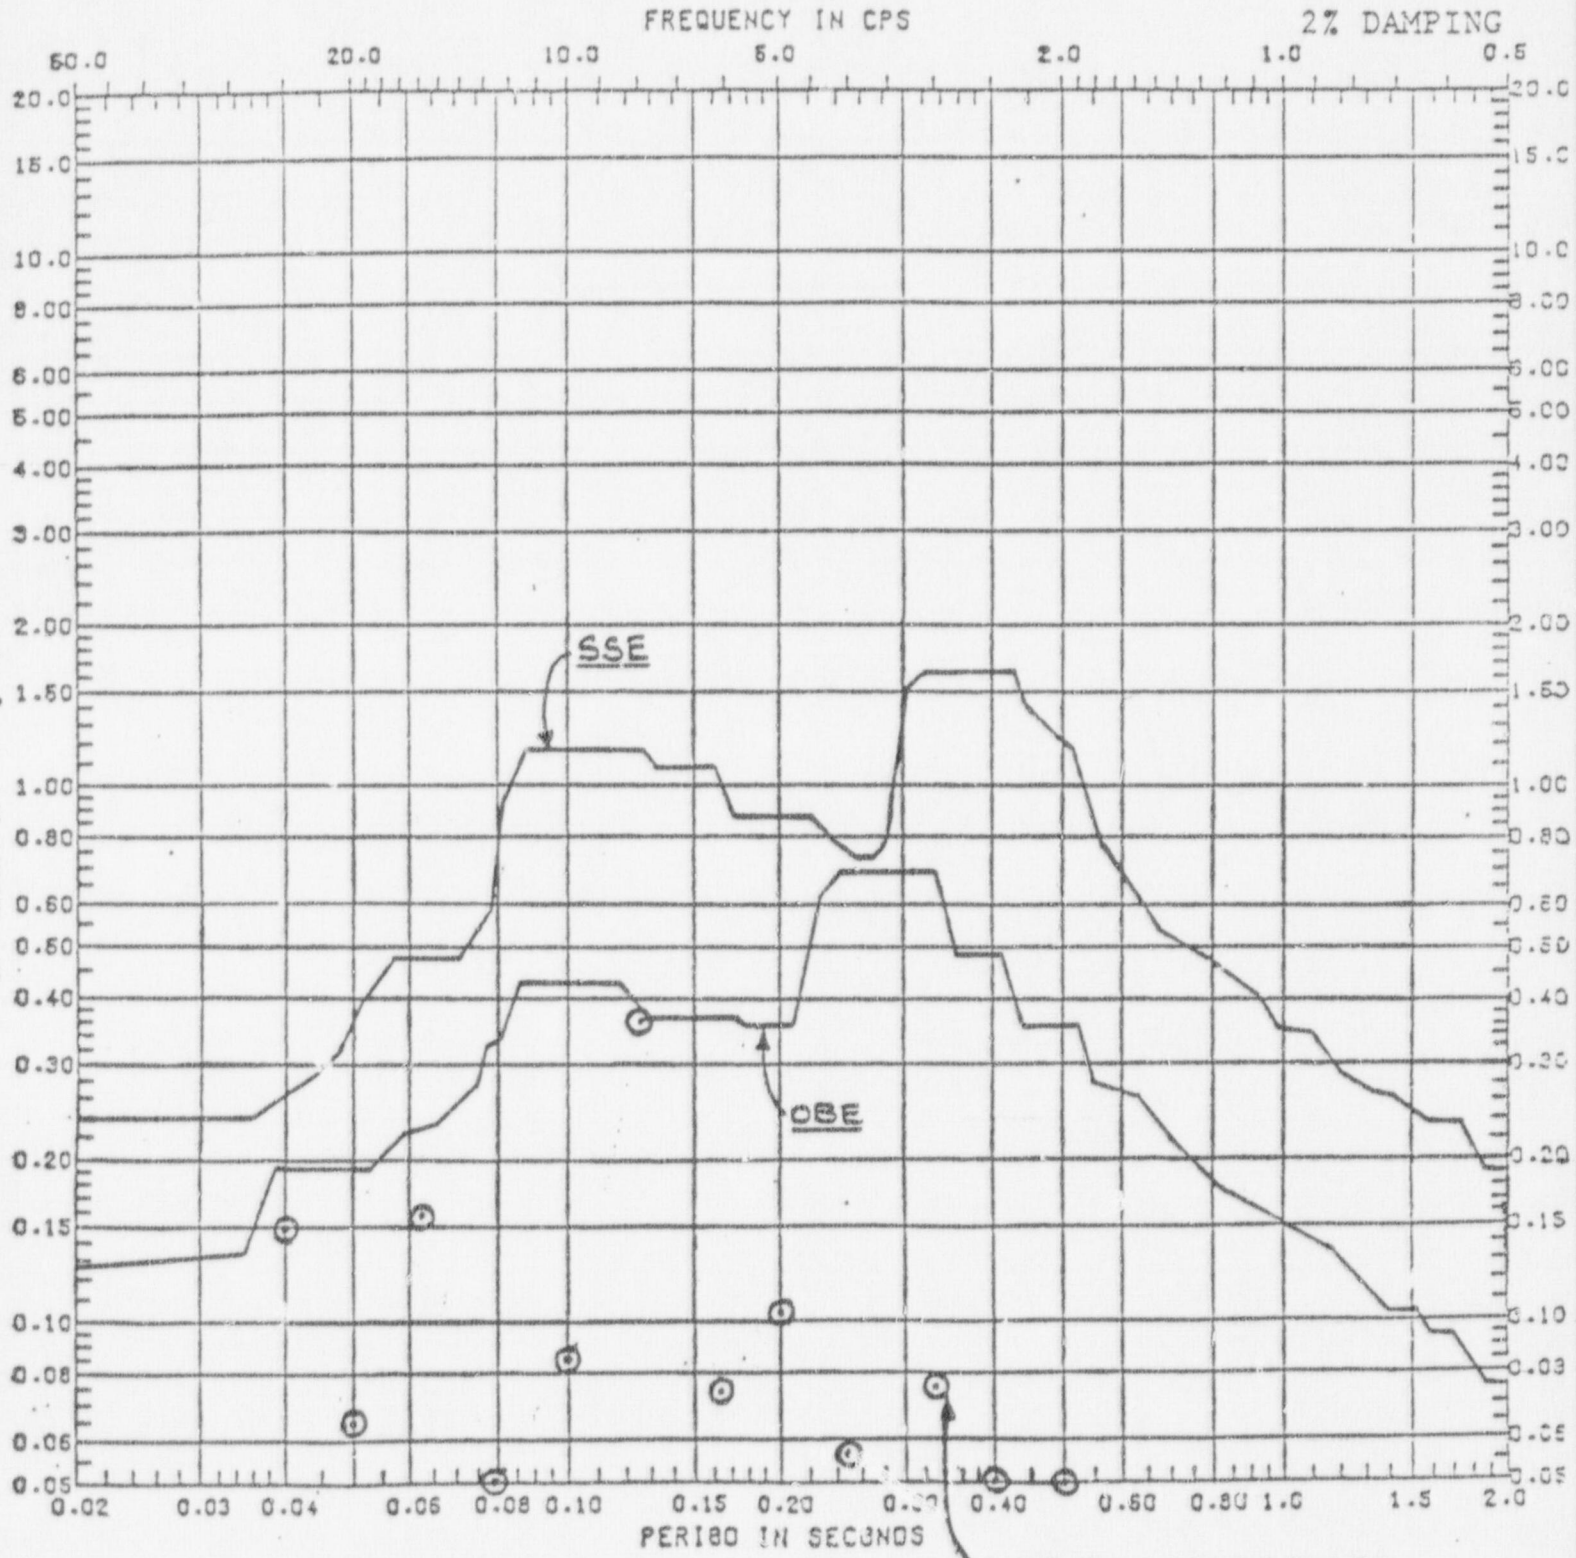
FIGURE-1

It can be observed that the vertical and the N-S recorded spectra are enveloped by the corresponding OBE spectra. The recorded E-W spectra is also enveloped by the corresponding OBE response spectra except at 20 Hz and 25 Hz.

All recorded responses are lower than the corresponding SSE spectra.

CLINTON UNIT-1
CIRCULATING WATER SCREEN HOUSE
ELEVATION 699'-0"
LOCATION MAIN FLOOR

ACCELEROGRAPH DATA
SPECTRA VERTICAL

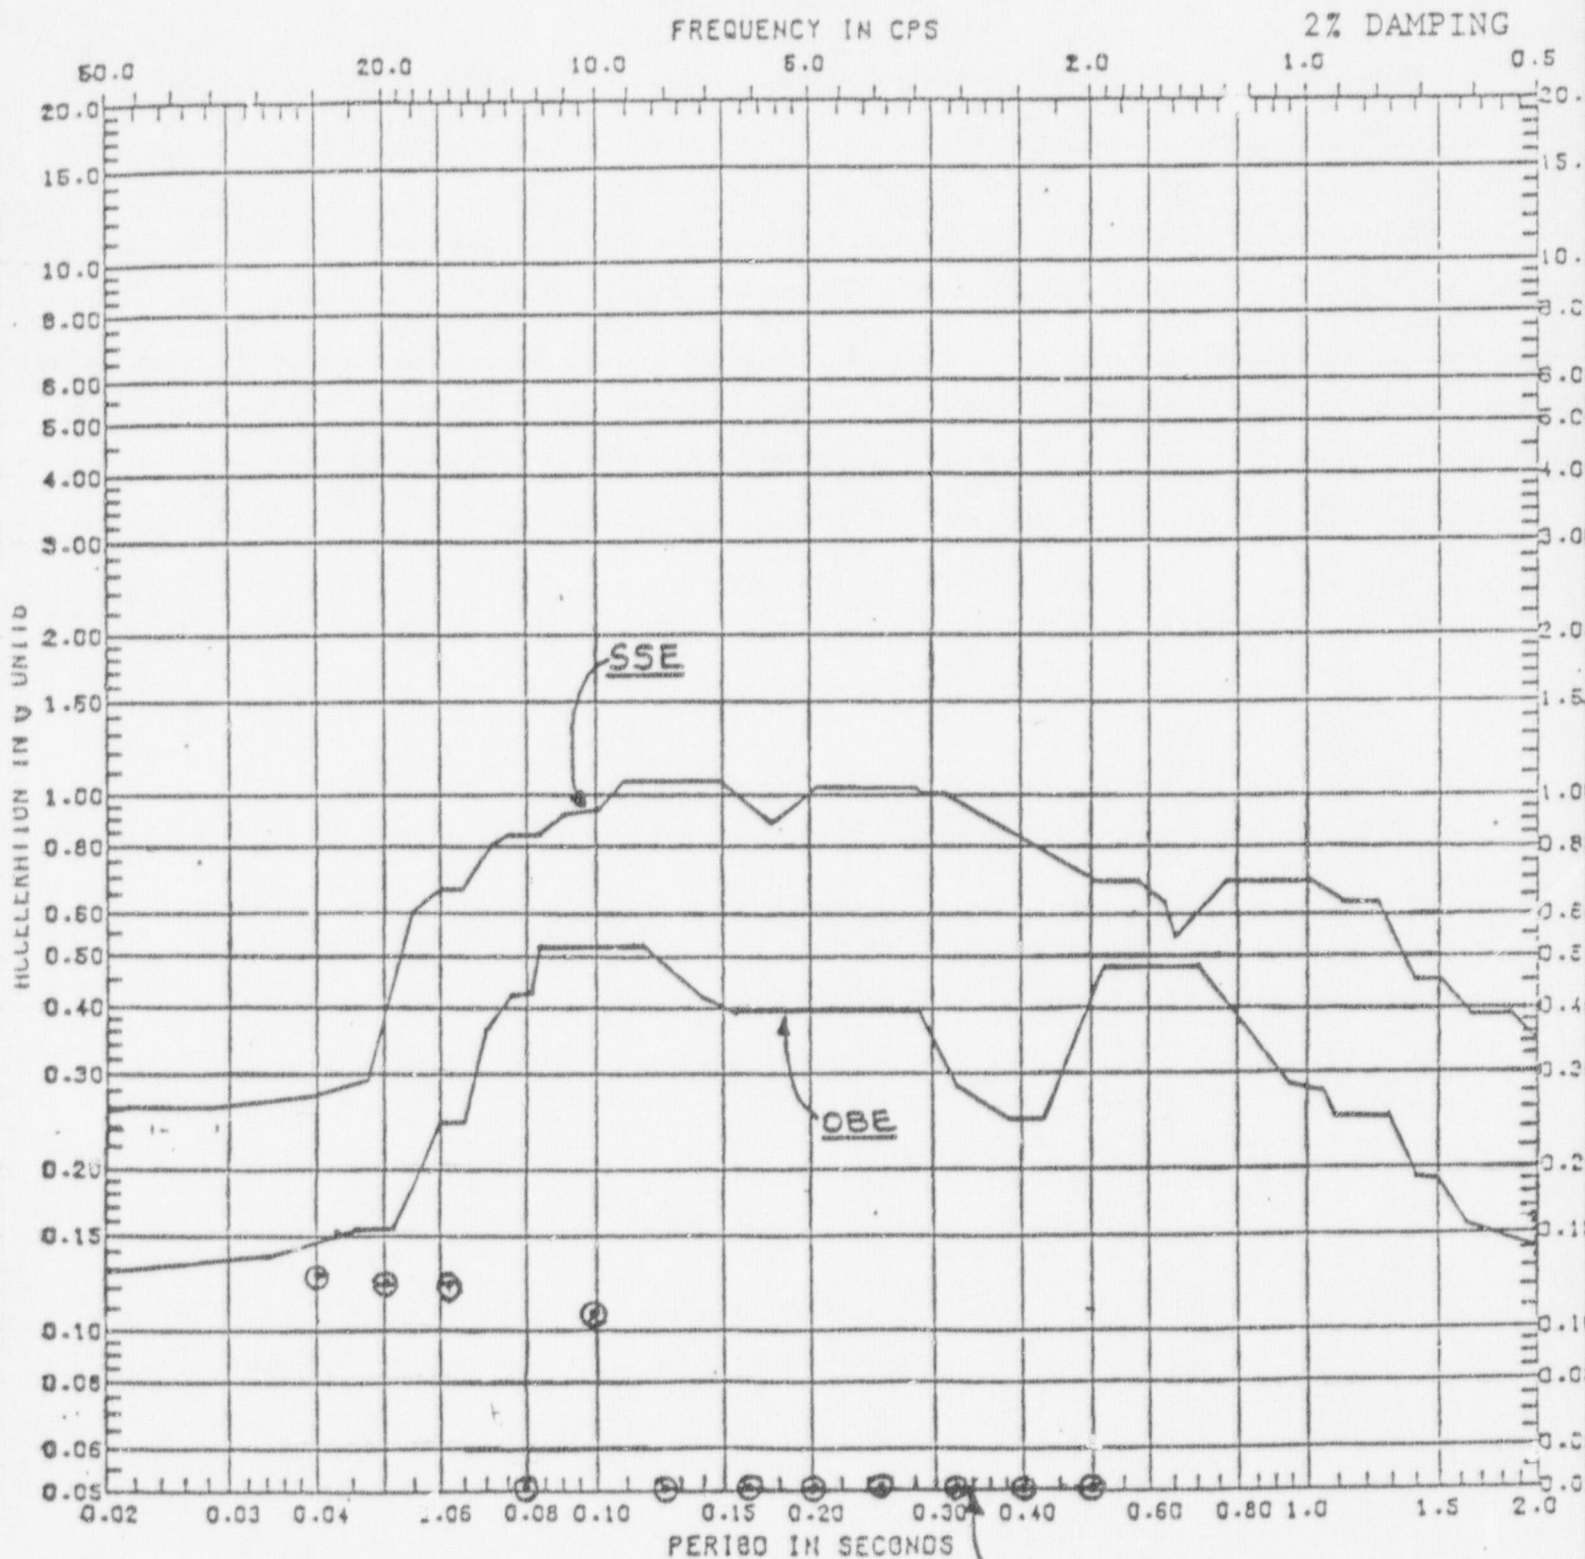
FIGURE-2

CLINTON UNIT-1
CIRCULATING WATER SCREEN HOUSE
ELEVATION 699'-0"
LOCATION MAIN FLOOR

ACCELEROGRAPH DATA
SPECTRA HORIZONTAL - NS

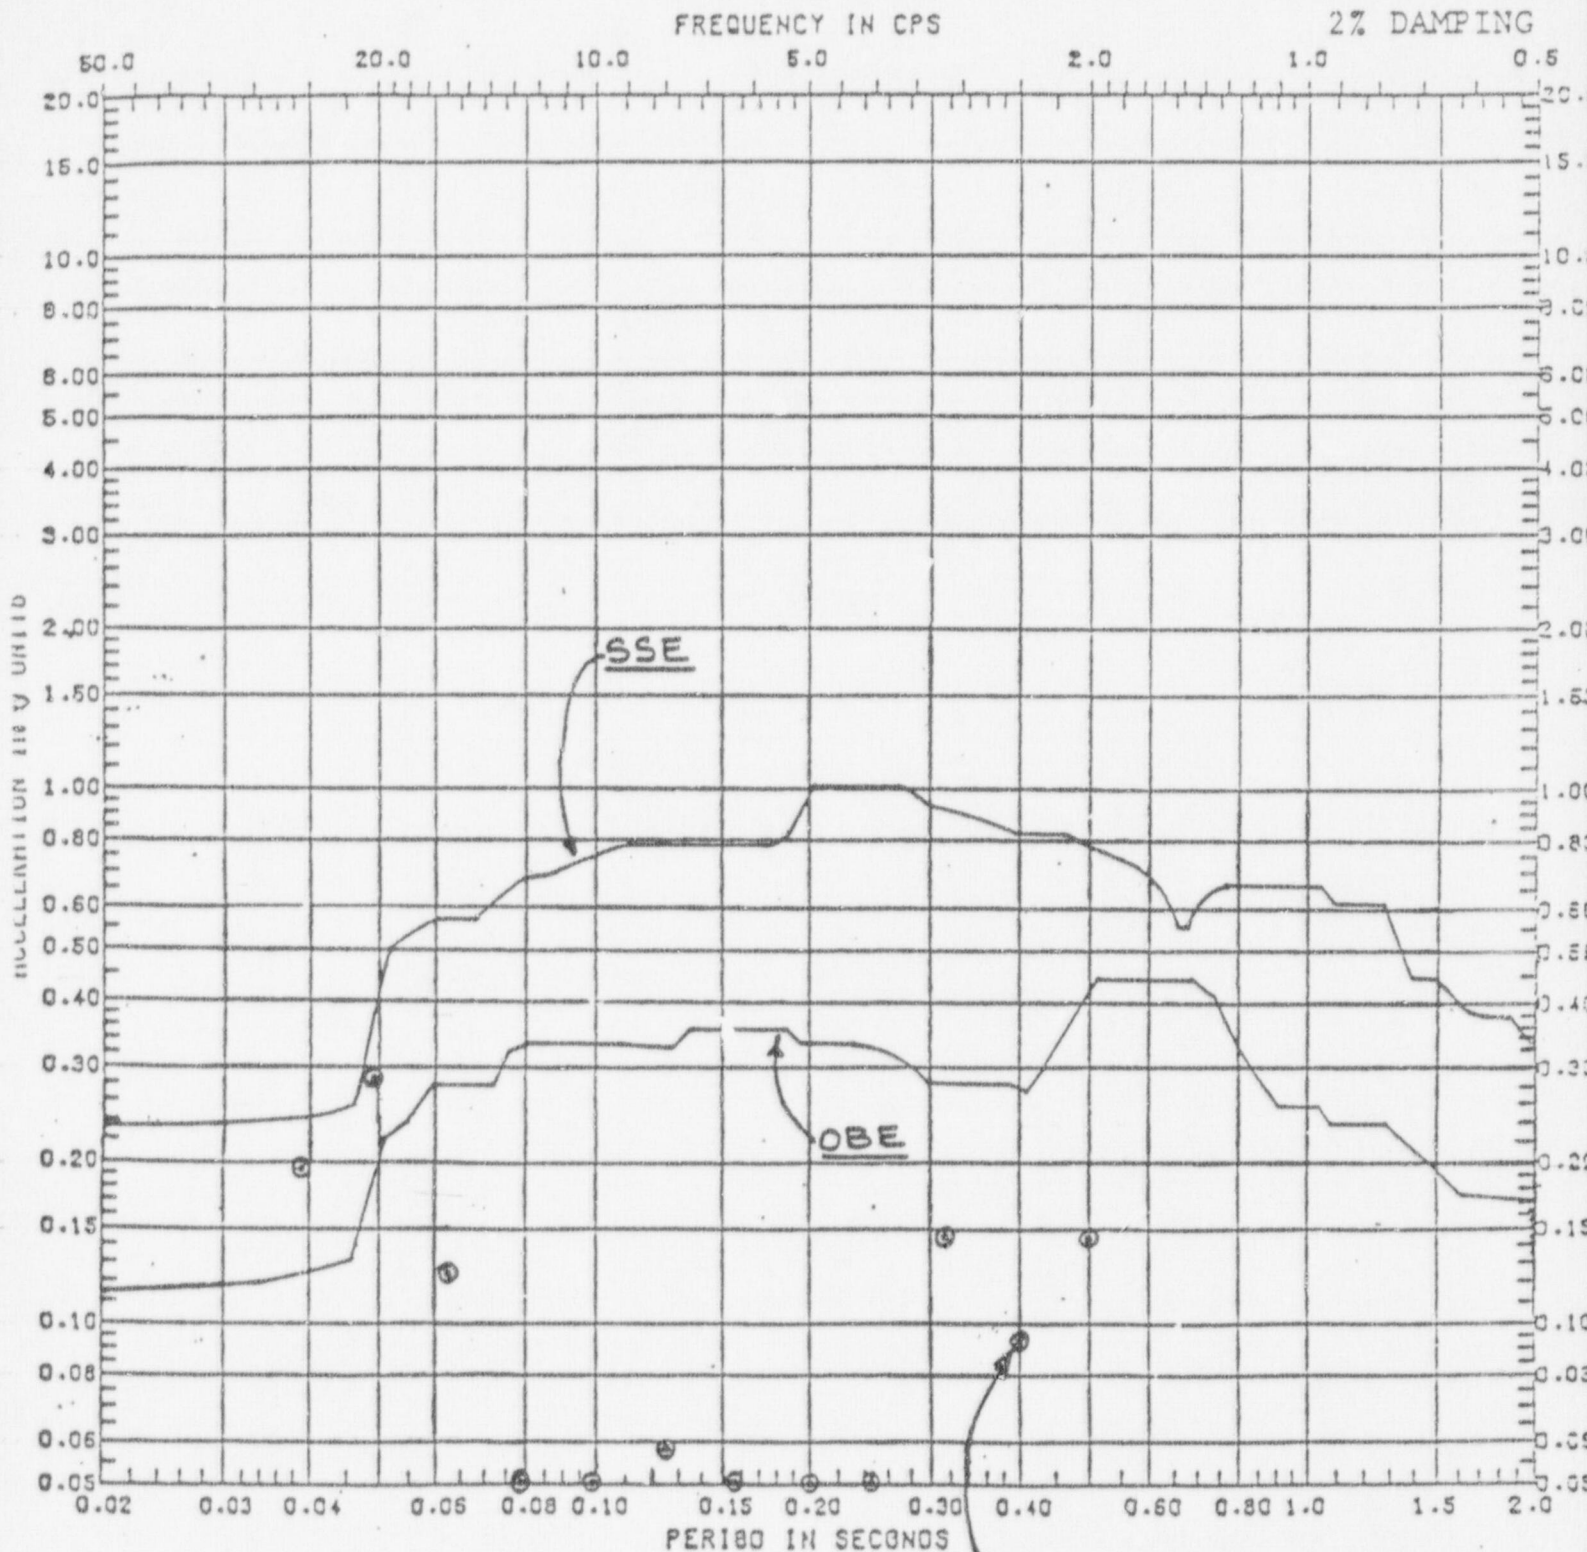
FIGURE-3

- B. The exceedance at two of the frequencies (20 Hz and 25 Hz) is indicative of high frequency contents of the ground motion and thus, is not significant (see NUREG-0887, Safety Evaluation Report, Supplement No. 9, Perry Nuclear Power Plant, March 1986). It is not unusual for lower magnitude earthquakes to have high amplitude, high frequency peak accelerations of limited durations. These high frequency peak accelerations are usually of short duration and little energy and do not cause damage.
- C. The response spectrum recorder is passive equipment. If prior to the earthquake the instrument was bumped, imparting a shock, the recorded reading may be indicative of the magnitude of this shock and not the earthquake motion. This is more likely to affect the high frequency recording.

CLINTON UNIT-1
CIRCULATING WATER SCREEN HOUSE
ELEVATION 699'-0"
LOCATION MAIN FLOOR

SPECTRA HORIZONTAL - EW
