PEACH BOTTOM ATOMIC POWER STATION

SUBJECT: Licensee Event Report  
Peach Bottom Atomic Power Station - Unit 2

This LER concerns the Inoperability of the High Pressure Coolant Injection (HPCI) System as a result of incorrect wiring of an analog isolator recently installed in the HPCI System flow controller loop.

FACILITY NAME (1) Peach Bottom Atomic Power Station - Unit 2										DOCKET NUMBER (2) 0 5 0 0 0 2 7 7										PAGE (3) 1 OF 0 5			
TITLE (4) High Pressure Coolant Injection (HPCI) System Inoperable Resulting From A Flow Controller Analog Isolator Wired Incorrectly																							
EVENT DATE (5)			LER NUMBER (6)				REPORT DATE (7)			OTHER FACILITIES INVOLVED (8)													
MONTH	DAY	YEAR	YEAR	SEQUENTIAL NUMBER	REVISION NUMBER	MONTH	DAY	YEAR	FACILITY NAMES						DOCKET NUMBER(S)								
0	5	0	5	8	9	8	9	0	0	9	0	0	0	6	0	5	8	9	0	5	0	0	0
OPERATING MODE (9) N		THIS REPORT IS SUBMITTED PURSUANT TO THE REQUIREMENTS OF 10 CFR 5. (Check one or more of the following) (11)																					
POWER LEVEL (10) C1014		20.402(b)				20.405(c)				50.73(a)(2)(iv)				73.71(b)

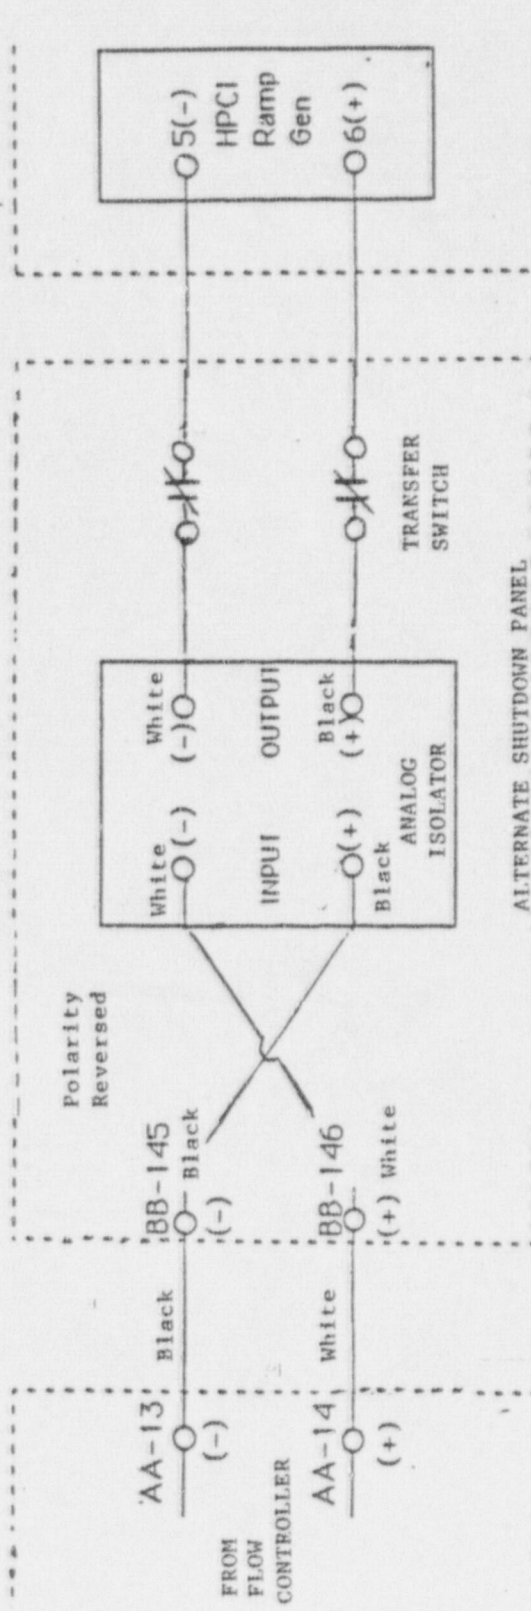
## ATTACHMENT 1

Improper Installation - The installation error (by a contract journeyman electrician) resulted in a discrepancy in the configuration of the analog isolator. The polarity was reversed between the flow controller and the ramp generator (EIIS:GEN). The causes of this discrepancy were:

- (1) Making field connections using the industry standard practice of color matching (black to black, etc) in lieu of point to point as specified in the installation instructions. Polarity reversal occurred at this point.
- (2) Applying the industry standard practice of positive (+) to black and negative (-) to white when bench wiring the isolator without regard to the external wiring color convention. Peach Bottom does not utilize a wire color standard.

SIMPLIFIED HPCI FLOW CONTROL

LOOP DIAGRAM (Partial)
