LICENSEE EVENT REPORT (LER)

FACILITY NAME (1) Calvert Cliffs, Unit 1	DOCKET NUMBER (2) 0 5 0 0 0	PAGE (3) 1 OF 0 7
---	--------------------------------	----------------------

TITLE (4)
Damaged LPSI/Shutdown Cooling Suction Piping Restraint

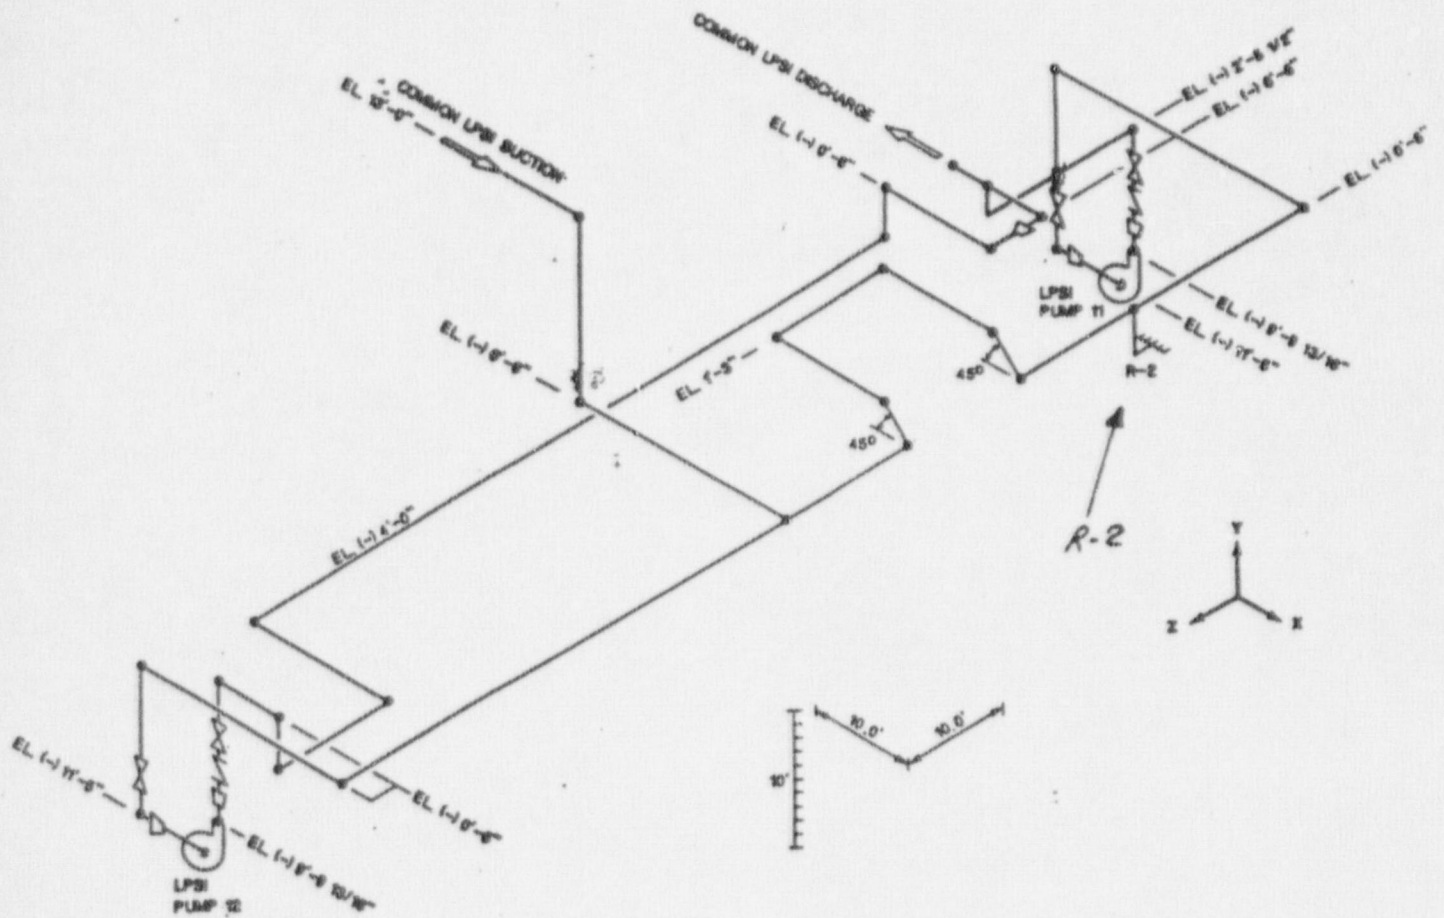
FIGURE 1
UNIT 2 LPSI/SHUTDOWN COOLING PIPING

On March 17, 1989, while performing a test on #11 Containment Spray pump, with the plant at 0% power and in Mode 5, the system engineer identified a bent vertical support for a piping restraint (restraint R-2) on the LPSI suction piping in Unit 1 (see Figure 1). The system engineer immediately notified the quality control, design engineering, and inservice inspection (ISI) groups. The system engineer then took pictures of the damaged support and along with a design engineer informed the Shift Supervisor that the shutdown cooling system should be declared inoperable due to the bent restraint. Operators made provisions to use the steam generators for decay heat removal, to meet the intent of technical specification requirements, while keeping the shutdown cooling system in service because it was still functional.

Further inspection that evening revealed a 13/16" deflection on the east vertical members of restraint R-2. The design engineer then contacted Bechtel Power Corporation to discuss the problem and develop an action plan that would address the analysis and redesign of restraint R-2.

* Both of the east side verticals were bent back about 13/16". The normal distance between the stanchion on the pipe and the vertical members is 1/16".

* The horizontal beams and base plate connected to the vertical members and attached to the ceiling were also damaged. The deflection on the lower flange of the beams was approximately 1/8" and on the upper flange approximately 1/16". FEC-89-01-35 was written to replace the beams and base plate with stronger ones.

The supports for the R-2 piping restraint were damaged due to the slamming of #12 LPSI discharge check valve when #12 LPSI pump was stopped while both LPSI pumps were running. The damage most-likely occurred when the check valve slammed shut thereby causing a pressure wave in the west direction with a resulting force in the east direction back towards the pump and the suction piping. The supports were not of sufficient design to withstand the forces generated by the check valve slam.

1. A new, stronger design for the R-2 restraint was installed.
2. ISI performed a walkdown of Unit 1 low pressure safety injection, high pressure safety injection, containment spray, and component cooling water piping supports. No damage attributable to pipe movement from check valve slams was found.
