SUBJECT: SURVEY OF V. C. SUMMER CONTROL ROOM

NRR FINDINGS V. C. SUMMER CONTROL ROOM

Subject: Generic Studies Related to Generic Issue 83 on Control Room
Habitability Fin A-2328

PLANT VISIT SUMMARY

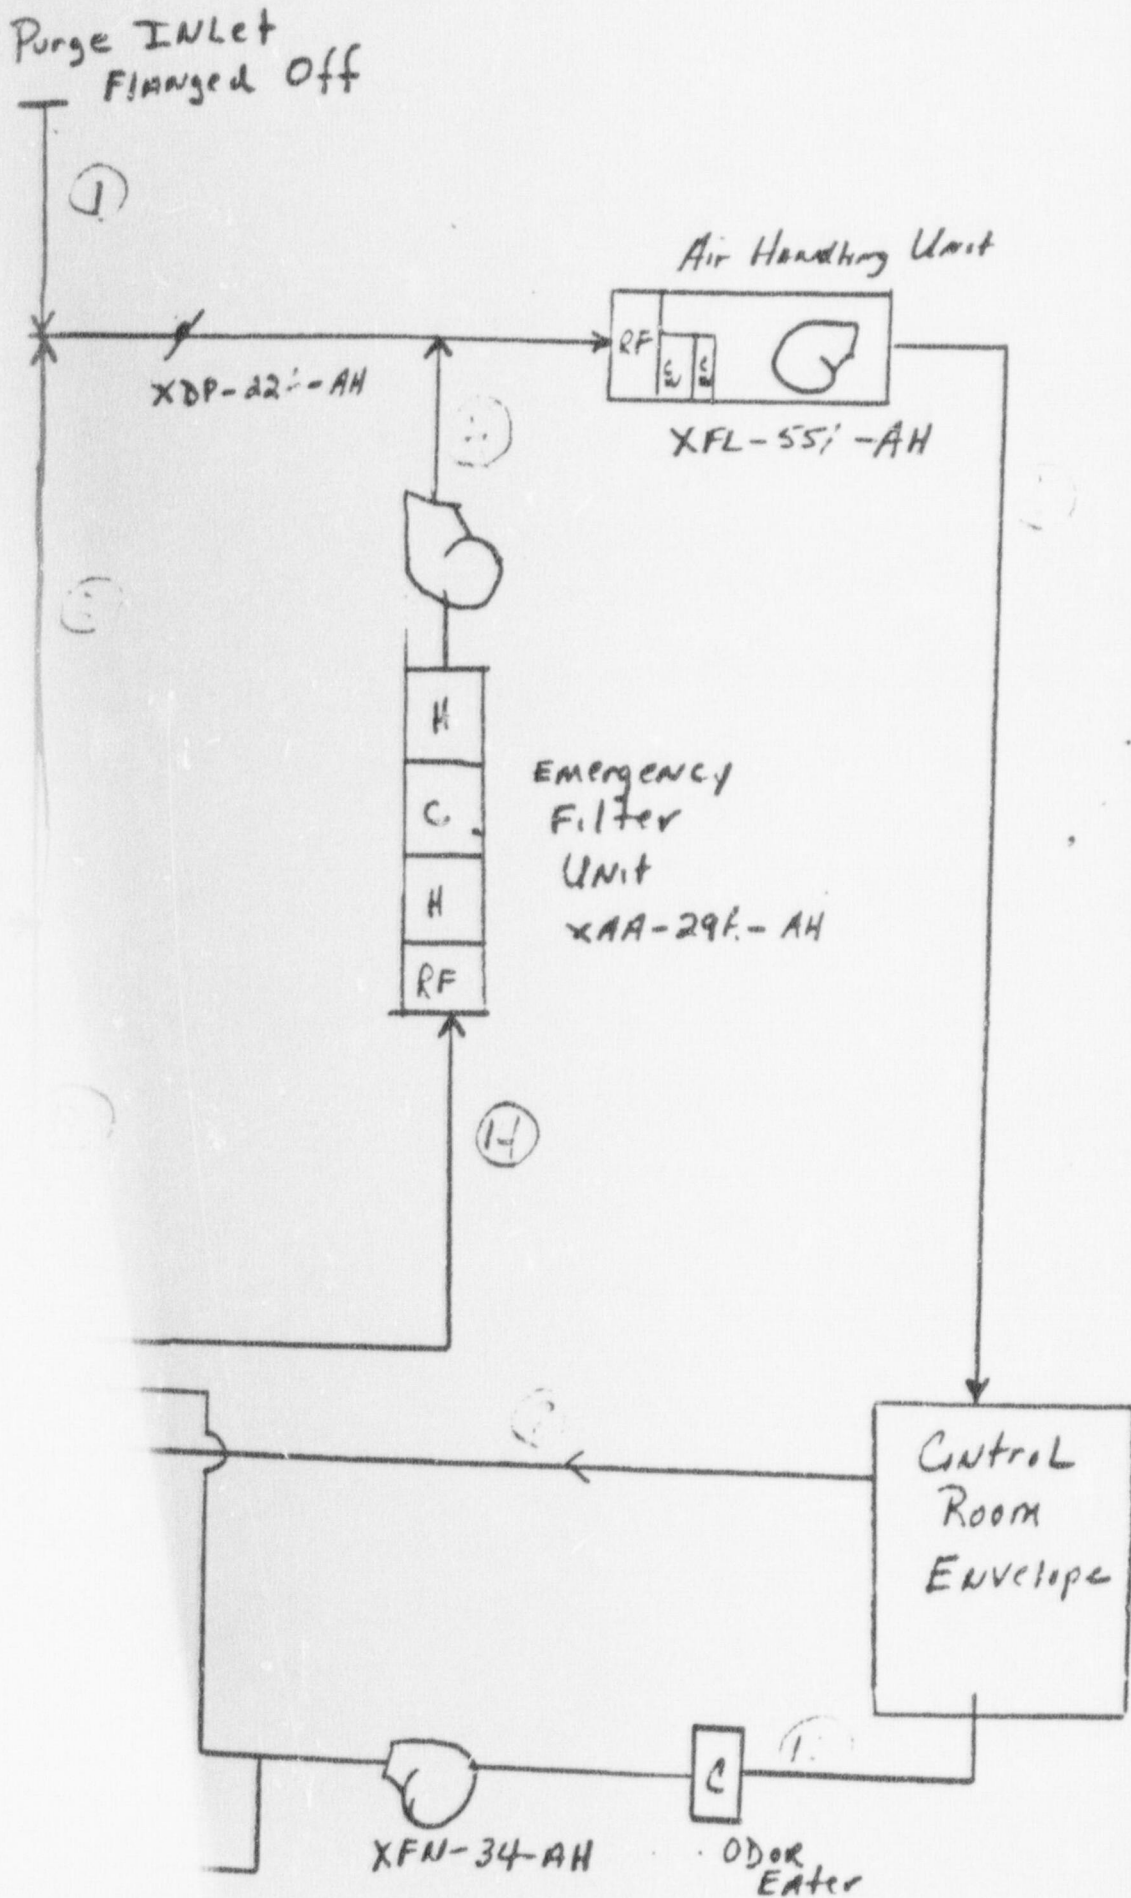
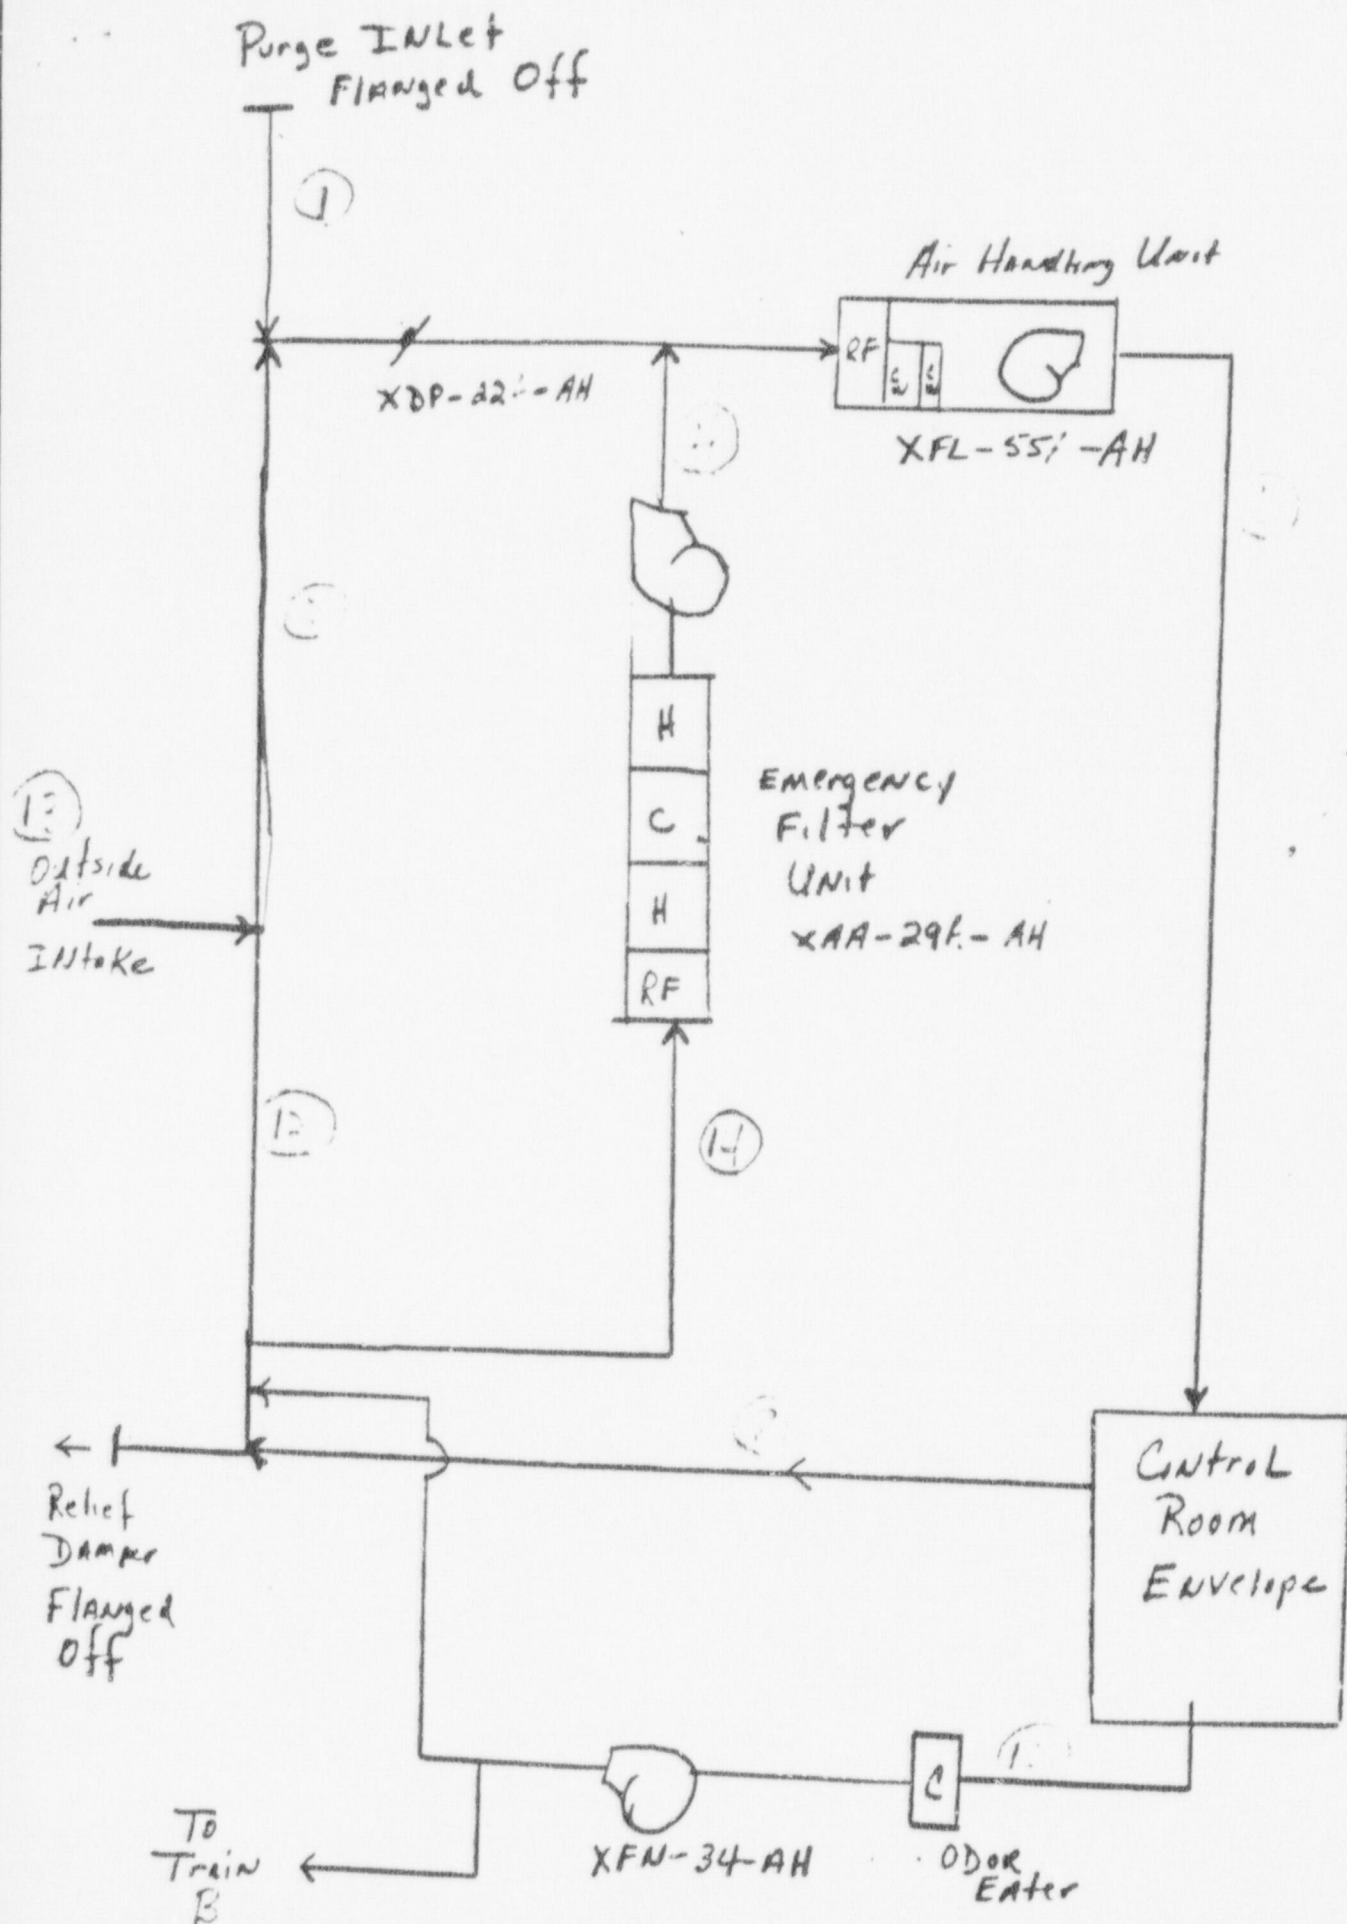
Figure 1 V.C. Summer Test 11 F.

With train A operating in its emergency mode the two sets of data showed:

- (1) There appears to be a considerable amount of inleakage into the air handling unit. It ranged from 363-1246 cfm. This inleakage is unfiltered.
- (2) There appears to be a considerable amount of inleakage between the locations where flows at measurement points 8, 10, and 12 are made and the location where flow at measurement point 14 is made. This inleakage ranged from 1050-1620 cfm.

- (3) Only outleakage occurs across the emergency filter train. This outleakage ranges from 740-800 cfm.
- (4) The control room exhaust (return air) is greater than control room supply which would seem to indicate that the control room has another source, not measured by the survey team, which is pressurizing the envelope. The source is unknown but the deficiency between the two flows is 785-2550 cfm for the two data sets.

- (5) Filter flow is 17-19% greater than the technical specification value.
- (6) With the toilet and kitchen fan removed from the ductwork and the ductwork blanked off, the amount of flow supplied to the control room increased by 2.22% while the amount of return flow decreased by 2.78%.

With Train A idle, a flow balance around the idle air handling unit seems to indicate that there is outleakage from the air handling unit. This situation is confirmed by the fact that inleakage occurs when the train is operating. Similar confirmation occurs with respect to the outleakage in the ductwork between measurement point 14 and the locations where measurements 8, 10, and 12 are made.

The flow direction through measurement point location 2 is particularly baffling. During emergency operation, flow through the outside air intake almost equals, the flow through measurement point 12. Differences range from 1.7-9.4%. If the point 12 flow rate is added to the flow rates measured at location 2, 600-700 cfm of flow cannot be accounted for. The flow direction was determined, and it was toward the emergency filter train when the train was operating. If the train was not operating, the flow appeared to be toward the air handling unit and damper XDP-22A-AH. One scenario which may explain the situation, with the train idle, is described as follows. Back pressure from the control room causes flow toward the air handling unit (364 cfm for data set 1). Some of this flow leaks out from the air handling unit. That flow which remains (unknown) is combined with the flow from point 2 to pass through the fan and the emergency filter unit. Approximately 130 cfm leaks out from the emergency filter train. The flow from the emergency filter unit combines with the flow from the control room return duct (point 8). This gives the combined flow at point 12, which is proceeding toward the air handling unit. A portion of the flow, 148 cfm at point 2, is probably directed towards the flanged intake while the remainder is directed towards either the air handling unit or the emergency filter fan.

When the train is operating in its emergency mode of operation, since the outside air intake flow is almost equal to the flow at point 12, which is the makeup flow to the filter unit, one might conclude that the flow at point 2 seems to be recirculated by the emergency filter train back to point 2 where most of the flow is lost. Point 2 almost seems like a black hole. Flow seems to get lost here.

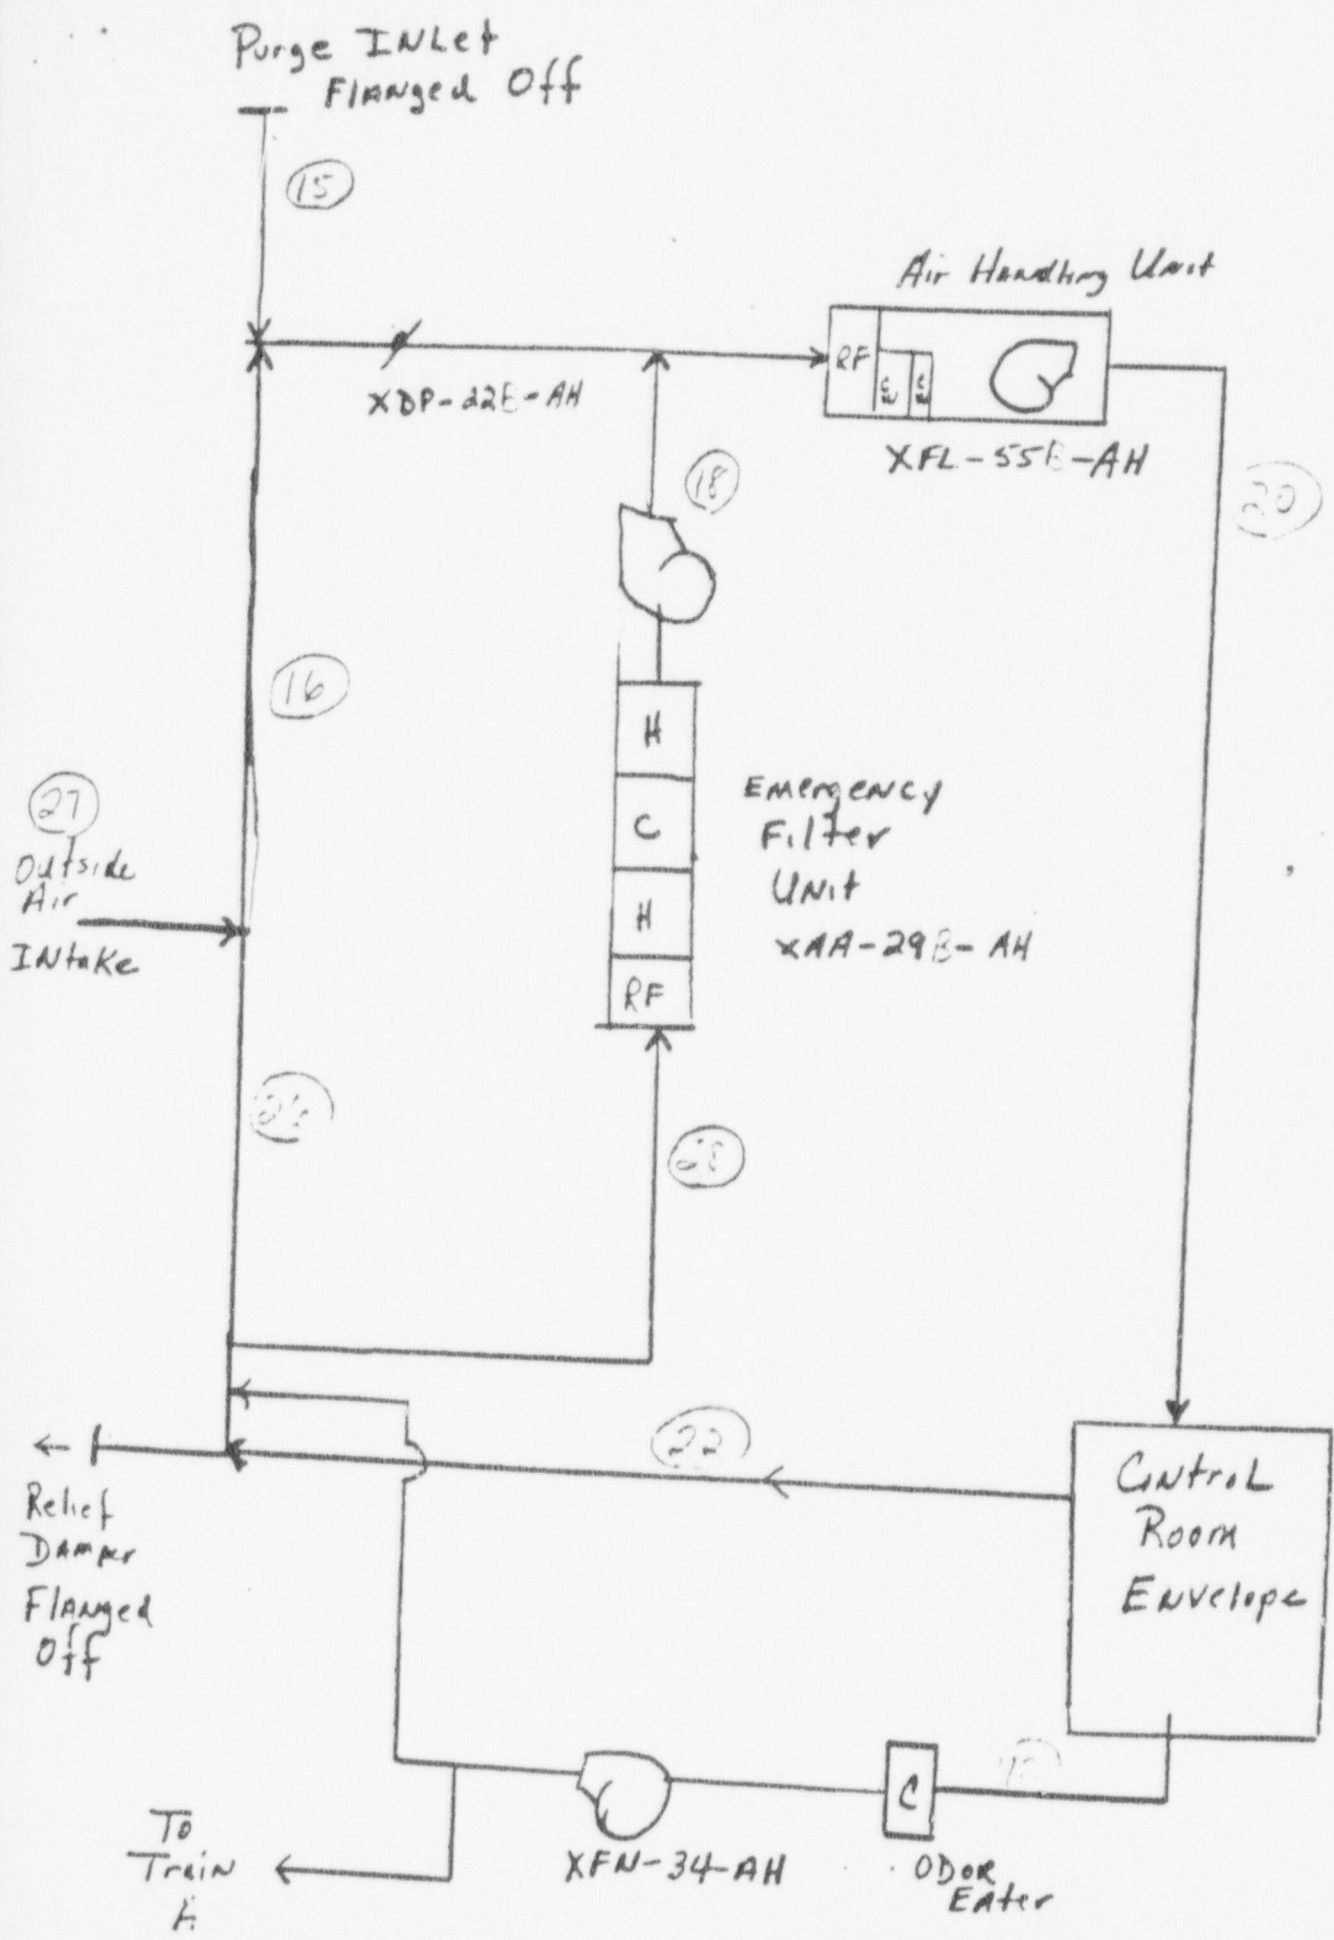
Figure 2 V.C Summer Train 13

With train B operating in its emergency mode of operation the two sets of data showed:

- (1) Outleakage from the air handling unit ranged from 450-680 cfm. This was the opposite of train A where inleakage occurred.
- (2) Outleakage occurred across the emergency filter unit. This ranged from 2800-3700 cfm.

- (3) As with train A, there was a considerable amount of inleakage in the ductwork between measurement points 22 and 26 and that at point 28. Amounts varied from 3250-4080 cfm.

- (4) Control room supply flow was greater than control room exhaust (return) flow in one of the two cases. Supply and exhaust flows were almost equal with a difference of only 90-100 cfm in the two cases.

- (5) Flow through the emergency filter train was 13-16% greater than the technical specification value.
- (6) When the toilet and kitchen exhaust fan was removed from the ductwork, the amount of flow to the envelope decreased and the amount of return air from the envelope increased. With the ductwork blanked off, envelope supply flow was less than envelope return flow.

For train B measurement location 16 was similar to measurement point 2 on train A. As with train A, location 16 provided abnormal flow results when considered with measurement points 15, 18 and 20.
