SUMMARY OF 3M ACTIVITIES
REGARDING
LEAKING Cs-137 SOURCE INCIDENT
MARY BIRD PERKINS CANCER CENTER

3M MEDICAL-SURGICAL DIVISION
January, 1989

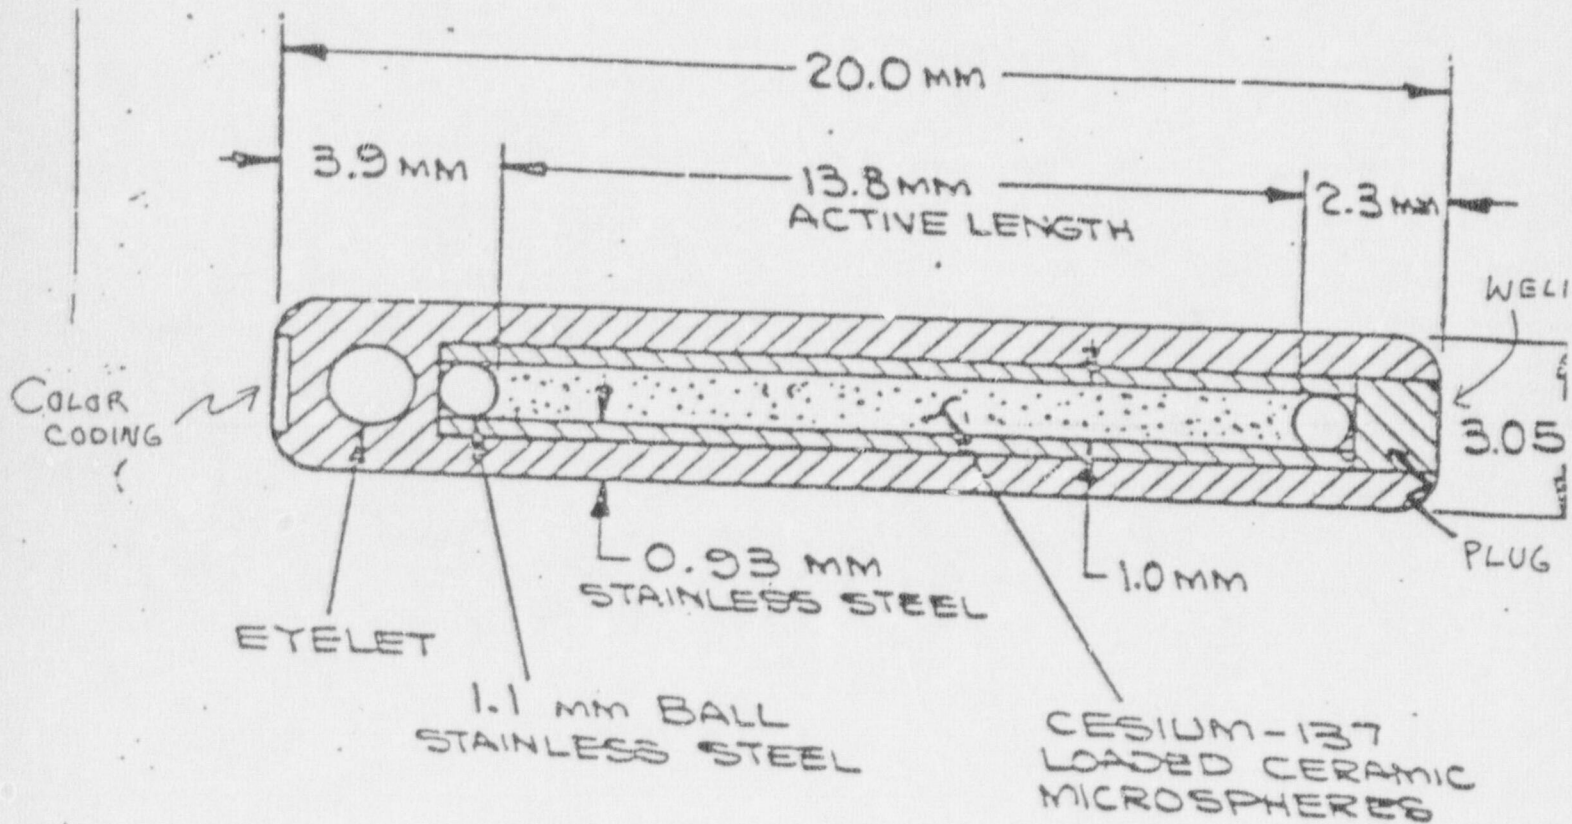
The 3M Cesium-137 tube source involved in this incident consisted of an INNER stainless steel capsule (alloy no. 304) containing Cs-137 bound to ceramic microspheres, enclosed within an OUTER stainless steel capsule of the same alloy. Construction details of the source are depicted in ATTACHMENT 1 and described below.

Outer Capsule: As depicted in Attachment 1, the eyelet and color coding are located on the left side of the source. The right side of the outer capsule shows a plug which is press-fit and welded after the inner capsule has been added.

Inner Capsule: The inner capsule consists of a stainless steel tube containing Cs-137 microspheres with stainless steel balls press-fit into each end and welded.

Schematic Diagram of Modified 3M Cesium-137 Source,
Series 6500

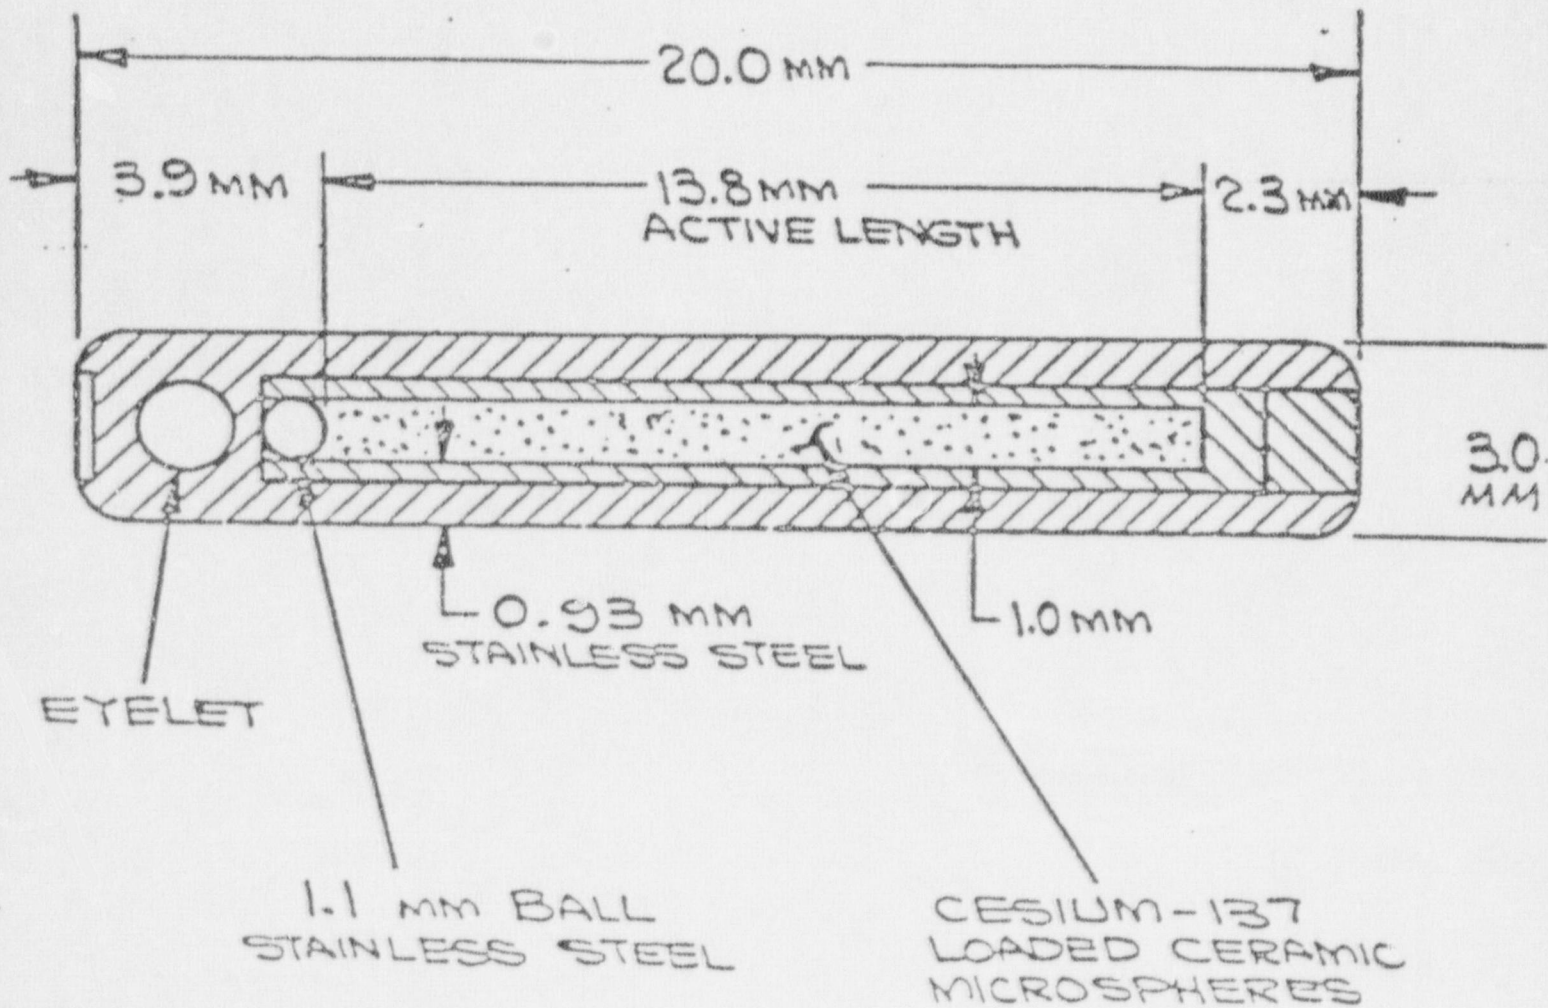
ATTACHMENT 2

Prior to 1986, the inner capsule consisted of a stainless steel rod drilled to contain Cs-137 loaded ceramic microspheres and sealed by one stainless steel ball welded in place (as depicted in Attachment 2). With this single exception, the two designs are identical.

3M old source design
