U. S. NUCLEAR REGULATORY COMMISSION

Docket/Report No. 50-277/89-08
50-278/89-08

Facility Name: Peach Bottom Atomic Power Station Units 2 and 3

Dates: February 18 to April 1, 1989

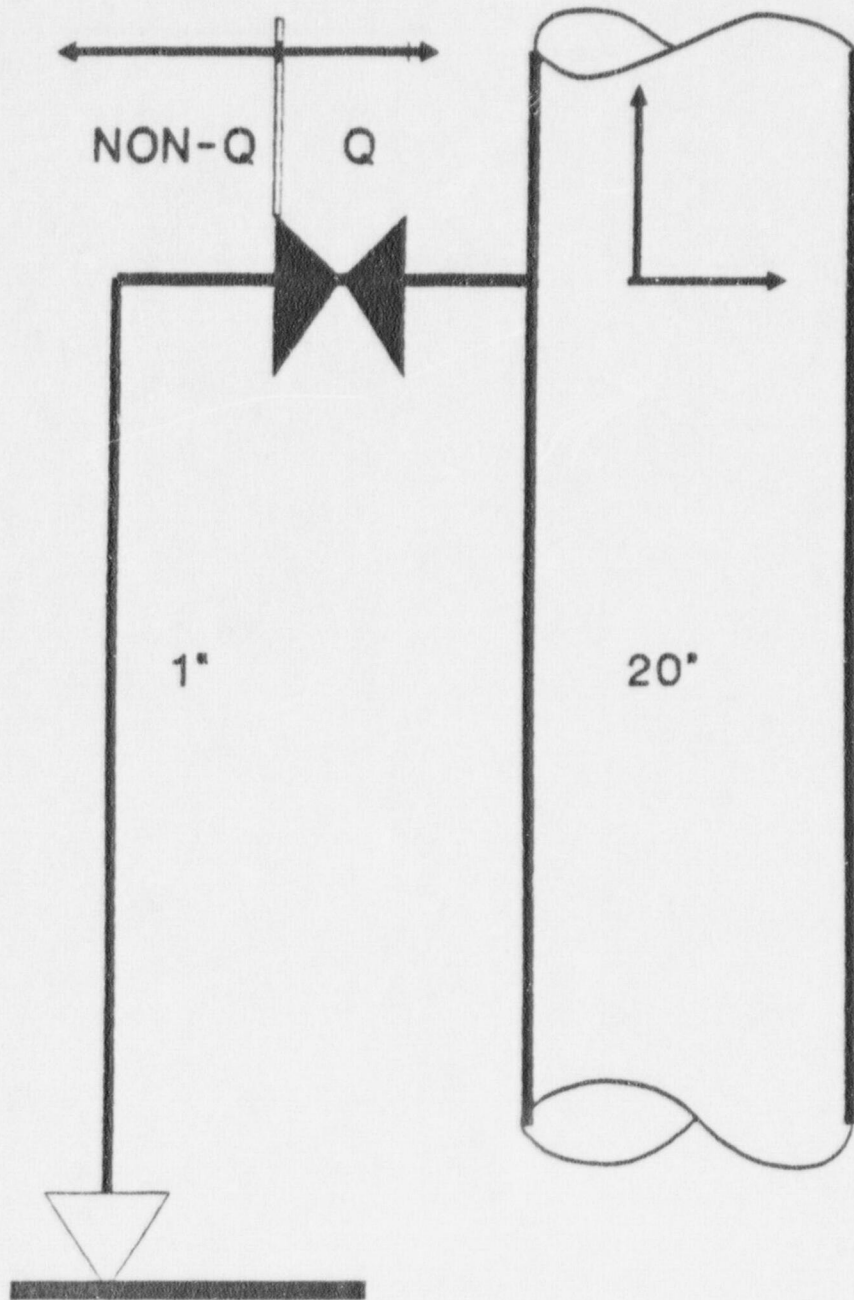
TYPICAL DRAIN LINE

The third overstressed condition occurred because the drain lines were welded into the drain funnels and to assure the lines would drain into the funnels and not create a flood hazard. However, the anchor point at the drain funnels was not included in the piping stress analysis models. The licensee indicated that all such conditions would be identified and corrected in both Units 2 and 3 prior to respective unit restart.

- OF THE 3 ORIGINAL PACKAGES DETERMINED TO HAVE EXCESSIVE STRESSES:
 - TWO WERE UNIQUE
 - ONE WAS GENERIC
- THE UNIQUE CONDITIONS INVOLVED SPECIFIC OVERSITES IN DESIGN OR CONSTRUCTION
- THE GENERIC CONDITION INVOLVED ECCS DRAIN LINES WELDED TO THEIR FUNNELS WITH NO CONSIDERATION OF PIPE MOVEMENT
 - THIS WAS AN ORIGINAL PLANT CONDITION

- ALL KNOWN SIGNIFICANT DISCREPANCIES REPAIRED
- FUNCTIONAL ABILITY DEMONSTRATION OF OVERSTRESSED LINES
- PROGRAM EXTENDED FOR WELDED-IN DRAINS
- COMMITMENT TO DEVELOP LONG TERM PROGRAM FOR BALANCE OF SMALL PIPE IN CONJUNCTION WITH CONFIGURATION MANAGEMENT PROGRAM
