AEOD TECHNICAL REVIEW REPORT

UNIT: North Anna, Unit 1
DOCKET NO.: 50-338
LICENSEE: Virginia Electric Power
NSSS/AE: Westinghouse/Stone & Webster

TR REPORT NO.: AEOD/T 707
DATE: August 5, 1987
EVALUATOR/CONTACT: S. Israel
J. Kauffman

SUBJECT: UNDETECTED LOSS OF REACTOR WATER

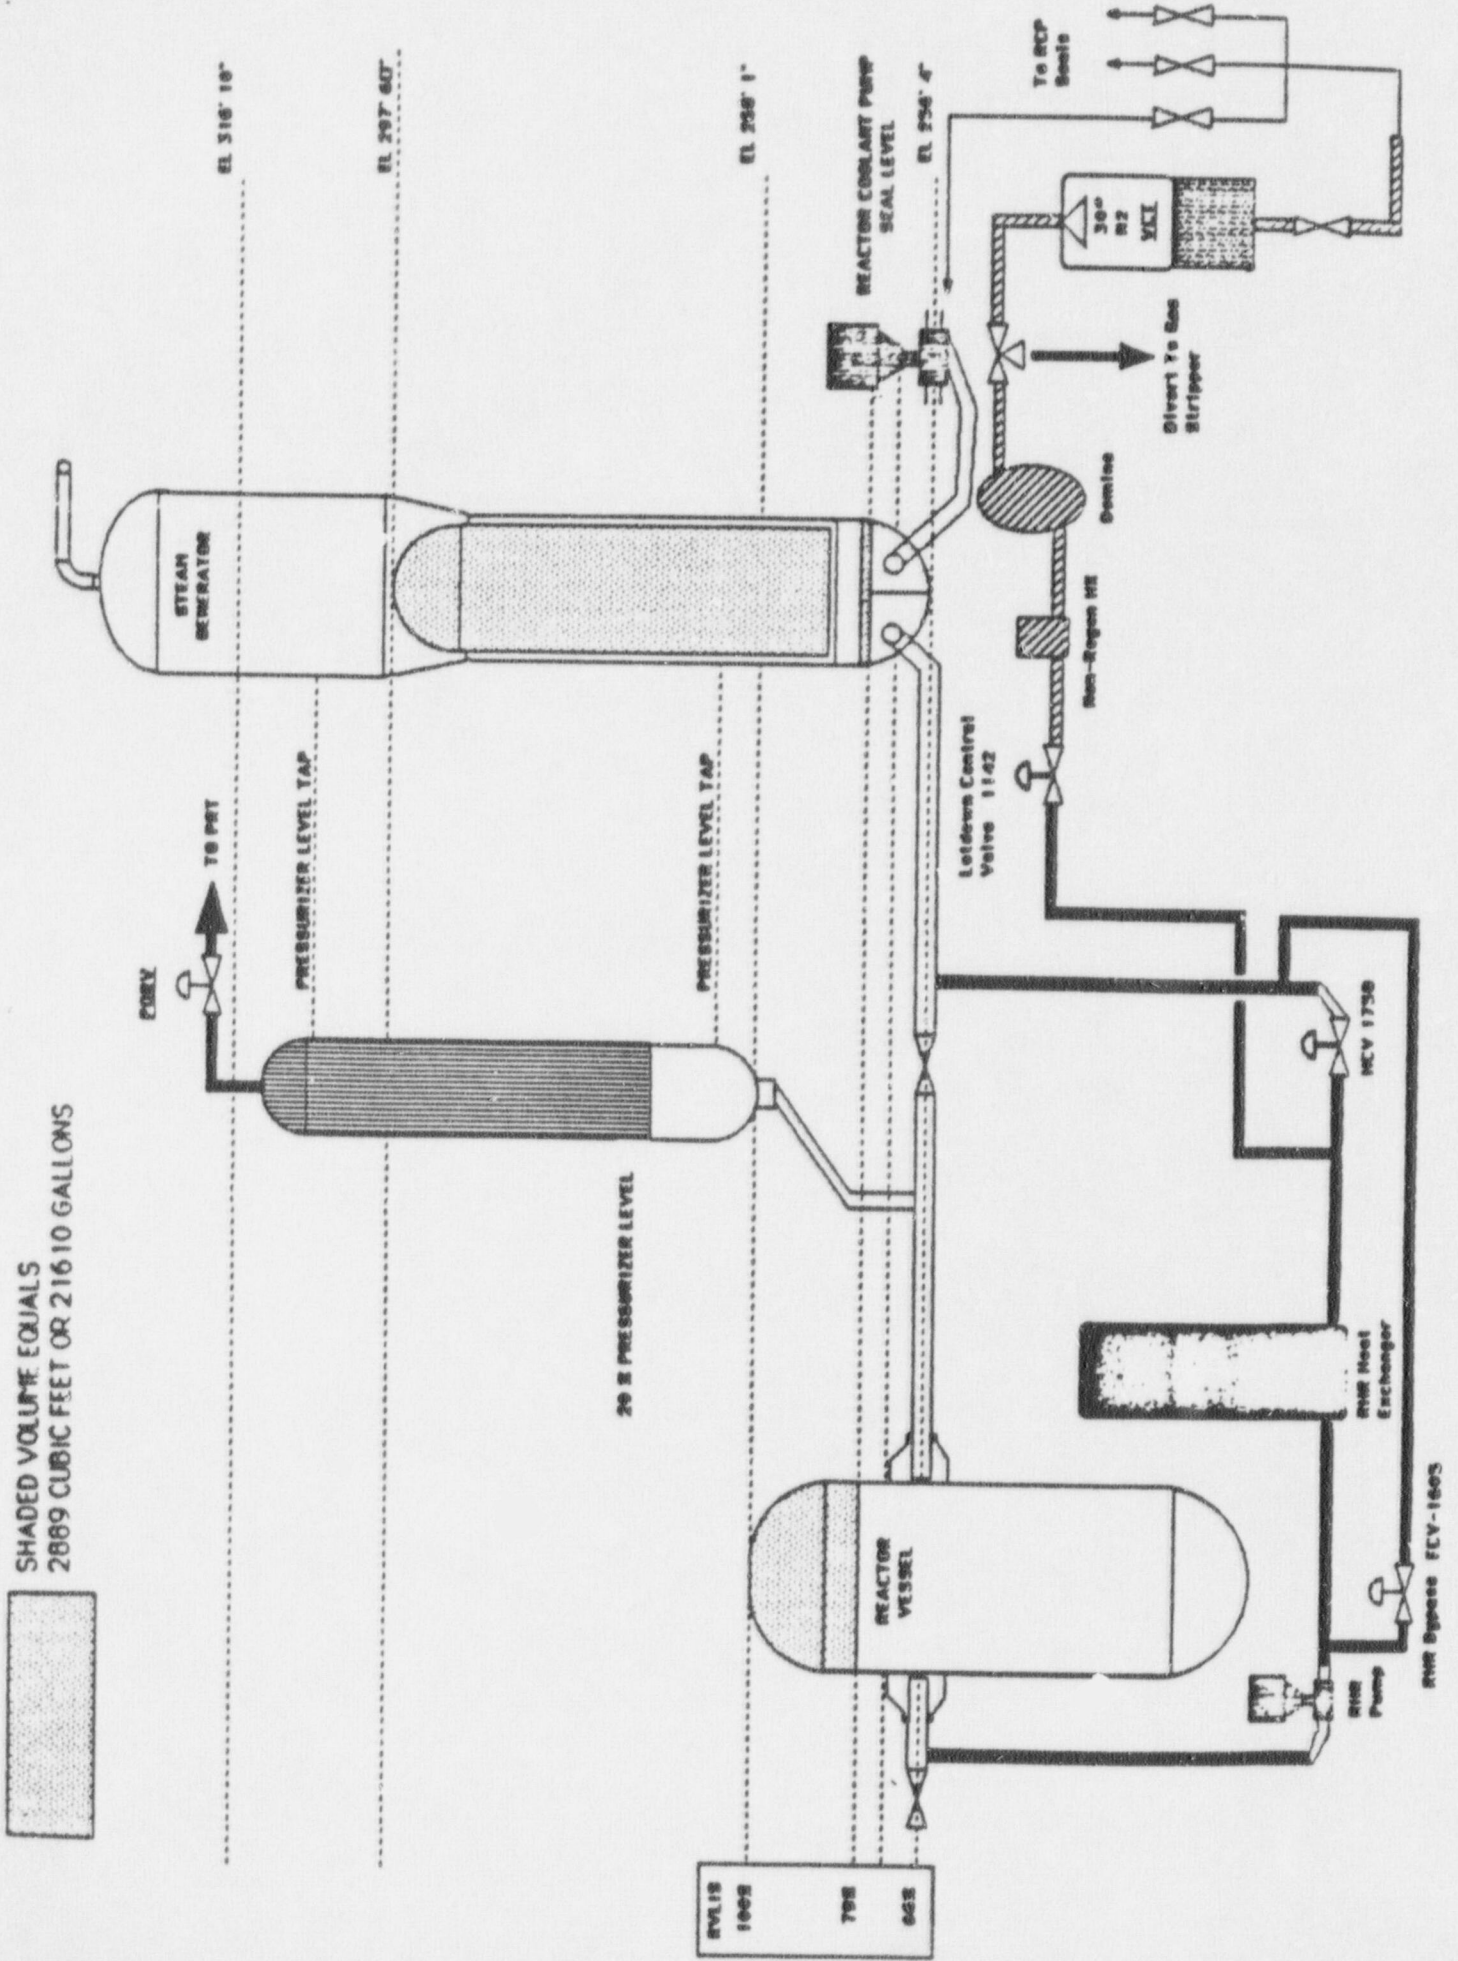
Figure 1 North Anna Plant Schematic

indication of primary system inventory. During this time period, the known coolant leakage into the containment was presumably being made up by charging from the VCT float through the reactor coolant pump seal injection (see Figure 1). The primary system was cooled down using the residual heat removal system.

SHADED VOLUME EQUALS
2889 CUBIC FEET OR 21610 GALLONS

Over the three day period, the pressurizer cooled off (a 240F pressurizer bubble temperature was noted after the initial depressurization) and the dissolved gases in the reactor water came out of solution and collected in the upper head as the plant continued to slowly depressurize. The operators did not use RVLIS which had maintenance tags hanging (also not required to be operable below mode 3), did not monitor pressurizer bubble temperature, and did not perform a mass balance check even though there was known leakage. While the operators monitored the pressurizer level, about 20 percent of the reactor inventory drained out of the system.
