SUBJECT: STABILITY ANALYSIS - TAILINGS EMBANKMENT AT MILAN
MILL, HOMESTAKE MINING COMPANY

LICENSING ASSISTANCE/
GEOTECHNICAL AND HYDROLOGICAL
EVALUATIONS/URFO
TASK ORDER NO. 2

REVIEW OF
HOMESTAKE MINING COMPANY
SUBMITTAL
MILAN MILL

APRIL 30, 1987

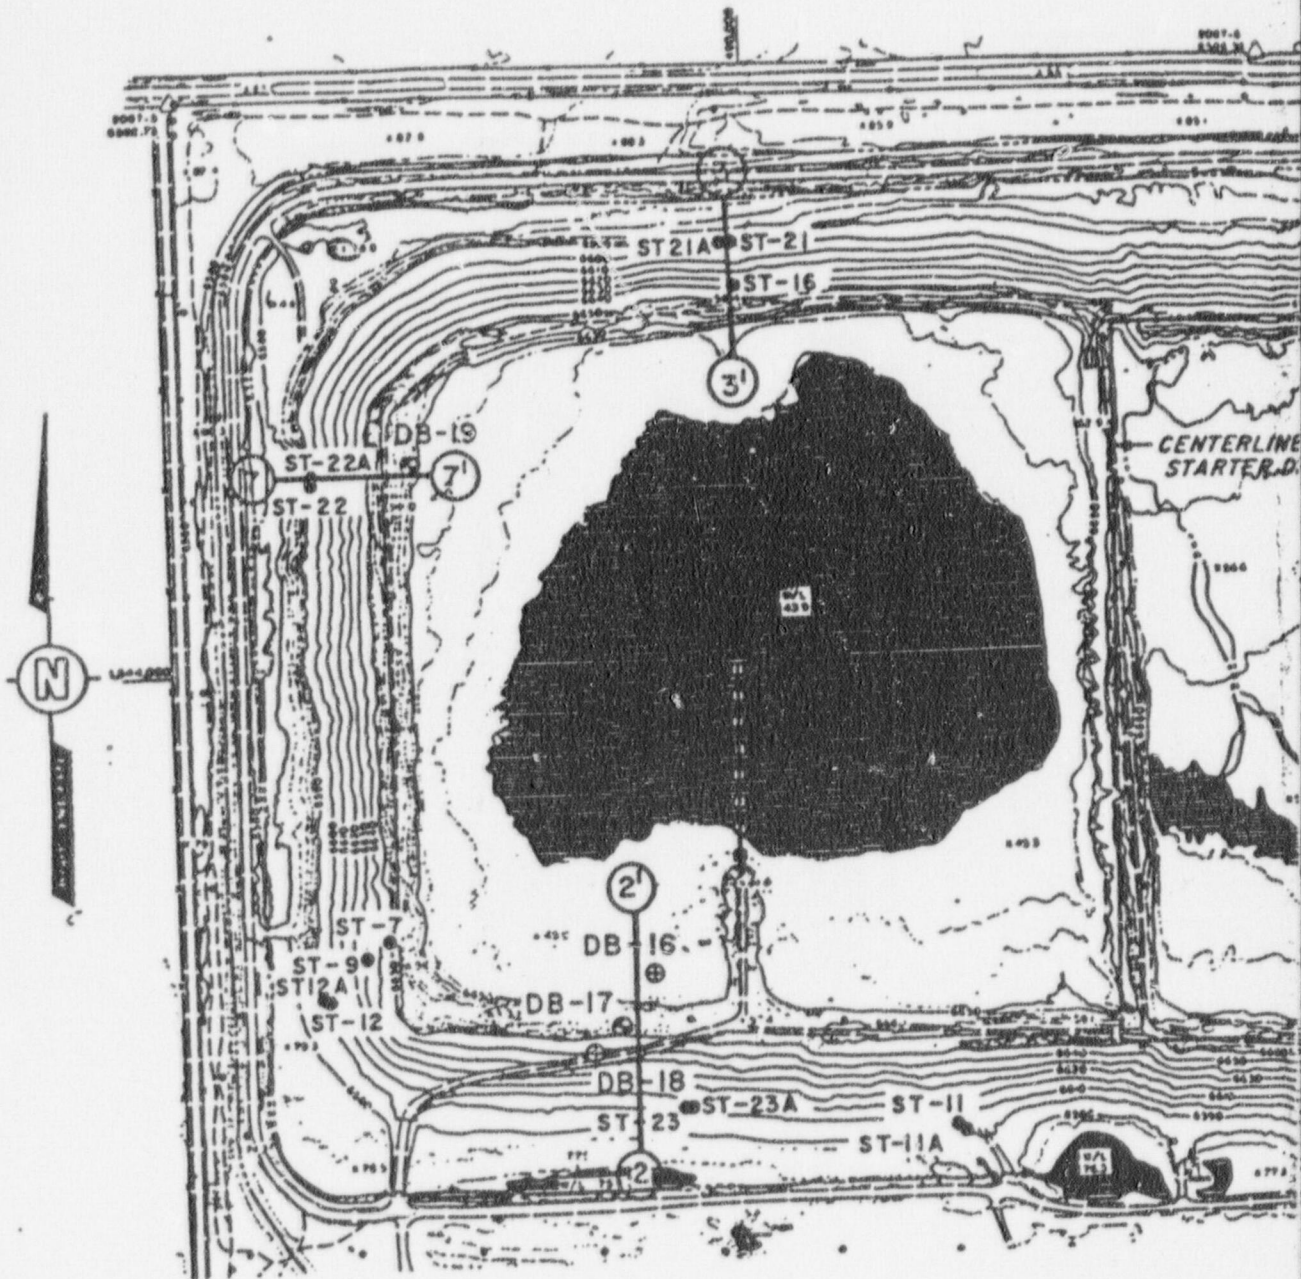
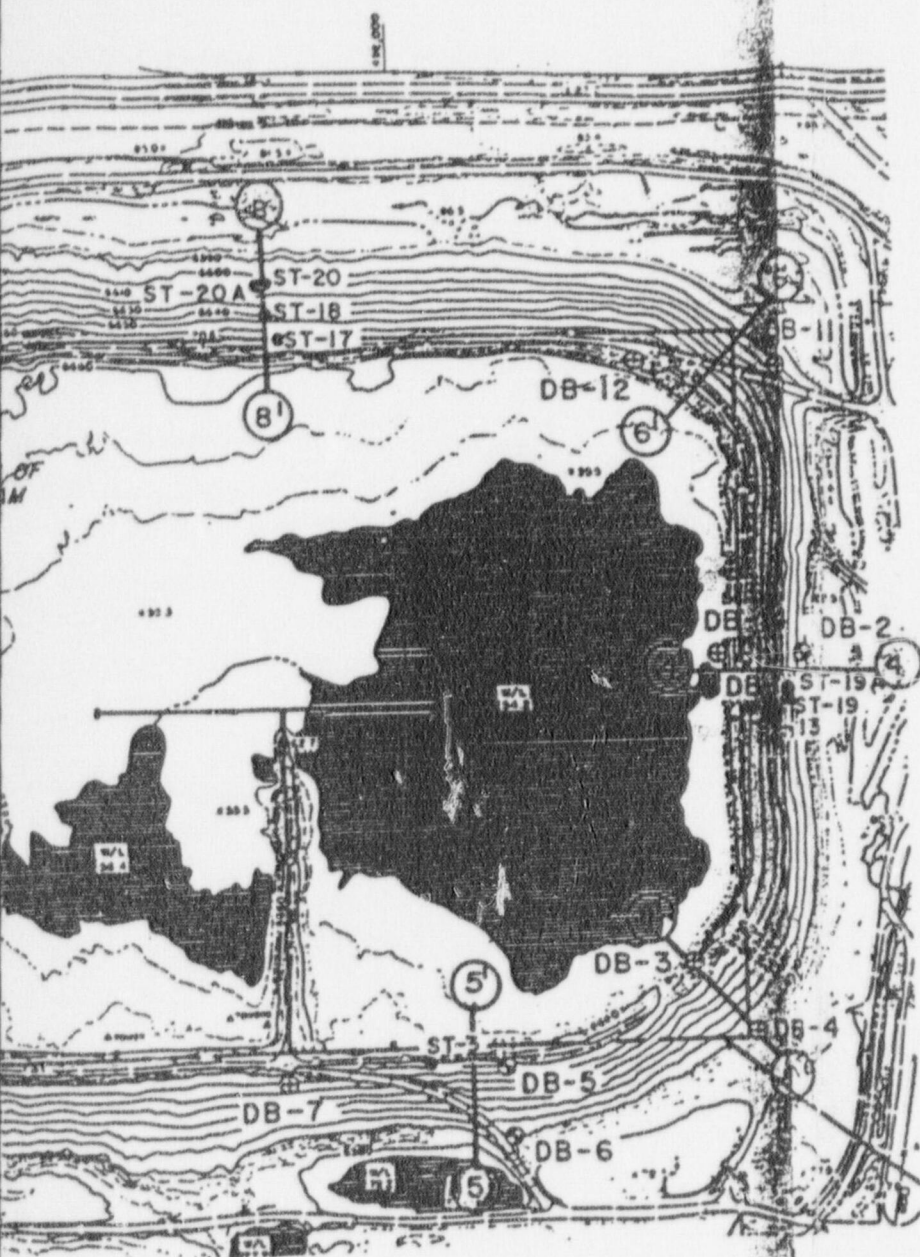
Figure 1

According to surveys dated December 20, 1986, the tailings embankment has a maximum crest elevation of 6680 feet at section 6-6' (Figure 1), a maximum height of approximately 100 feet, and downstream side slopes ranging from 2:1 to 2.3:1. Since operations have been severely curtailed, tailings are presently being deposited in the ponds at a low rate of approximately 2,000 tons per month, according to officials of Homestake Mining Company.

As noted in the D'Appolonia Report, stability analyses were performed on embankment cross sections taken at eight different locations (1-1' through 8-8', shown on Figure 1). Factors of safety at three locations, 1-1', 4-4', and 5-5' (Figure 1) did not meet the requirement of a 1.5 safety factor as specified in the NRC Regulatory Guide 3.11.

The phreatic level used in the stability analyses for the D'Appolonia Report was based upon piezometric measurements obtained in 1980. To monitor the phreatic surface, piezometers were installed in 1977 and in 1980 by D'Appolonia (Figure 1). The D'Appolonia Report noted that the phreatic surface within the tailings embankment did not significantly affect the safety factor until it became 50 percent greater than the piezometric level that existed in 1980. Assessments of the location of the phreatic surface have been made periodically and are kept current by Dr. Kuhn. Based upon the stability results presented in the quarterly stability report dated September 5,

Additional slope stabilization was being performed at the time of the onsite examination in the area of Section 3-3' (Figure 1), which has a relatively low factor of safety as indicated in the table above. The slope stabilization consisted of moving the crest of the embankment towards the pond, resulting in a general flattening of the slope. Based upon the stability analyses performed, this procedure does increase the factor of safety of the slope.
