RADIOLOGIC AND ENGINEERING ASSESSMENT

DOE ID NO.: GJ-00343-CS  
ADDRESS: 711 HORIZON DRIVE

SEPTEMBER 1987

**SUPPLEMENTAL  
STANDARDS**

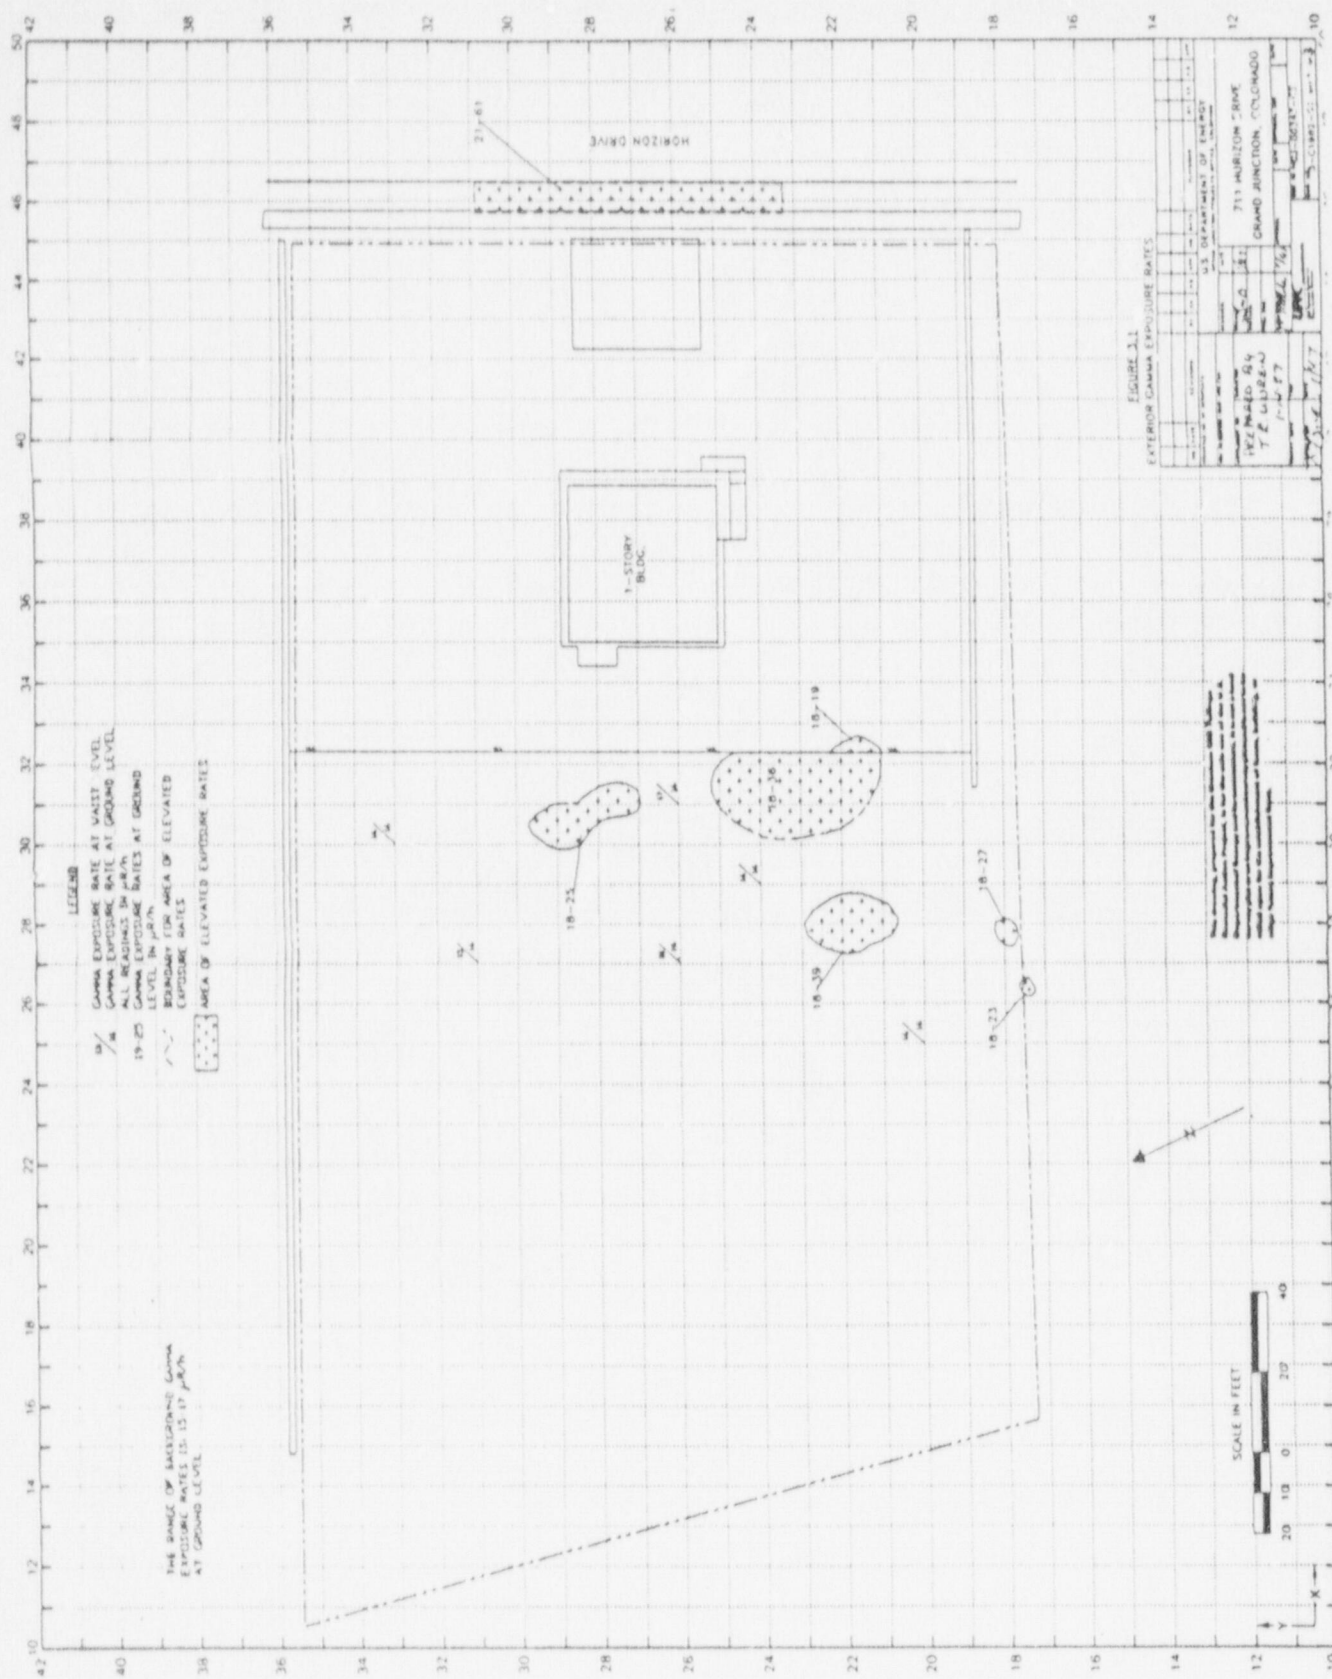
FIGURE 3.1  
SUPERIOR GAMMA EXPOSURE RATES

Area Background: 16 uR/h  
Gamma Exposure Rates Range from: 15 to 61 uR/h

Exterior gamma exposure-rate survey results are shown in Appendix Figure 3.1.

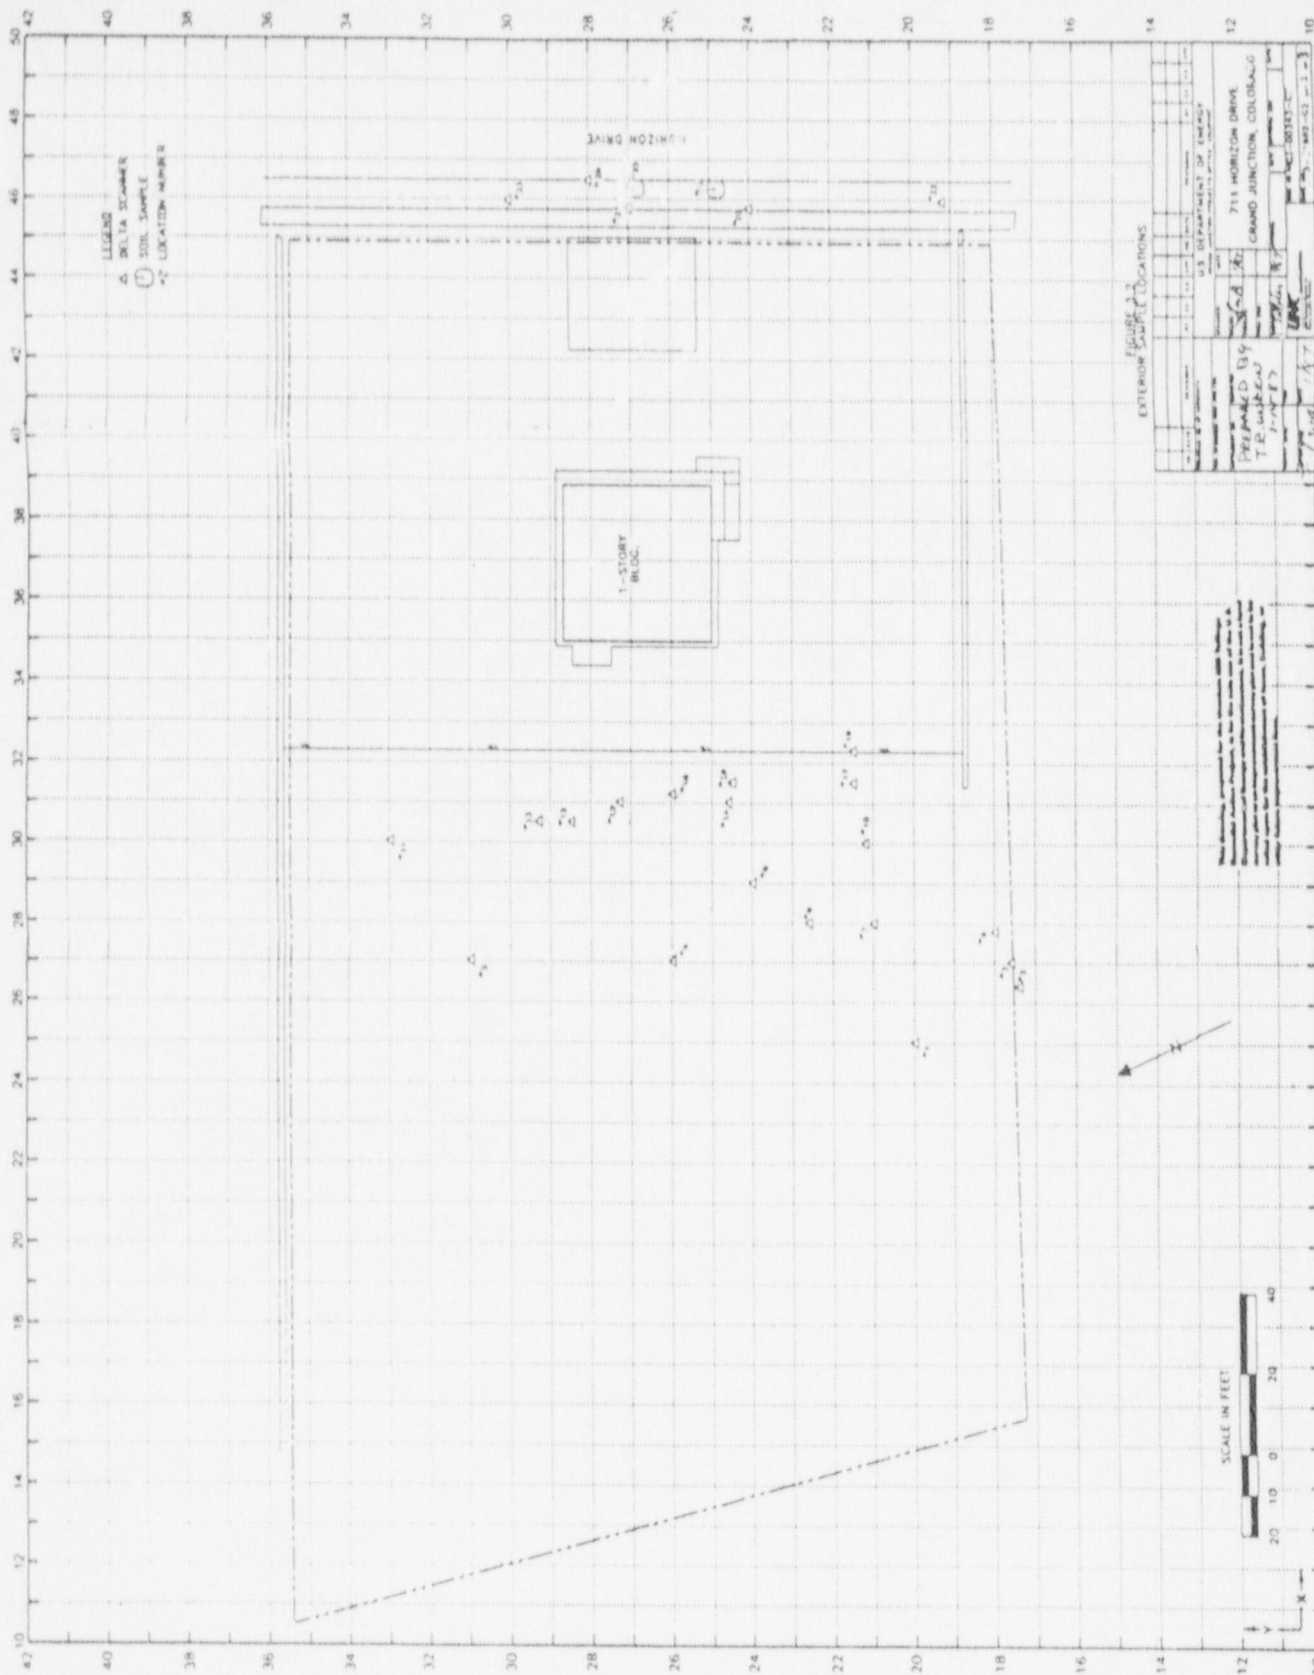
Areas which displayed elevated gamma levels were further investigated; the locations and types of these investigations are shown in Appendix Figure 3.2. Data from these investigations are included in Appendix Table 3.1.

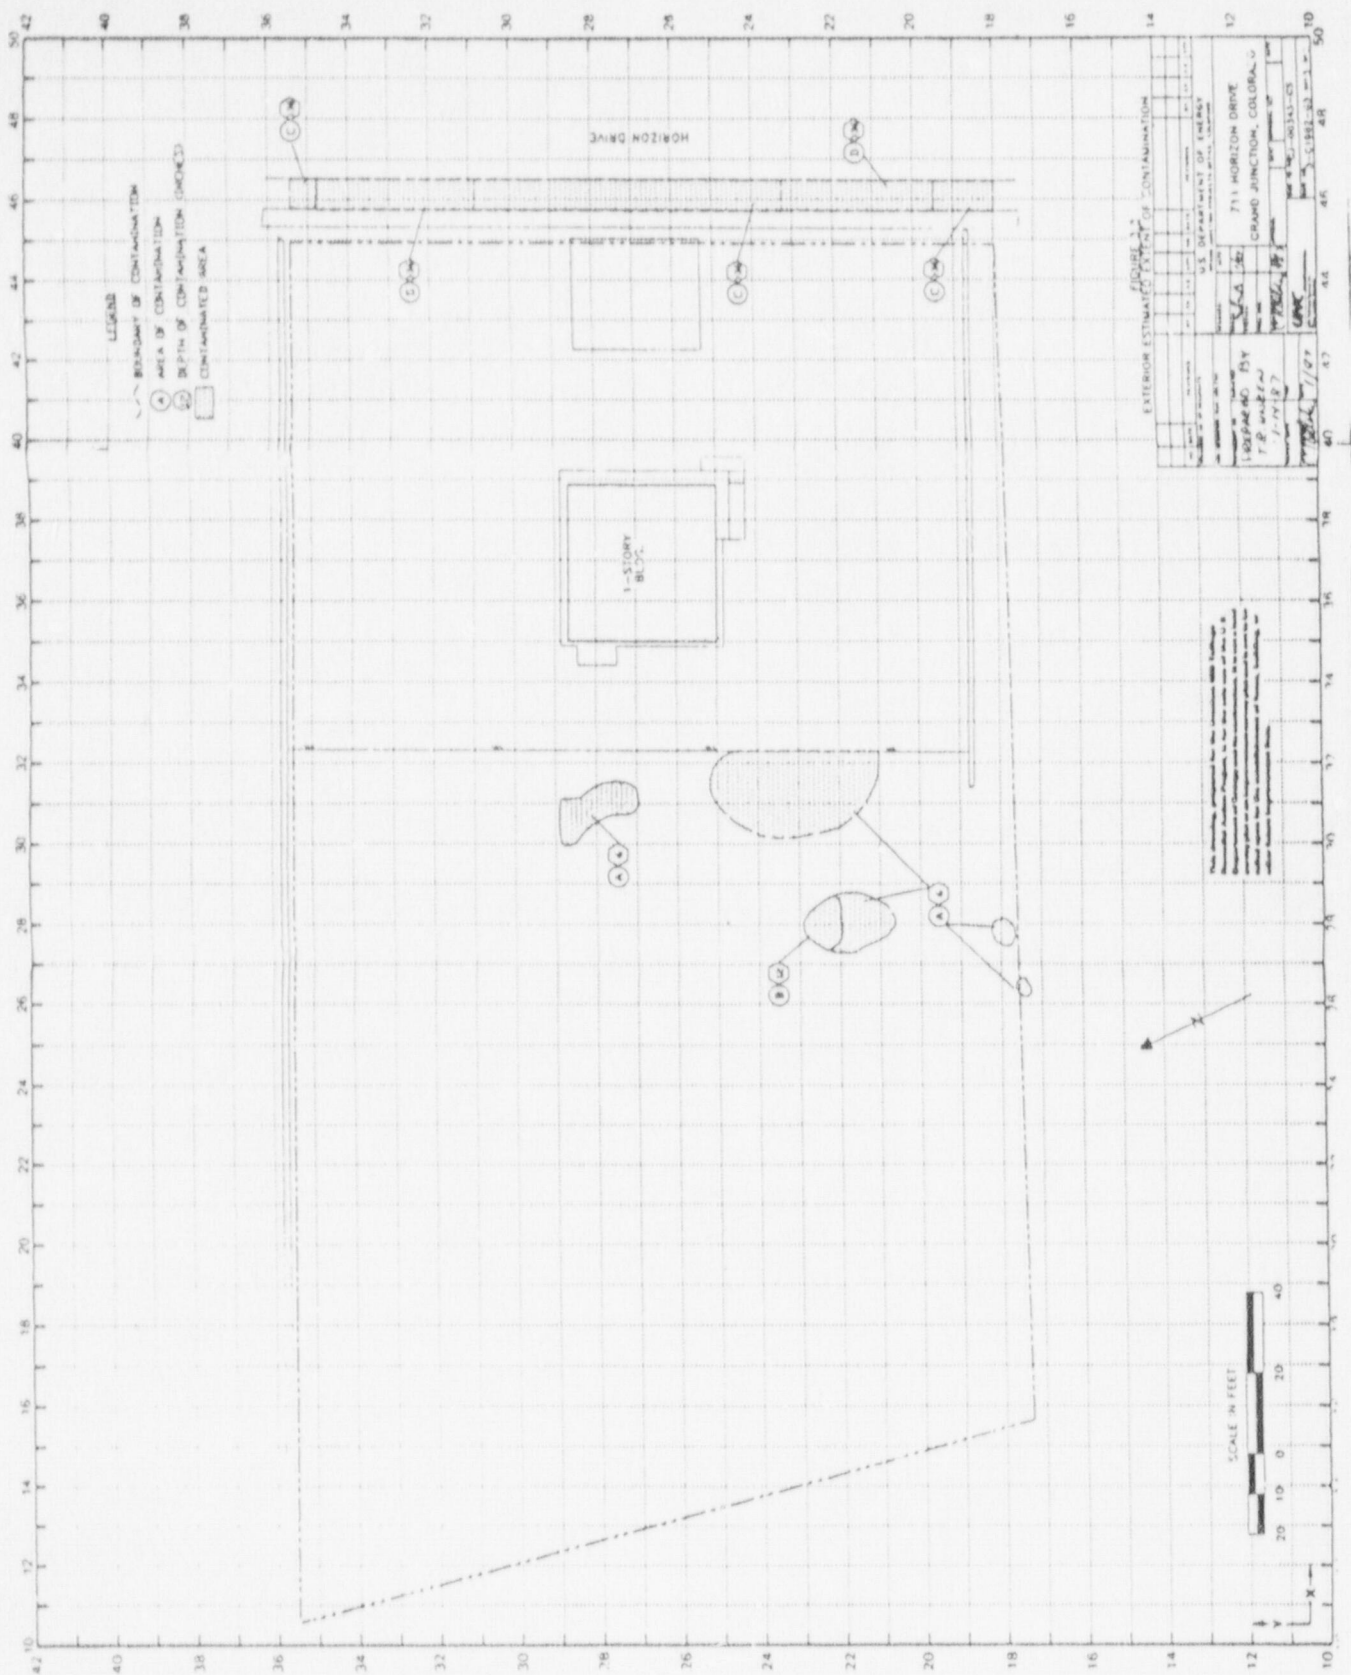
Appendix Figure 3.3 shows identified areas and estimated depths of contamination on this property, based on assessments of all measurements taken. As noted in this figure, areas recommended for remedial action that contain identified residual radioactive materials are:

- (Area A) In-Situ Ra-226: 28.3 pCi/g  
Surface Material: Dirt  
Location: West and southwest of building  
Total Depth of Contamination: 6 inches  
Comments: There are 5 deposits in this area.

- (Area B) In-Situ Ra-226: 12.4 pCi/g  
Surface Material: Dirt  
Location: West of building  
Total Depth of Contamination: 12 inches
- (Area C) In-Situ Ra-226: 330.0 pCi/g  
Surface Material: Dirt  
Location: East of building  
Total Depth of Contamination: >36 inches  
Comments: There is a main sewer line that underlies this area. The depth of contamination is based on ORNL soil sample data. There are 3 deposits in this area.

- (Area D) In-Situ Ra-226: None taken  
Surface Material: Concrete  
Location: East of building  
Total Depth of Contamination: >36 inches  
Other (height or thickness): Concrete thickness unknown  
Comments: There are 2 deposits in this area. The depth of contamination is based on ORNL soil sample data.

Areas A and B are exterior tailings deposits and should be removed. Areas C and D are buried deposits associated with a city sewer main. Supplemental Standards should be applied, see Appendix B for justification.
