UNITED STATES
NUCLEAR REGULATORY COMMISSION
REGION II
101 MARIETTA STREET, N.W.
ATLANTA, GEORGIA 30323

Report No.: 50-302/89-17

Facility Name: Crystal River 3

Inspection Conducted: June 19-20, 1989

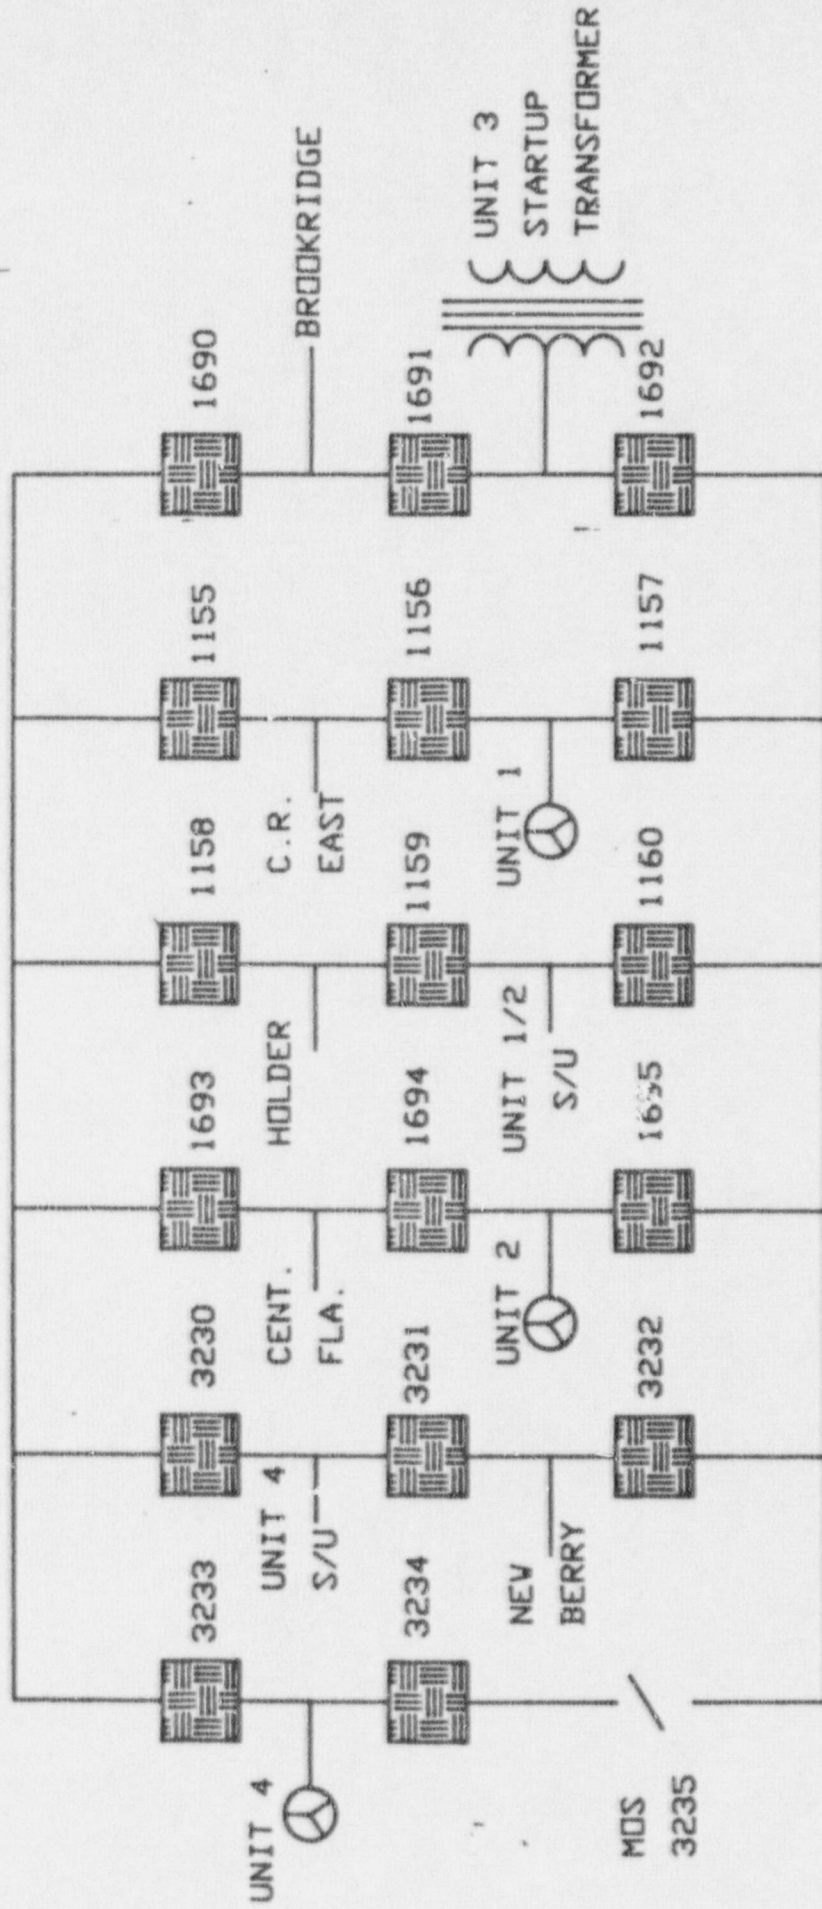
FIGURE 1

The non-nuclear switch yard personnel were checking the carrier signals of the Brookridge transmission system from metering cabinets in CR-1 and 2 (fossil units) control room areas. This would normally have no effect on the transformer configuration and switch yard breaker line up that was supplying power to CR-3 Start-up transformer. However, a relay technician inadvertently hit a test circuit switch (a Push Button [PB] that is not normally used) that simulates a fault on the system's transmission lines and two switch-yard breakers opened (1690, 1691). One of these breakers (1691) is in parallel with another breaker (1692) that supplies power to CR-3 Start-up Transformer.

The opening of (1690, 1691) two breakers would not have caused the loss of CR-3 Start-up transformer since breaker 1692 should have remained closed. However, a fault detector relay, which should have indicated that breaker 1691 was open, failed and indicated that breaker 1691 was still closed. As a result the next breaker, 1692, automatically opened to clear the non-existent fault. This isolated CR-3 Start-up transformer and CR-3 had a LOSP event. The Emergency Diesel Generators started and assumed the ES loads.

230KV SWITCHYARD BUS

These switchyard relays are scheduled for replacement by a solid state system that is more reliable. The replacement is anticipated to occur during the next CR-3 refueling. Since the PB circuit is only accessible by a hinged cover that is fastened by screws opposite the hinged end (The cover also has to be removed to check the carrier signals), it is considered by the licensee that no additional protection is needed for the PB. In the interim, before the solid state system is installed, the relay department is considering the permanent disabling of the PB switch since they are not used. This event was caused by personnel error and a faulty relay.

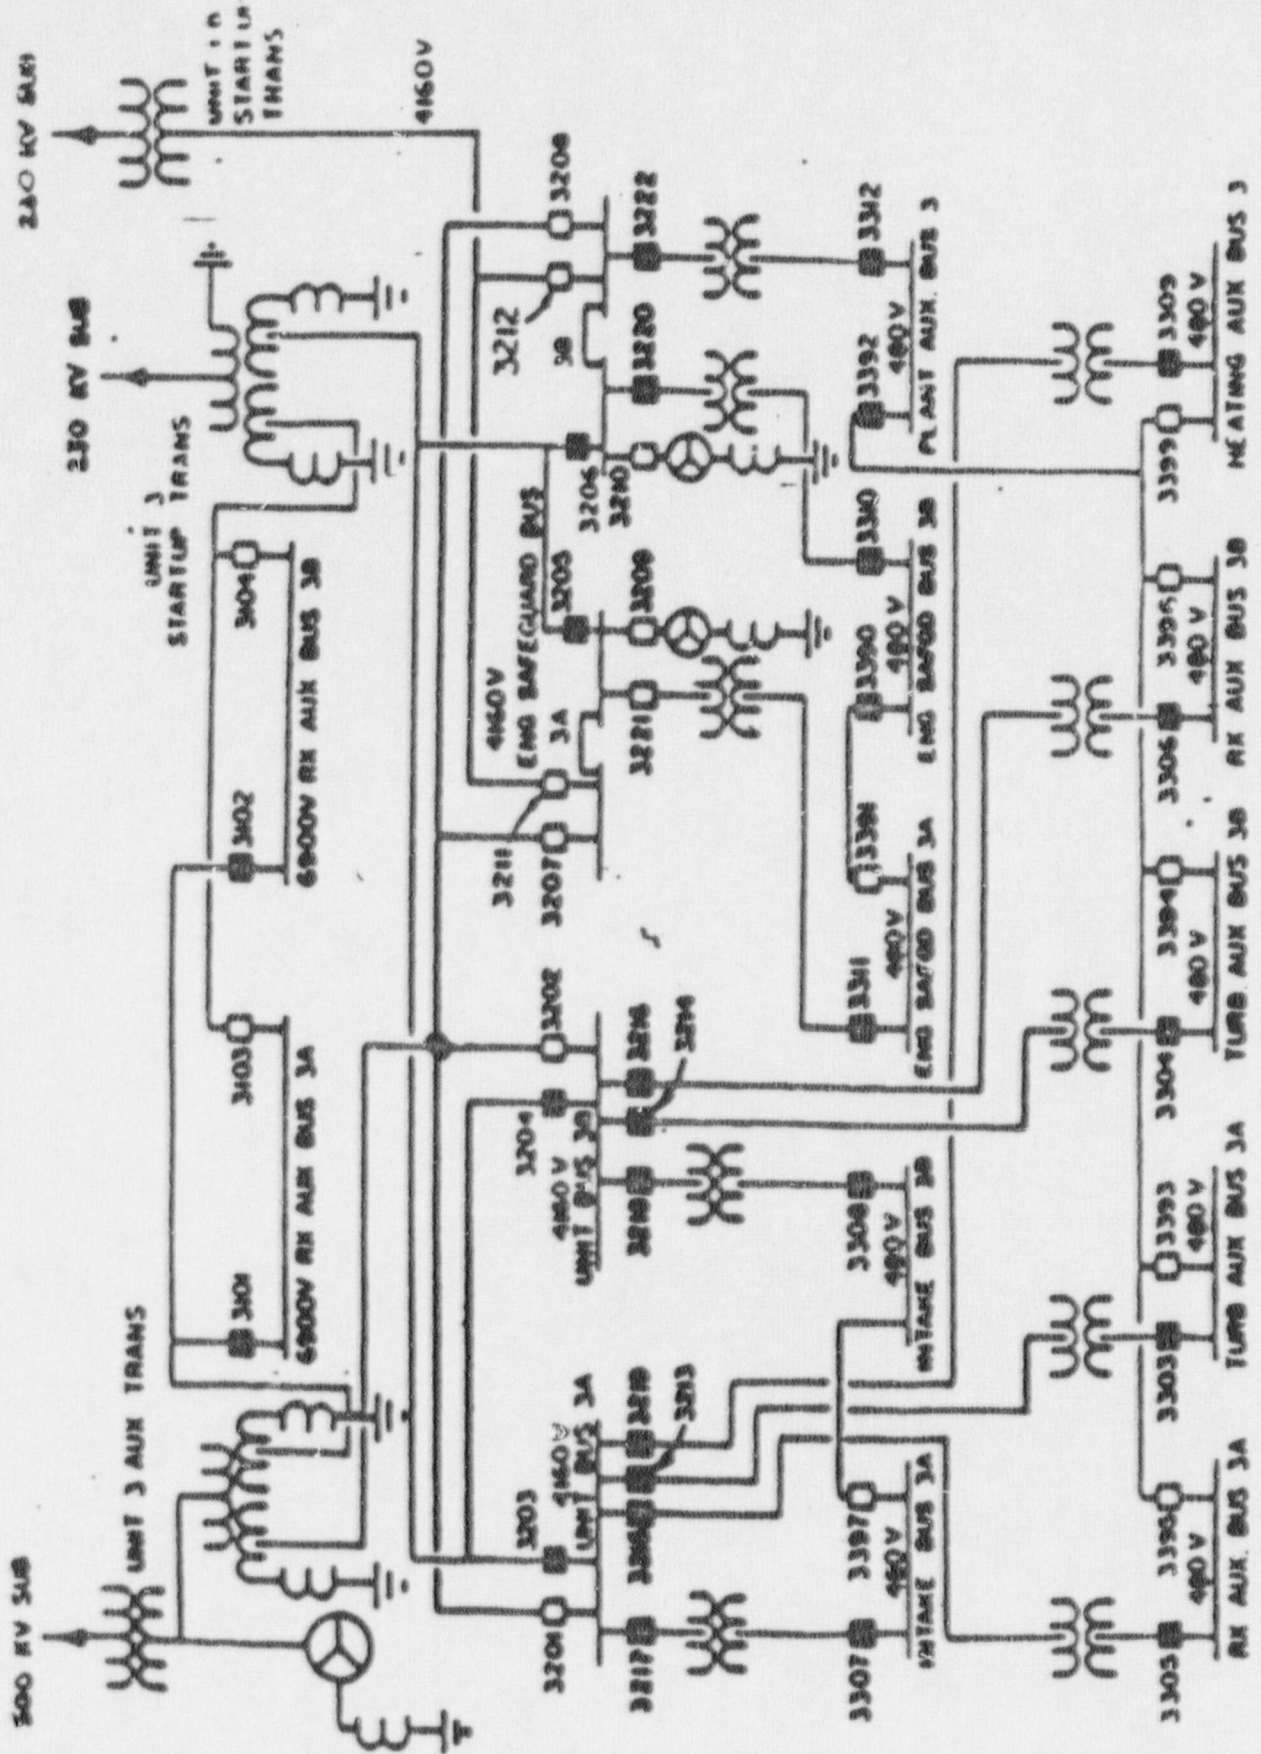
FIGURE 2

The FSAR states that the preferred off-site power source for CR-3's ES buses is the Unit 3 Start-up transformer and the alternate and independent source is the Units 1 and 2 (Fossil Units) Start-up transformer via a direct cable connection. Transfer to the alternate source is by manual operations. The on-site Emergency Diesel Generators assume the ES bus loads in the following manner:

AC DISTRIBUTION SYSTEM
