ARKANSAS POWER & LIGHT COMPANY

SUBJECT: Arkansas Nuclear One - Unit 2
Docket No. 50-368
License No. NPF-6
Licensee Event Report No. 50-368/89-012-00

FACILITY NAME (1) Arkansas Nuclear One, Unit Two
DOCKET NUMBER (2) PAGE (3)
0510101 31 61 8110F1017
TITLE (4) Safety Injection System Check Valve Malfunction Due to Missing Internal Parts Results in Reactor Coolant System Backleakage

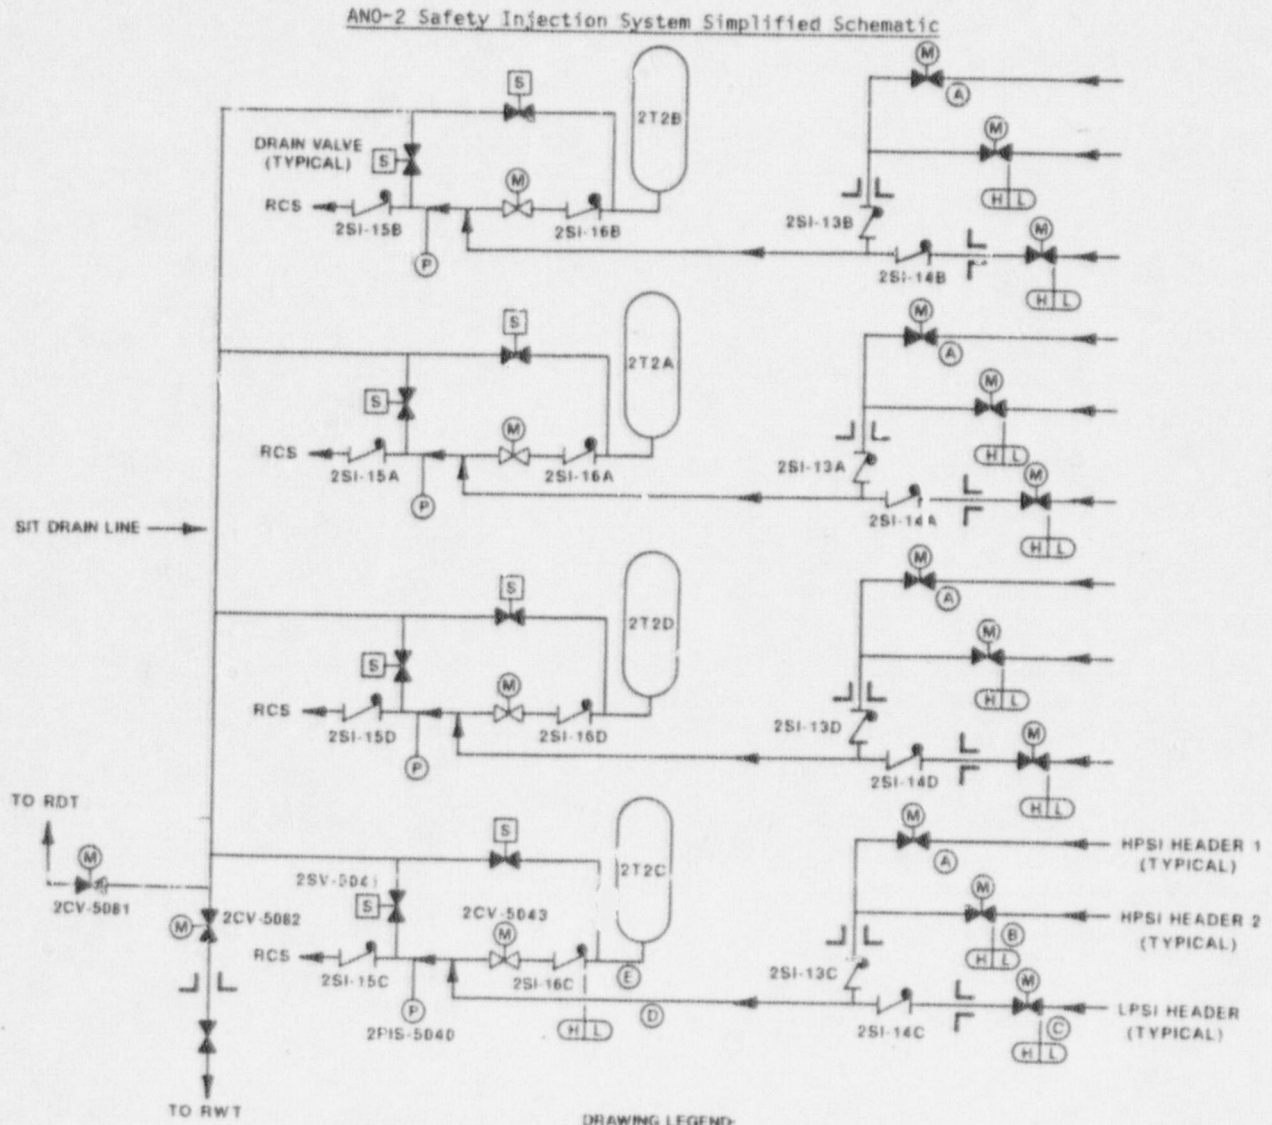
Figure 1

It is important to note that the discussion above is intended to represent a worst-case scenario. Although the consequences of such an event would be significant, the probability of occurrence at this facility is considered to be small. Specifically, at ANO-2, as indicated on Figure 1, the HPSI header 1 piping upstream of the injection MOVs has a design pressure of 2485 psig. Therefore, even a concurrent failure of the redundant HPSI check valve(s) under the conditions postulated above would not be expected to overpressurize this piping. HPSI header 2 piping upstream of the injection MOVs has a design pressure of approximately 1950 psig. Exposure of this piping to pressures greater than design does not inherently imply a postulated rupture of the piping due to the margins incorporated as part of the design of piping systems. The LPSI piping upstream of the injection MOVs has a design pressure of 500 psig, therefore, this piping would be most susceptible to potential failure due to overpressurization. However, the ANO-2 Technical Specifications require periodic monitoring and measurement of backleakage through the redundant check valves protecting this piping (2SI-14A, B, C and D) and provide specific limits on allowable leakage thereby providing a high level of confidence of the functional capability of these valves to prevent backleakage.
