U.S. NUCLEAR REGULATORY COMMISSION
REGION I

Report No. 70-1100/89-03

Licensee: Combustion Engineering, Incorporated
1000 Prospect Hill Road
Windsor, Connecticut 06095

Facility Name: Nuclear Fuel Manufacturing and Nuclear Laboratories

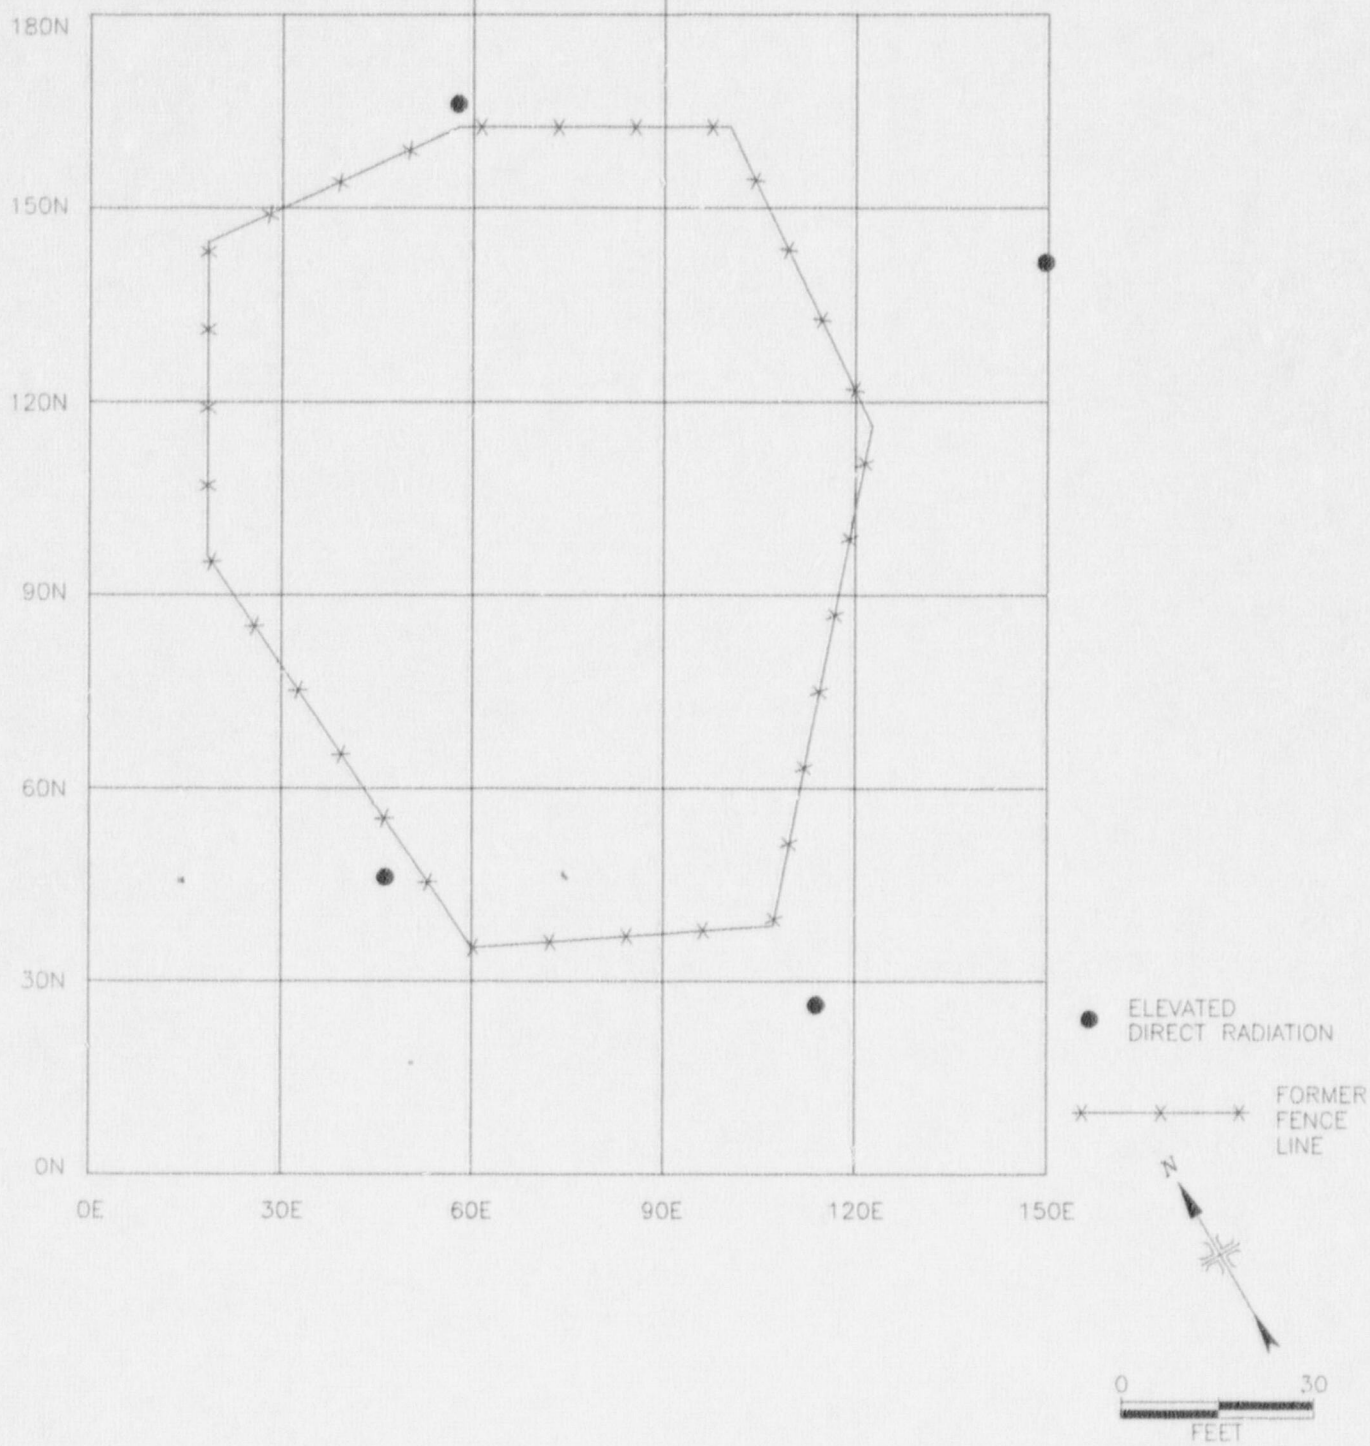
FIGURE 1: Locations of Elevated Direct Radiation Levels Identified by the Surface Scan

Surface scans identified four areas with elevated direct radiation levels which are shown on Figure 1. The results of the soil sample analysis for the composite soil samples, collected from each grid block, and for the samples from the areas identified by the surface scan are presented in Tables 1 and 2, respectively. Table 2 contains the results for samples collected prior to and subsequent to remediation.

Post-remediation concentrations of radionuclides in soil were: U-235, <0.2 to 0.8 pCi/g; U-238, <0.4 to 4.6 pCi/g; Th-232 <0.3 to 7.7 pCi/g; and Th-228, 0.6 to 6.9 pCi/g. With the exception of the sample from 45N, 45E, radionuclide concentrations are within guideline levels. The follow-up sample from 45N, 45E had a Th-232 and Th-228 concentration of 14.6 pCi/g which exceeds the 10 pCi/g guideline.

The area of contamination is small, less than 10 ft², and isolated. The average Th-232 and Th-228 concentration throughout the grid block, based on the concentration in the composite sample, is 1.8 pCi/g.
