TENNESSEE VALLEY AUTHORITY

TENNESSEE VALLEY AUTHORITY - SEQUOYAH NUCLEAR PLANT UNIT 1 - DOCKET NO.
50-327 - FACILITY OPERATING LICENSE DPR-77 - LICENSEE EVENT REPORT (LER)
50-327/87030, REVISION 2

TITLE (4)
Blown Fuse In Emergency Start Circuits Result In Spurious Emergency Diesel Generator Starts On Two Occasions

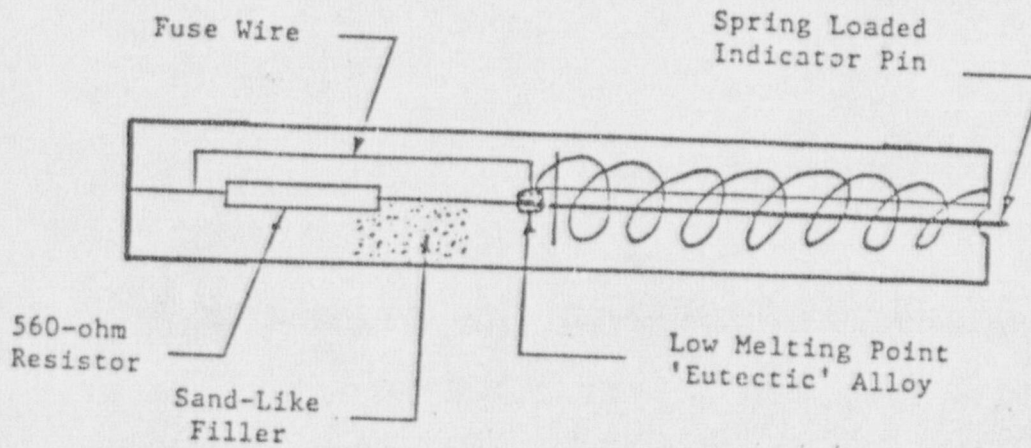
FIGURE A

These fuses consist of a fuse wire, a 560-ohm resistor, a spring-loaded indicator pin, and sand-like filler. One end of the spring, the resistor, and the fuse wire are soldered together as shown in Figure A. The solder material used is a eutectic alloy that melts under overcurrent conditions releasing the indicator pin. The fuse rating is 5 amperes.

When contacted on June 29, 1987, regarding this problem, Littlefuse disclosed that a change in both solder material and the soldering process had been made for Lots 4 and 6. TVA was not informed of this change. The vendor stated that the changes were made to improve production runs, and that they do not consider Lots 2 and 3 to be defective. TVA does not concur with this statement.

TVA still believes that the fuses manufactured in Lots 2 and 3 were defective. Elevated current testing of fuses from all affected lots has been conducted and continues to be conducted to ensure expected life predictions are consistent with actual test data from each lot.

FLAS-5 FUSE

Littlefuse Inc., indicated that due to changes made to both solder material and soldering process, FLAS-5 fuses of later production runs are expected to be more reliable. All FLAS-5 Lot Nos. 2 and 3 belonging to standby D/G circuits have been identified and were changed out with FLAS-5, Lot No. 6, on July 11, 1987.

Shipments of FLAS-5 Lot Nos. 10 and 11 were received during the month of August 1987. All FLAS-5 Lot Nos. 2 and 3 fuses have been replaced during the month of October 1987. Shipment of FLAS-5 Lot No. 12 was received during the month of September 1987 and is maintained as a stock material. It should be noted that failure of FLAS-5 fuses of Lots 4, 6, 10, and 11 has not occurred (similar to failure of fuses of Lots 2 and 3), since their installation.
