LICENSEE: Houston Lighting & Power Company
FACILITY: South Texas Project, Unit 1
SUBJECT: RESULTS OF BOTTOM-MOUNTED INSTRUMENTATION (BMI)
THIMBLE TUBE INSPECTION

South Texas Project Electric Generating Station
Units 1 and 2
Docket Nos. STN 50-498, STN 50-499
Bottom Mounted Instrumentation (BMI) Thimble Inspection

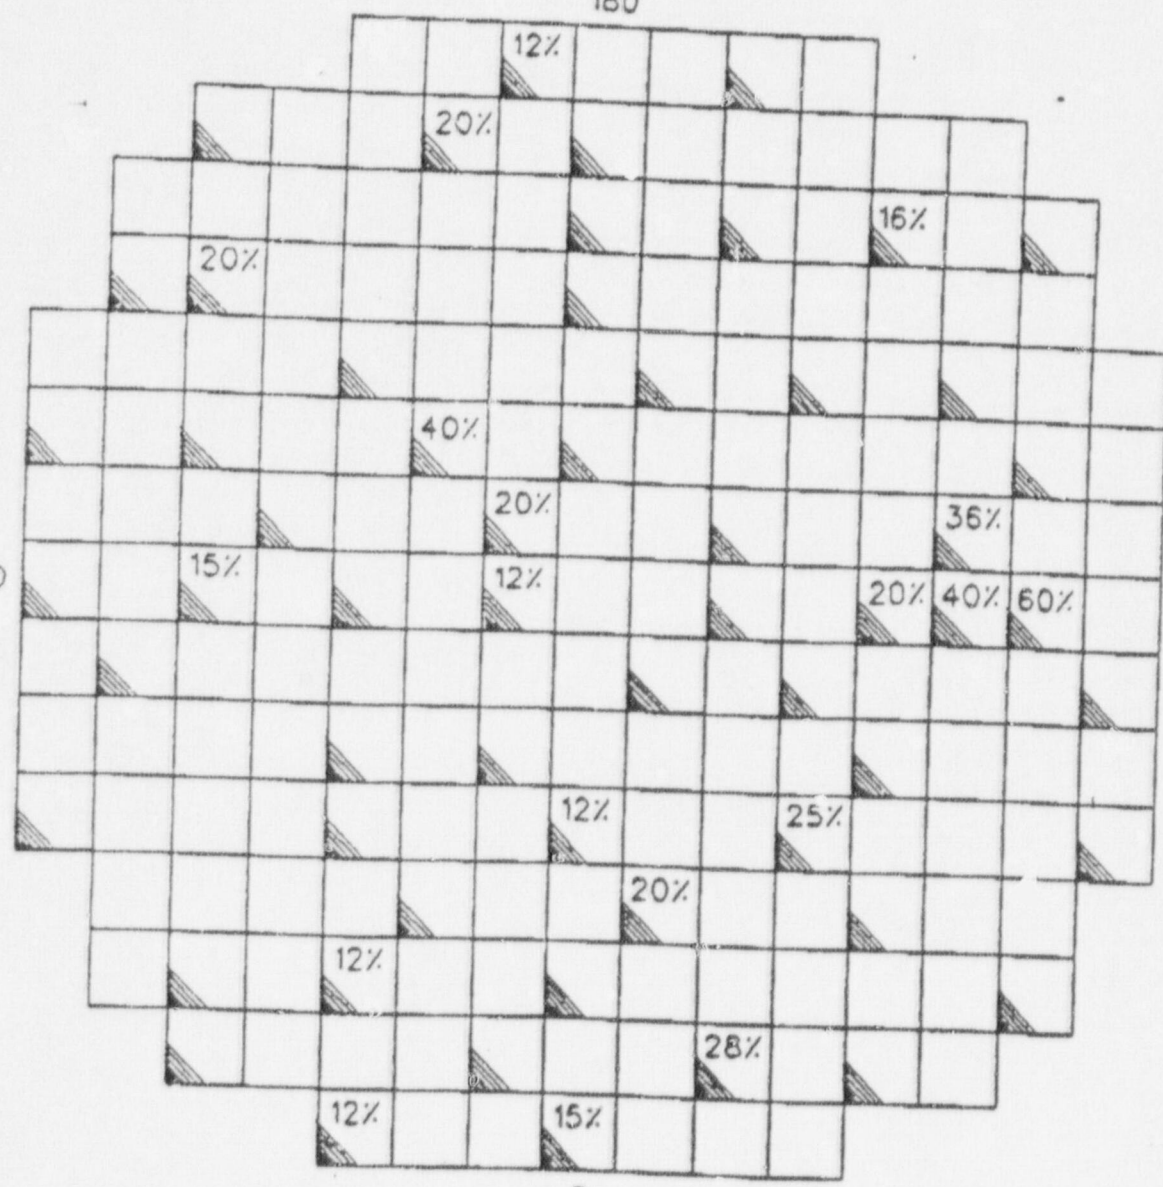
- THIMBLE LOCATIONS

SUMMARY OF THIMBLE WEAR
SOUTH TEXAS 1 - 5/9/88

QUANTITY	PERCENT WALL LOSS (FLOW LIMITER)	CORE LOCATION
1 EACH	60 %	B-8
2 EACH	40 %	K-6, C-8
1 EACH	36 %	C-7
1 EACH	28 %	F-14
1 EACH	25 %	E-11
5 EACH	20 %	J-7, D-8, G-12, K-2, N-4
1 EACH	16 %	D-3
2 EACH	15 %	H-15, N-8
5 EACH	12 %	L-13, H-11, J-1, J-8, L-15

WEAR AT LOCATION OTHER THAN FLOW LIMITER
(ALL BELOW LIMITER)

QUANTITY	PERCENT WALL LOSS	CORE LOCATION
1 EACH	20 %	K-2*
1 EACH	16 %	B-8*
1 EACH	15 %	H-15*
1 EACH	12 %	D-3*
3 EACH	10 %	D-12, F-1, P-4

* INDICATES THIMBLES THAT HAVE WEAR AT THE FLOW LIMITER
AND A SECOND ELEVATION

REPOSITION AND CAP:

B-B = 60%

K-6, C-8 = 40%

REPOSITION:

C-7 = 36%

F-14 = 28%

E-11 = 25%

G-12, K-2, N-4, D-8, J-7 = 20%
