# UNC MINING AND MILLING

June 9, 1981

QUARTERLY REPORT - UNC MINING & MILLING  
Northeast Church Rock Tailings Facility  
File No. 3346

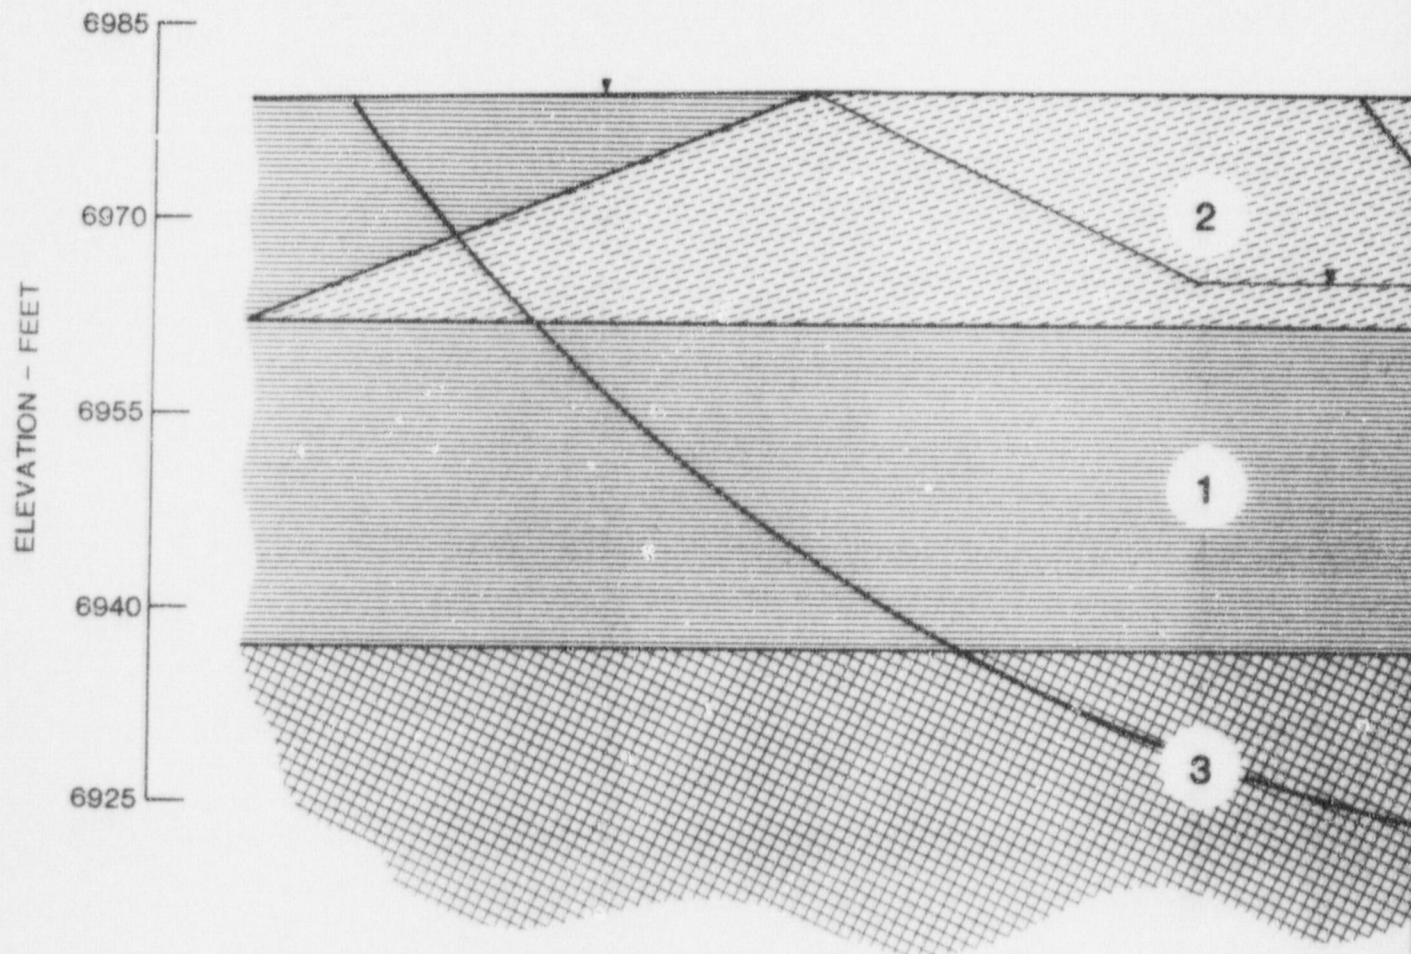
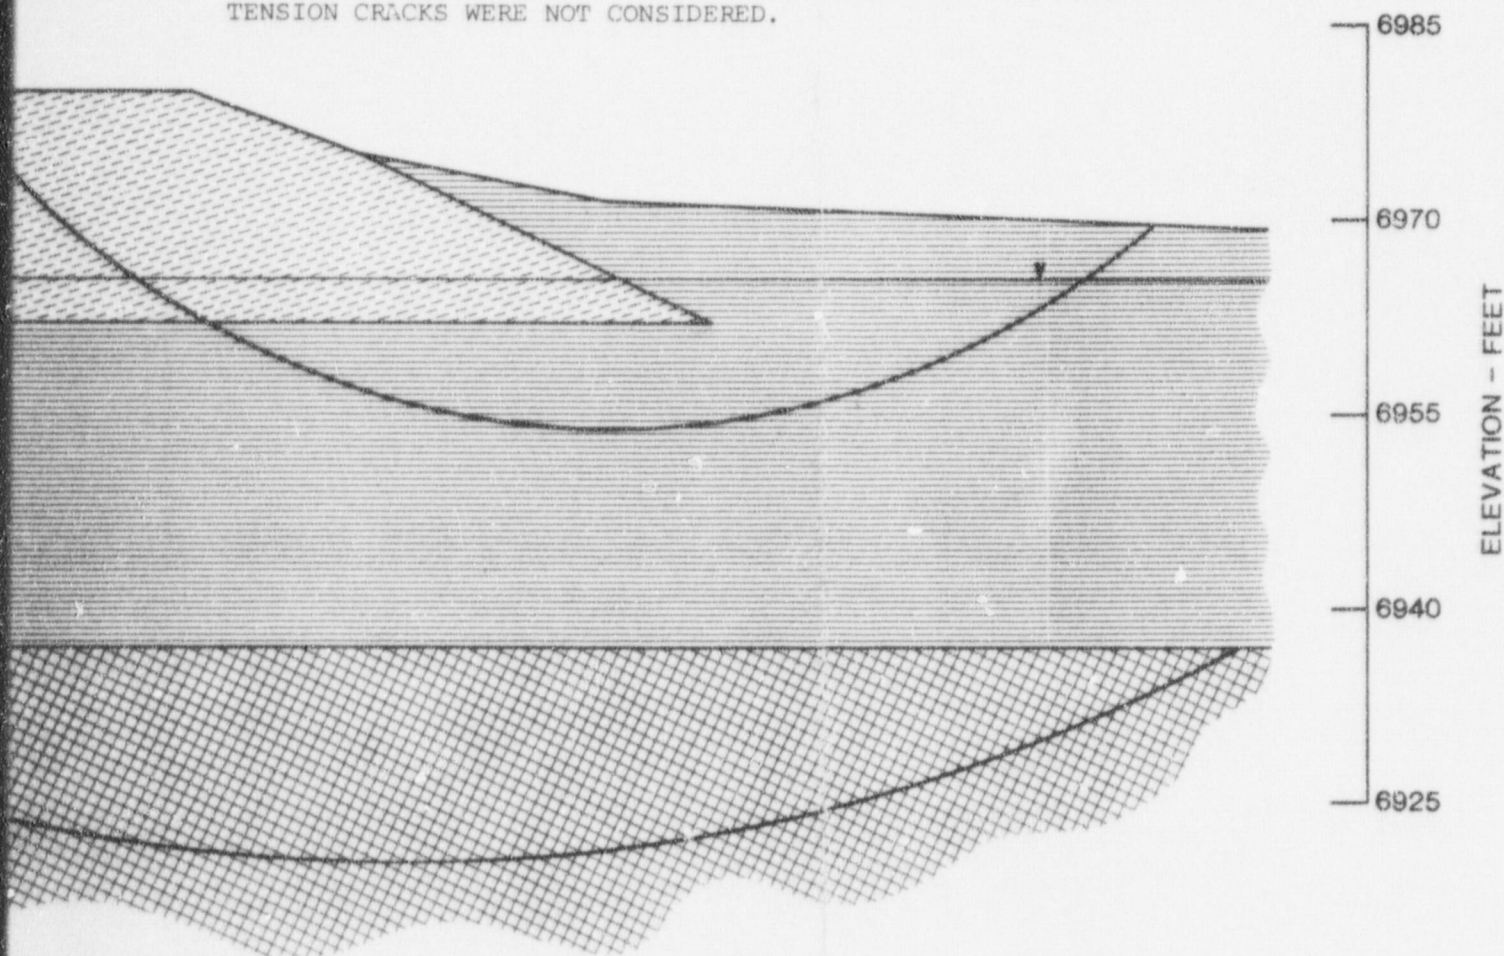
SLOPE STABILITY ANALYSIS  
SOUTH CROSS DIKE

The stability analysis of the north and south cross dike and the main dam of the central cell was performed by Mr. John Raney, P.E., UNC's retained Geotechnical Consultant, and is presented herewith. Computed minimum factors of safety were found to be higher than the required minimum for both static and pseudostatic loading conditions. The field survey was performed by UNC personnel under my supervision. The locations of the cross sections, on the most critical slope configurations of the dike, are shown on the attached map.

| CONDITION | COMPUTED | REQUIRED |
|---|---|---|
| FULL POOL | 5.6 | 1.5 |
| PSEUDOSTATIC<br>( $g = 0.1$ ) | 2.7 | 1.0 |

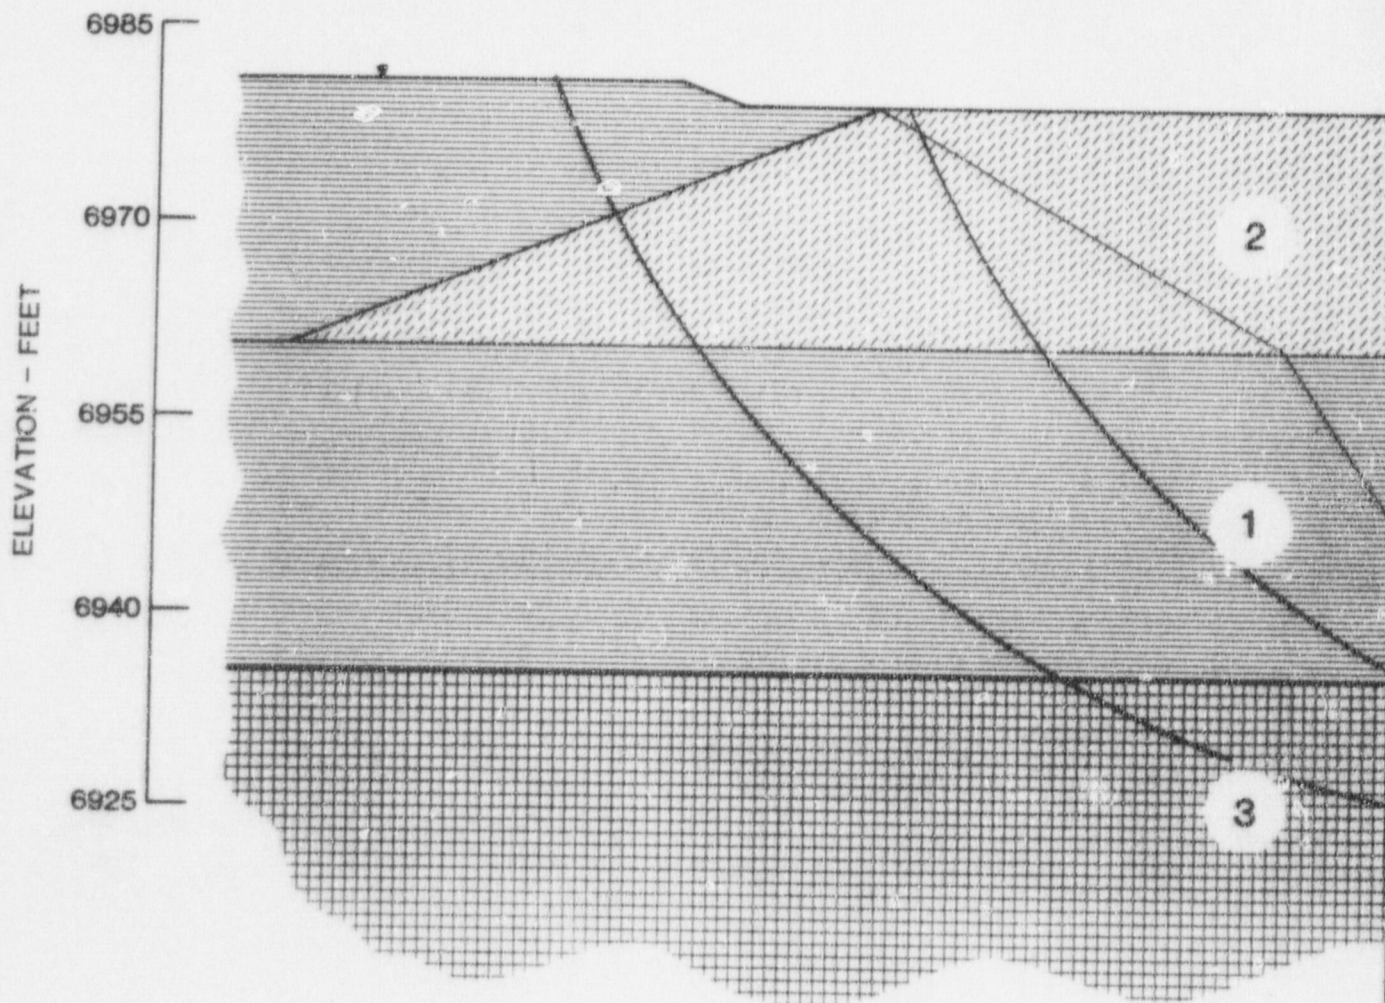
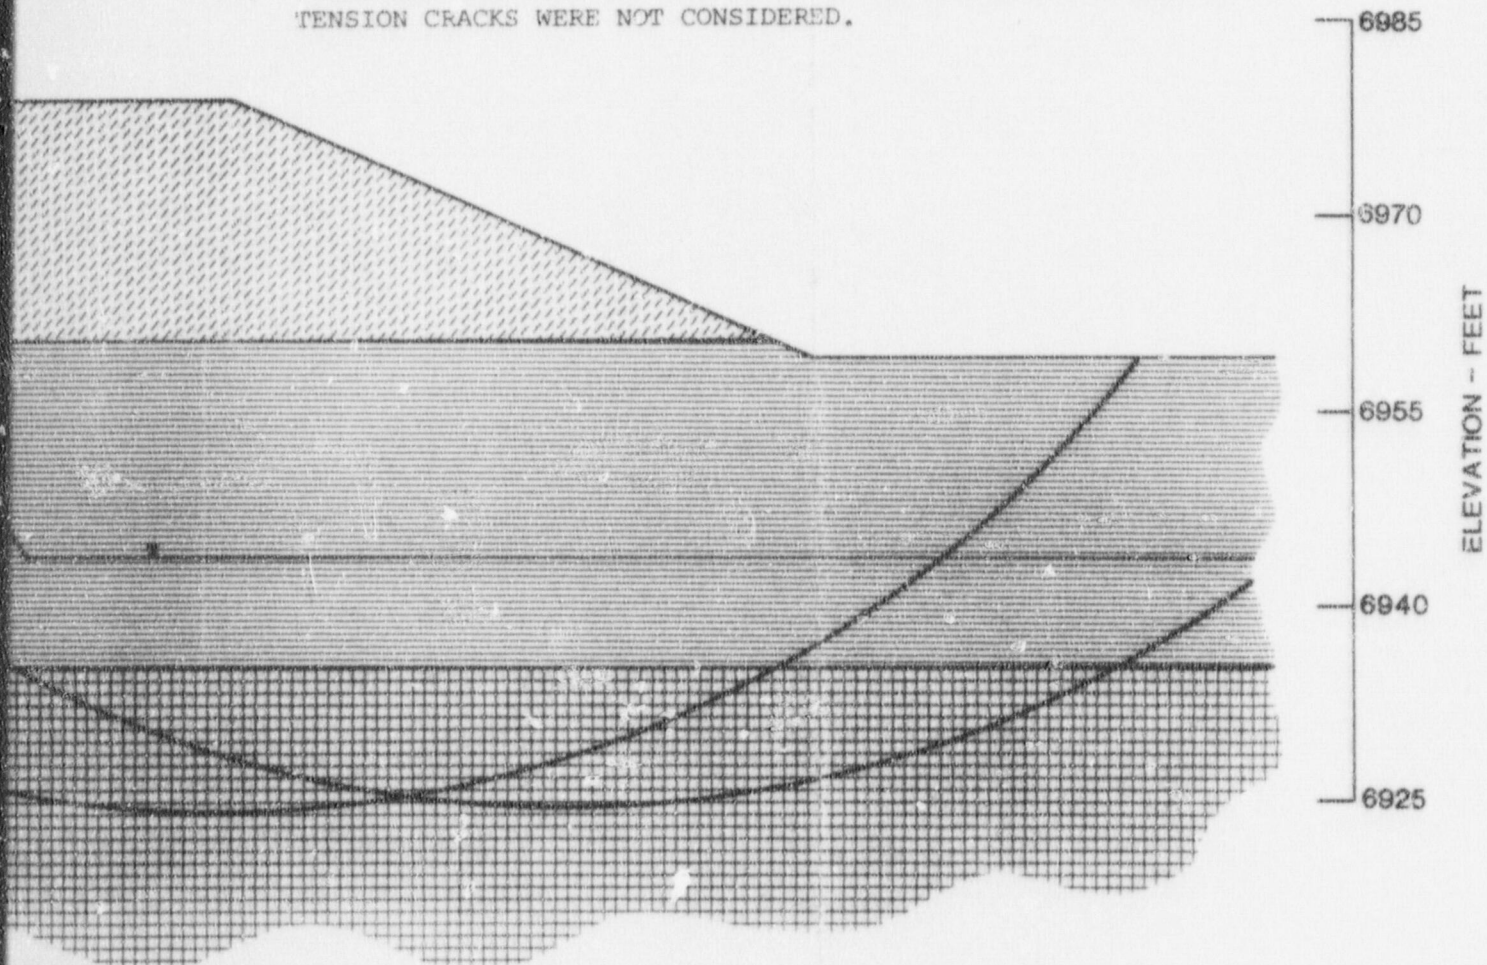
SLOPE STABILITY ANALYSIS  
NORTH CROSS DIKE

| CONDITION | COMPUTED | REQUIRED |
|---|---|---|
| FULL POOL | 3.3 | 1.5 |
| PSEUDOSTATIC<br>( $g = 0.1$ ) | 2.2 | 1.0 |

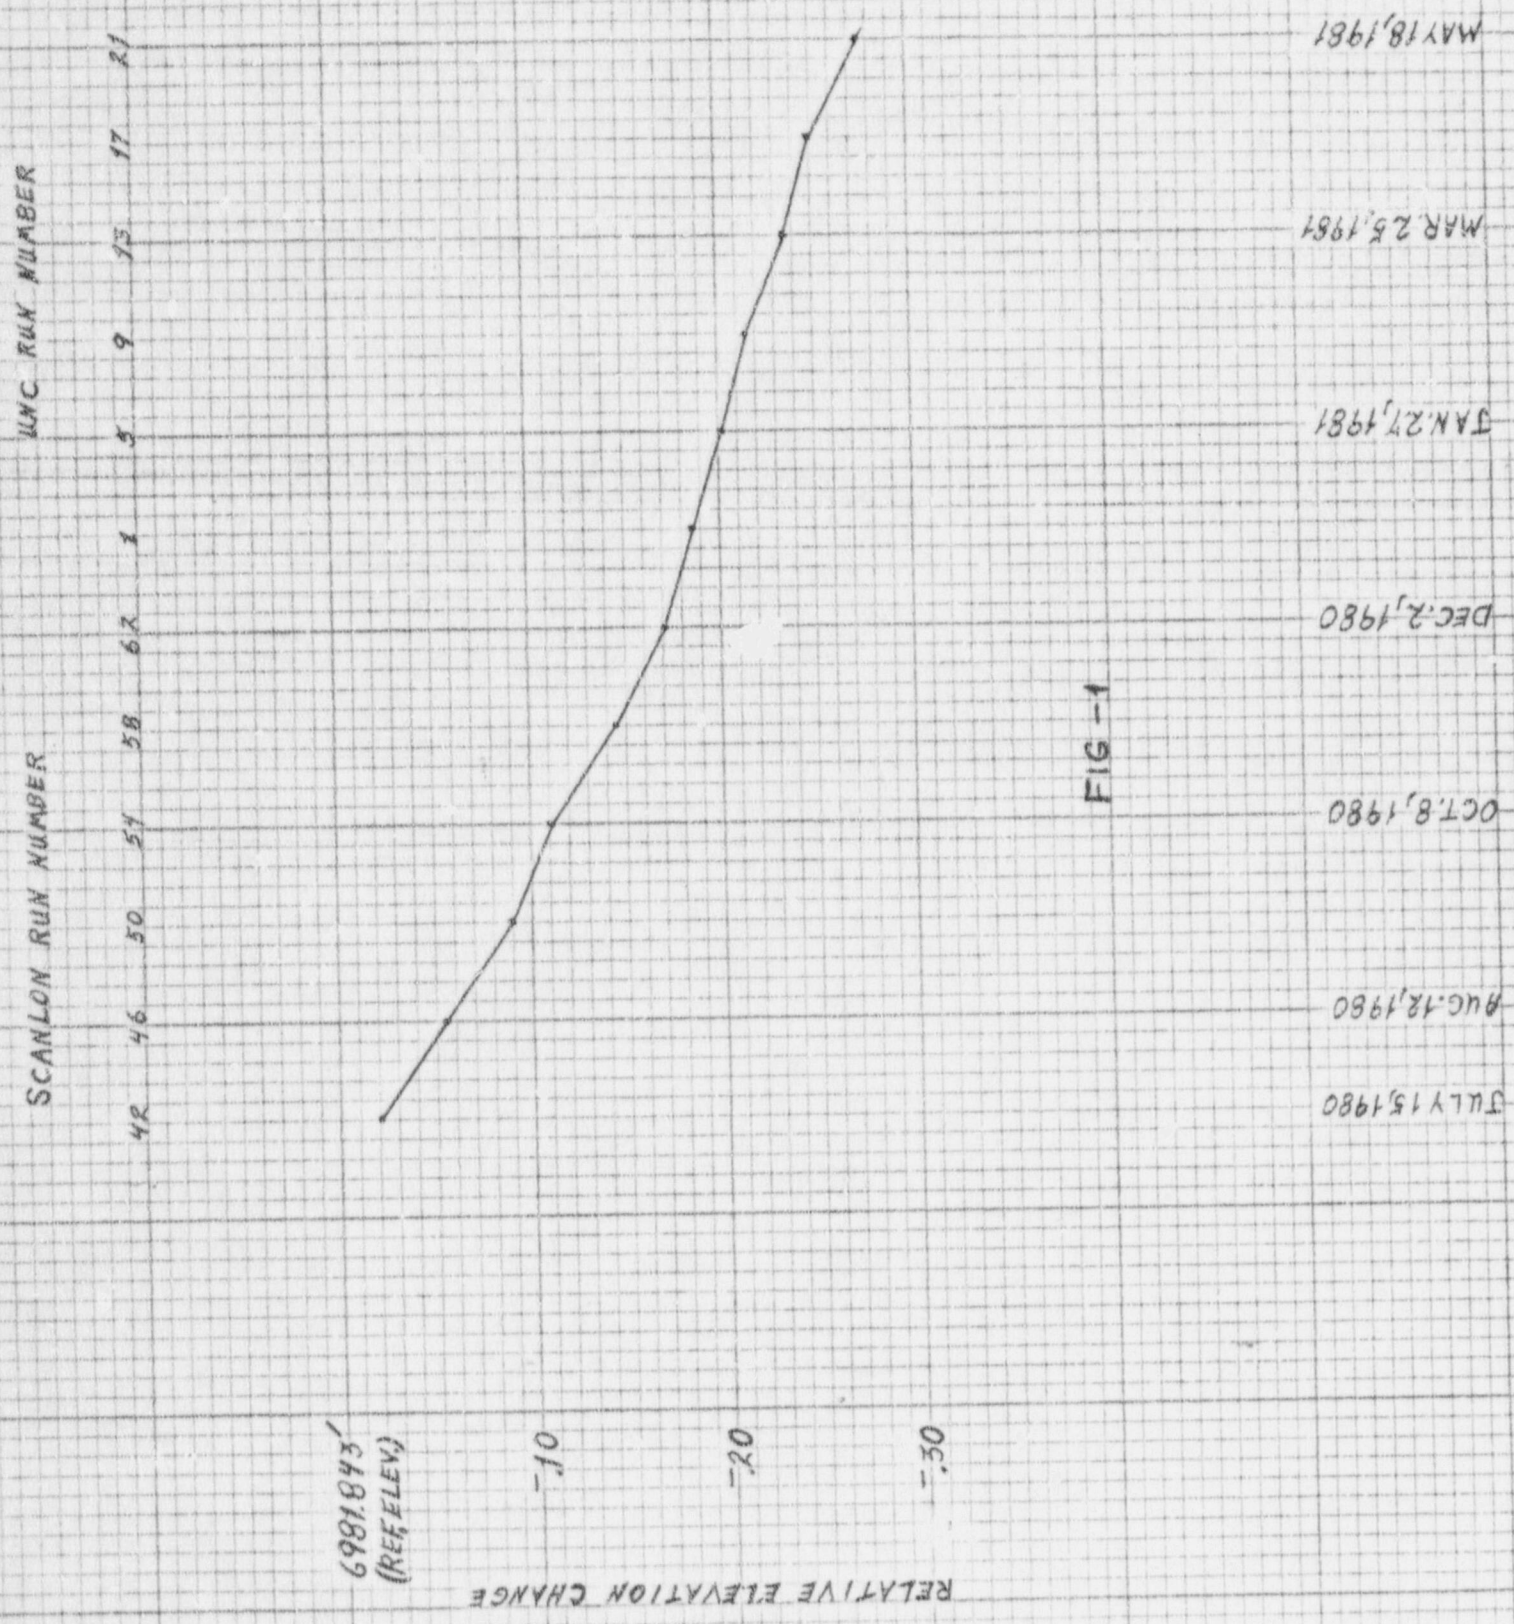
FIG -1

The plots of the recorded settlement for some monuments along the north and south cross dikes and the main dam are presented in Figures 1 through 11. Though settlement is still in progress, it is my opinion that the primary settlement which was to occur has already taken place and the recent settlements are very slow and small.
