UNC MINING AND MILLING

Pursuant to the request of the New Mexico Environmental Improvement Division, United Nuclear Corporation presents this report to the Division concerning the breach of the tailings impoundment at UNC's uranium milling facility located near Church Rock, New Mexico, Monday, July 16, 1979. The report includes a determination as to the cause of the breach, a review of sampling procedures, a plan for clean-up and decontamination based upon the sampling results, and a proposal for the resumption of operation of the milling facility.

STABILITY AND INTEGRITY ASSESSMENT
of
NORTHEAST CHURCH ROCK TAILINGS DAM

July 20, 1979

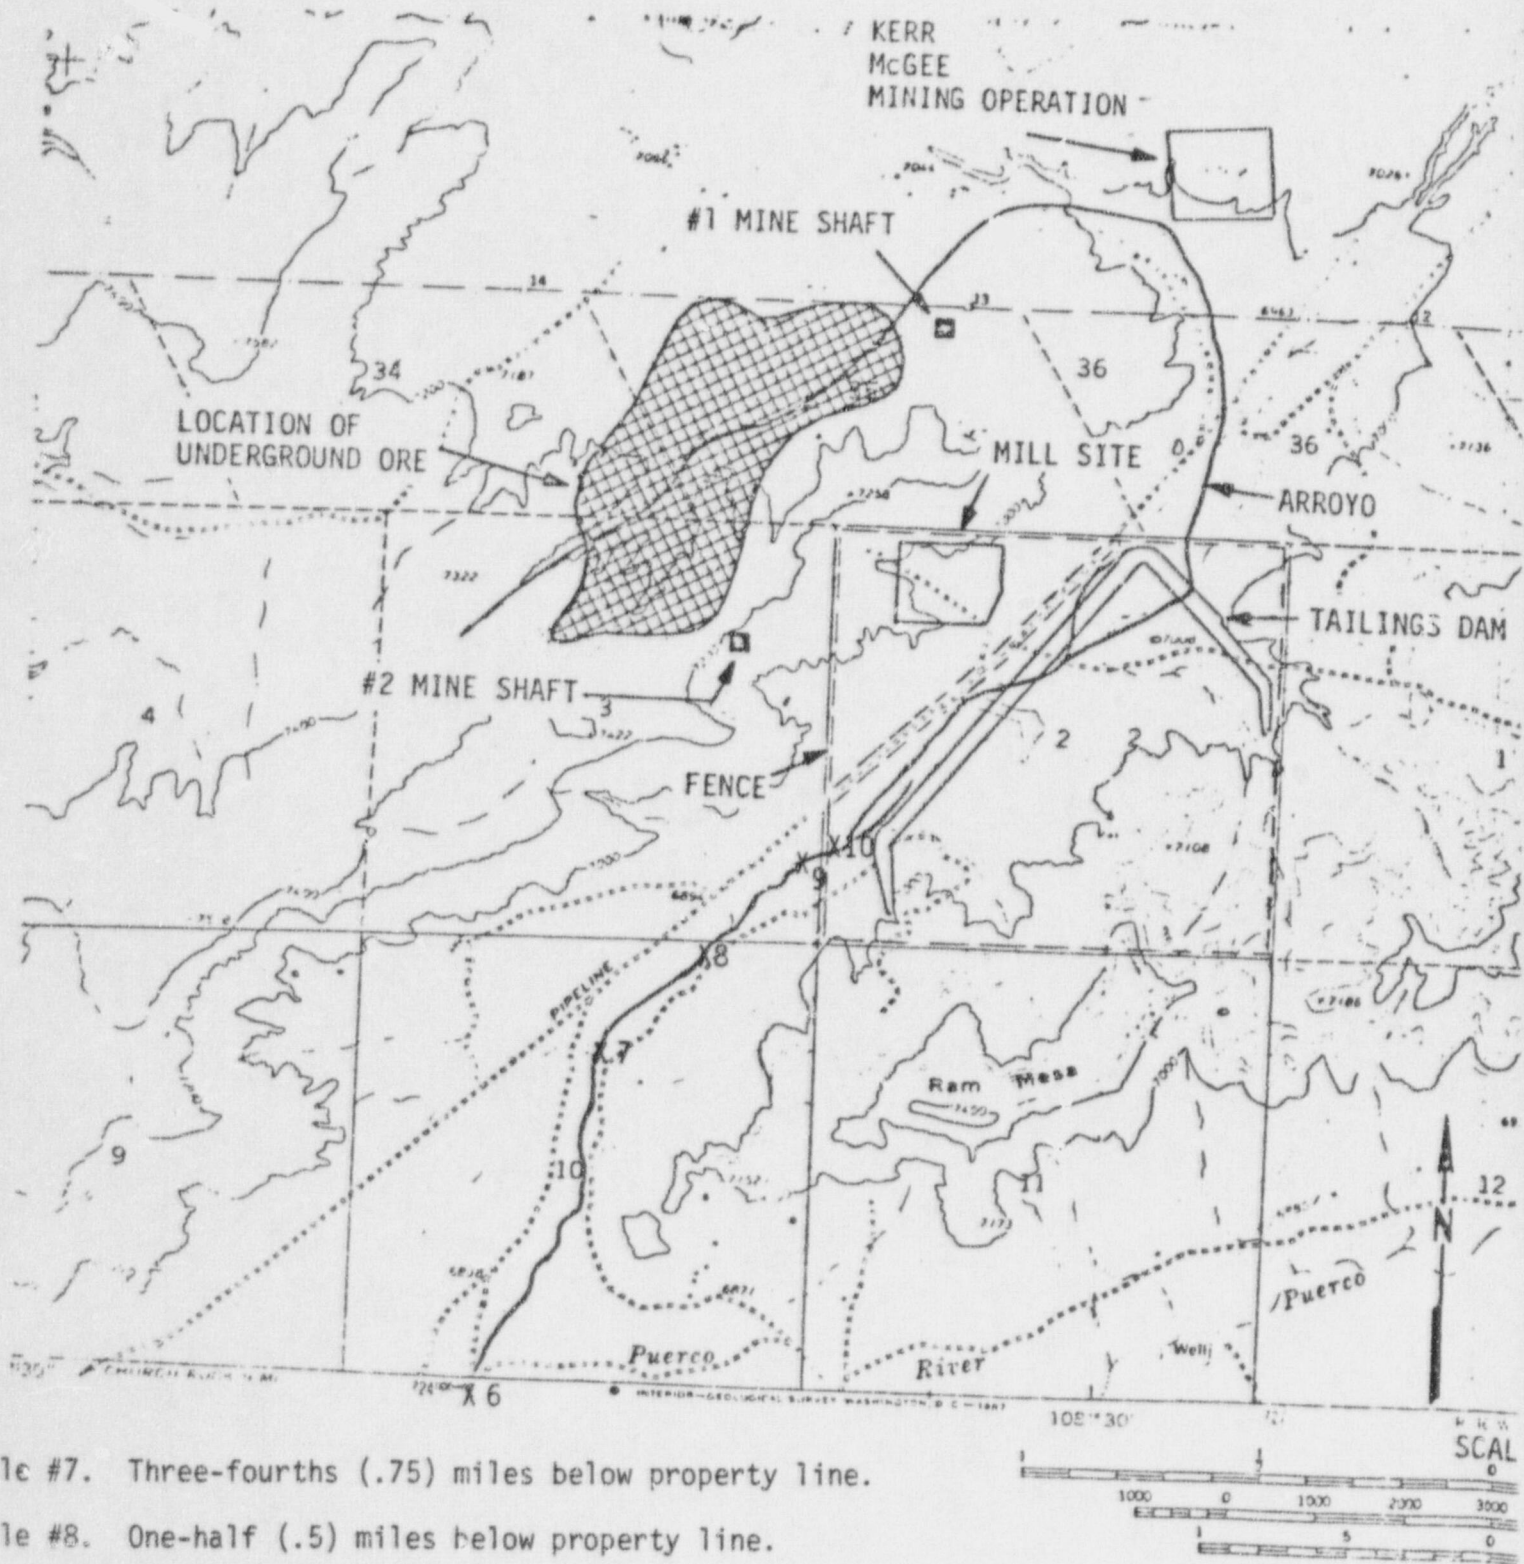
DAM BREACH STREAM SEDIMENT SAMPLES

Sample #7. Three-fourths (.75) miles below property line.

Sample #8. One-half (.5) miles below property line.

Sample #9. Five hundred (500) yards below property line.

Sample #10. Above and below the spill inside the property line.

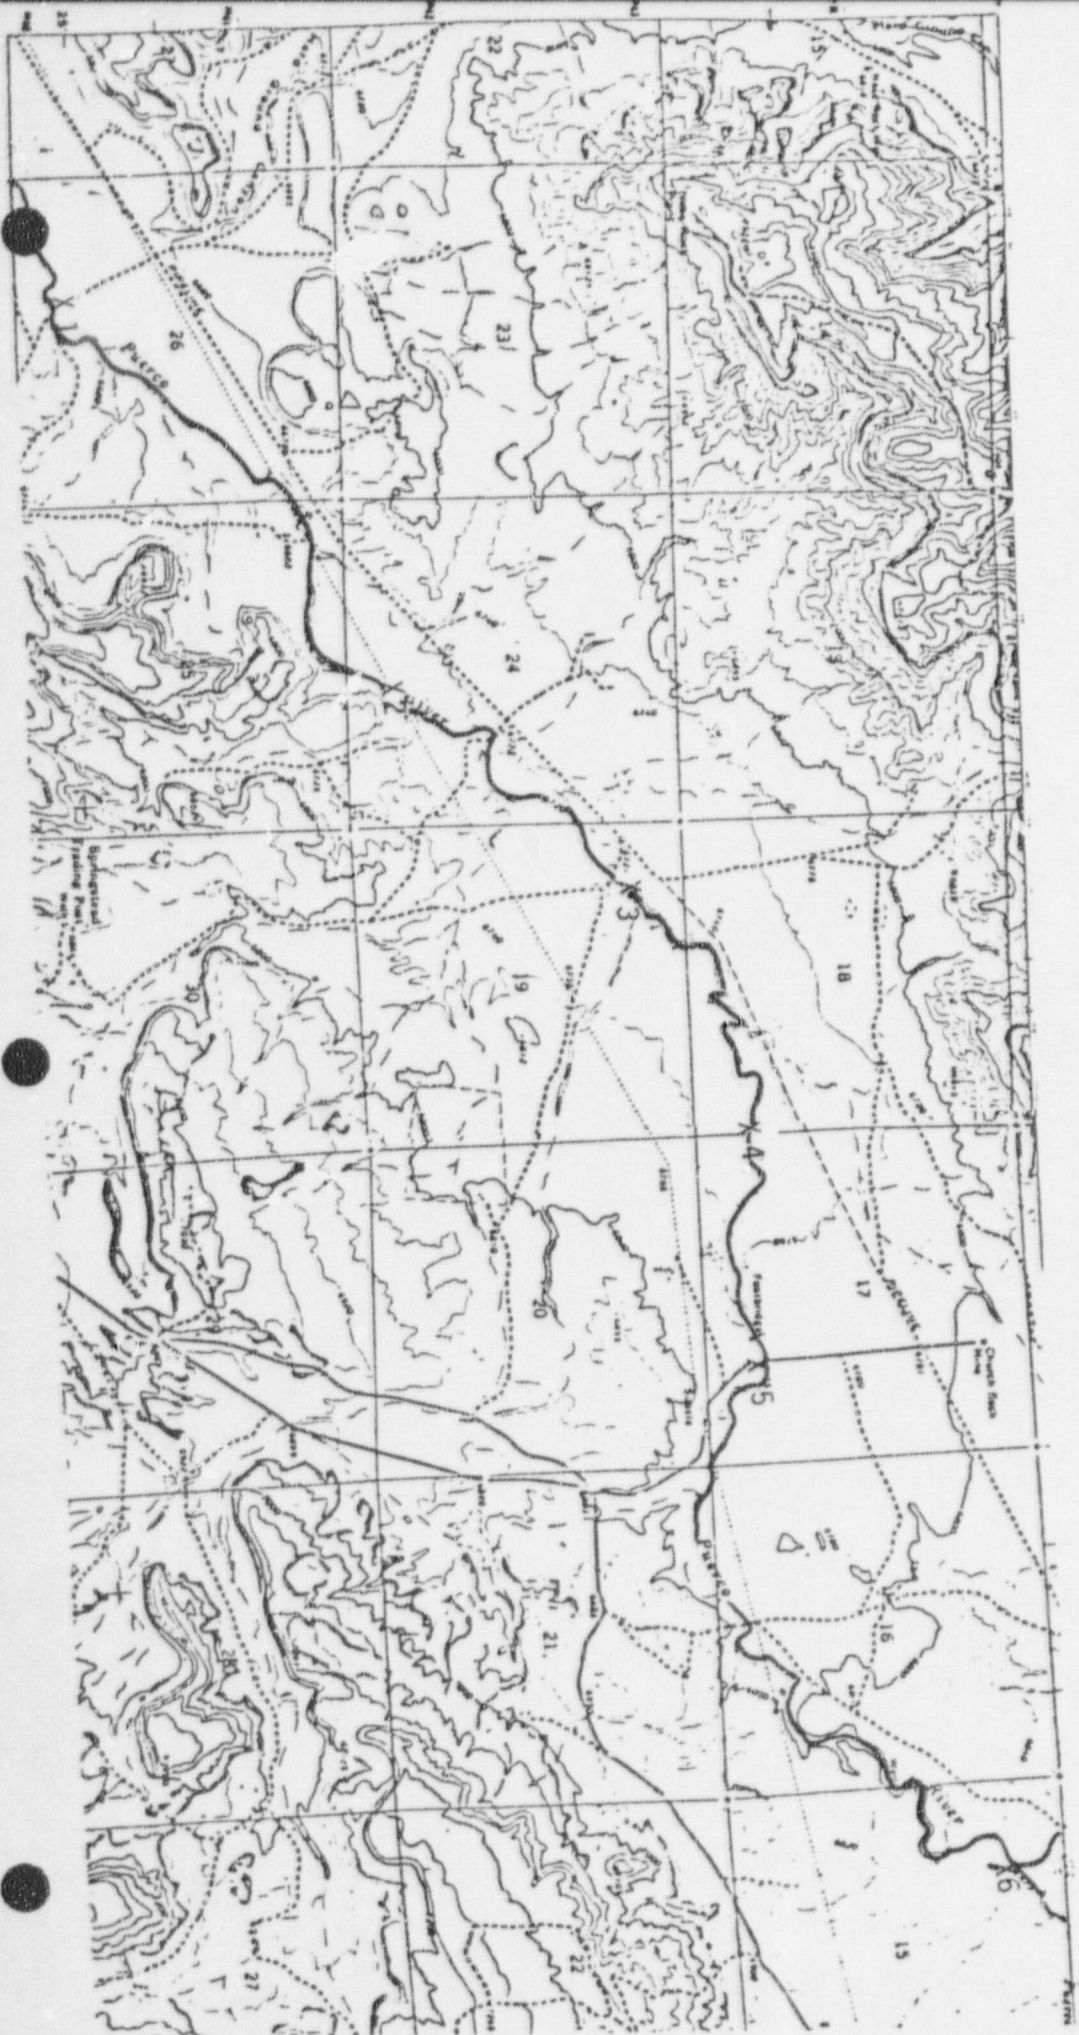
DAM BREACH STREAM SEDIMENT SAMPLES

- Sample #1. Ten (10) miles below property line.
- Sample #2. Seven and one-half (7.5) miles below property line.
- Sample #3. Six and one-half (6.5) miles below property line.
- Sample #4. 566 Bridge, Five (5) miles below property line.
- Sample #5. Pinedale Bridge, Four (4) miles below property line.
- Sample #6. Below Puerto confluence, one and one-half (1.5) miles below property line.
