Report Nos.: 50-327/88-60, 50-328/88-60

Facility Name: Sequoyah Units 1 and 2

Inspection Conducted: December 22 and 23, 1988, and February 22, 1989

Scope: This special, unannounced inspection was conducted to review licensee resolution of the differences between measured and predicted critical boron concentrations observed during restart testing of both units, and to review methods being used to predict critical conditions.

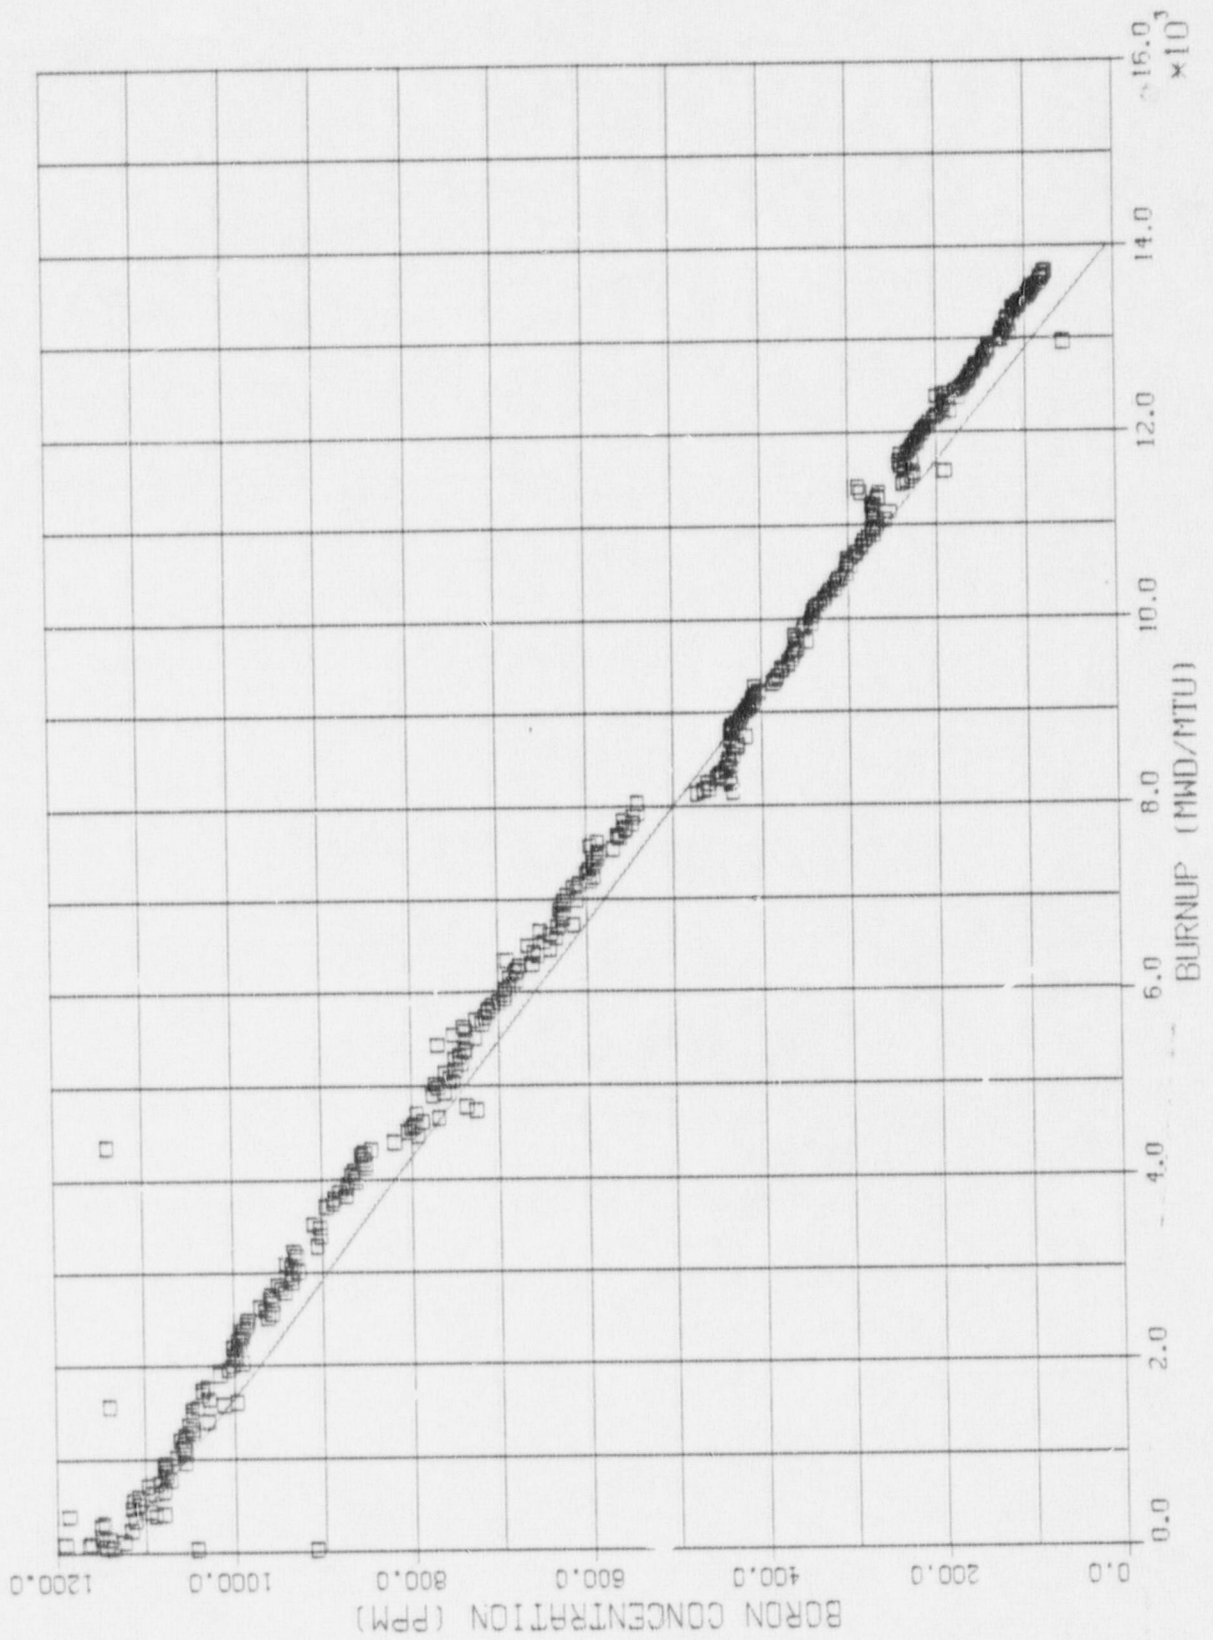
MEASURED BORON VERSUS CYCLE BURNUP (MWD/MTU)

Similarly, no significant modeling errors were apparent in the HFP critical boron concentration data for Unit 2 operation (attached). The inspector discussed with the licensee how the measured and predicted curves were derived, and what factors were included. The agreement between the measured and predicted data was acceptable, and the observed effects of the extended shutdown on the agreement between measured and predicted boron concentrations were consistent with industry experience.
