Subject: Crystal River Unit 3
Docket No. 50-302
Operating License No. DPR-72
Licensee Event Report No. 89-023

LICENSEE EVENT REPORT (LER)

TITLE (4) **Technician Error and Relay Failure Leads to Degraded Off-site Power and Results in Reactor Trip and Emergency Feedwater Actuation**

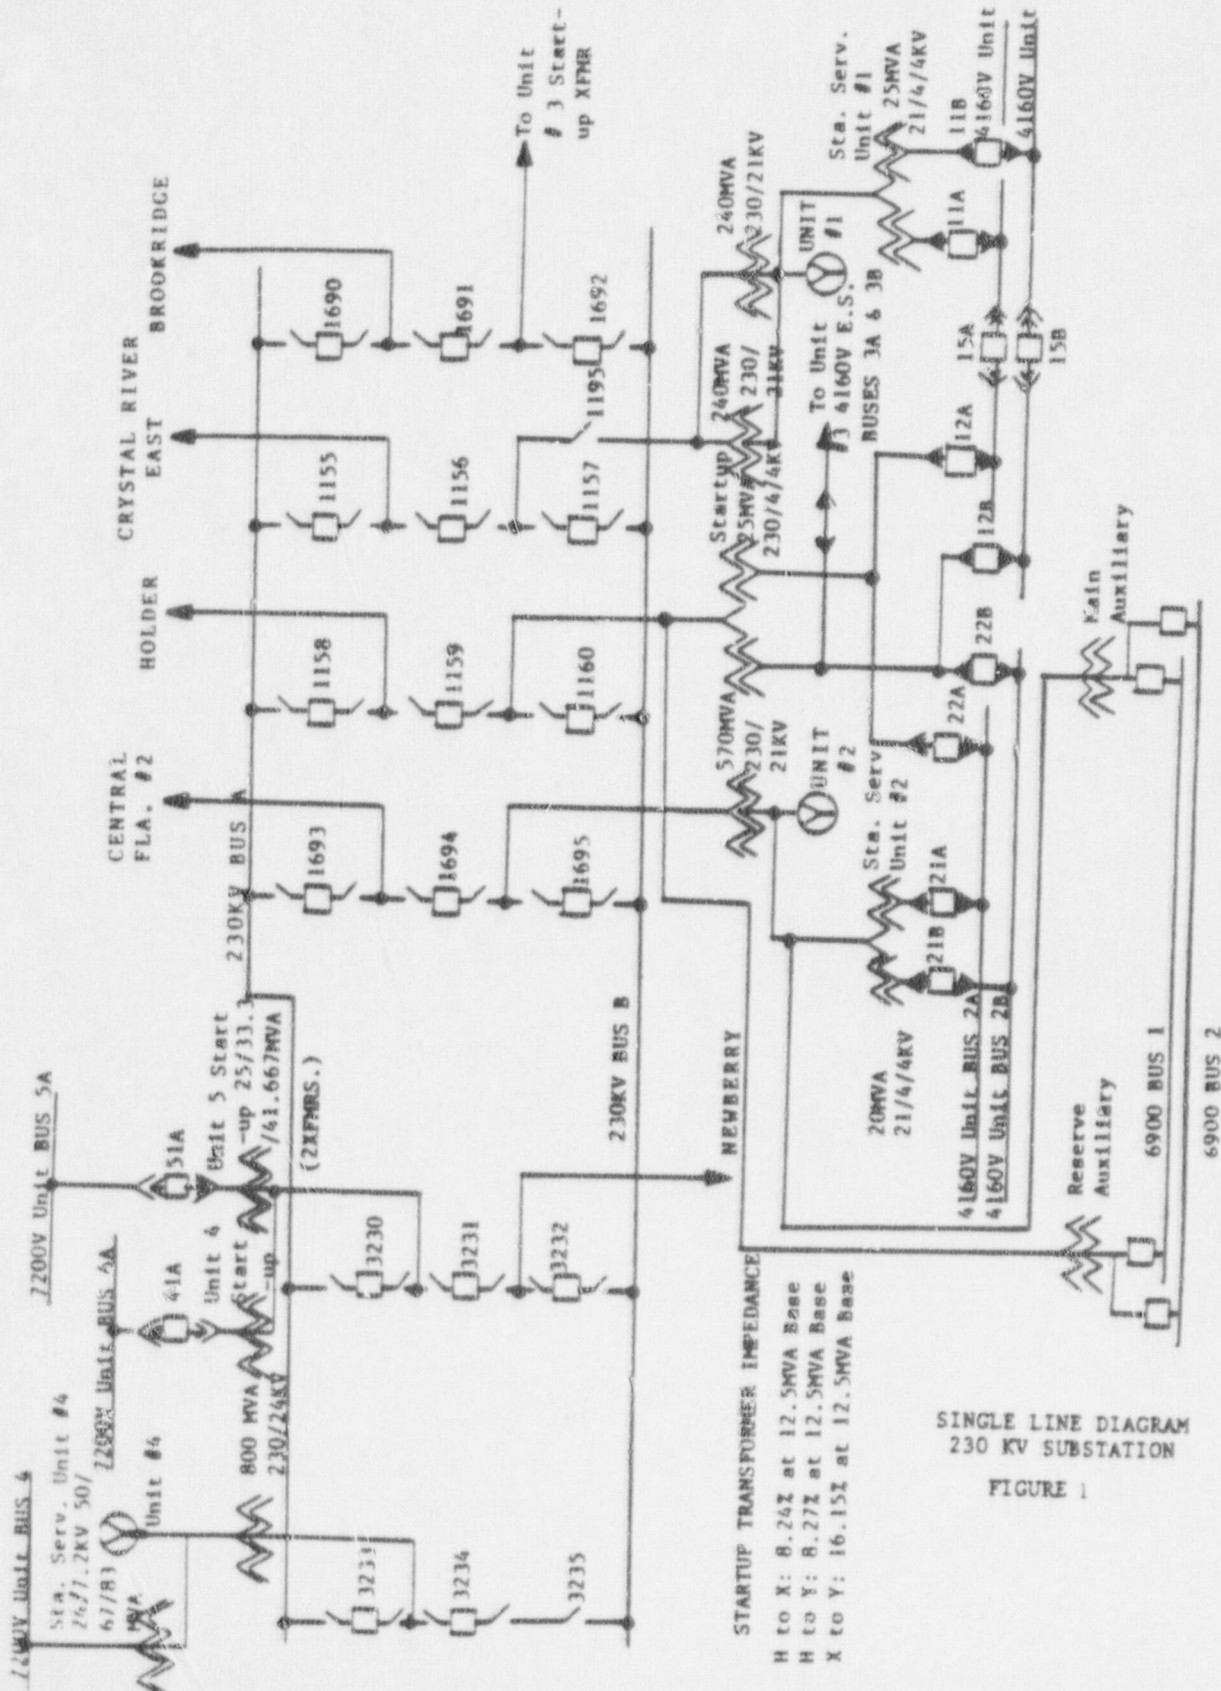
SINGLE LINE DIAGRAM
 230 KV SUBSTATION
 FIGURE 1

On Friday, June 16, 1989 Crystal River Unit #3 (CR-3) was in MODE 1 (Power Operation) at 12% reactor power with the Main Turbine [TA,TRB] latched and rolling. The Unit #3 Start-up Transformer [EB,XFMR] was supplying all 4160V and 6900V buses [EA,EB,BU]. Relay technicians were testing carrier signal levels in the Brookridge line metering cabinet [FK,CAB] in the 230 KV switchyard [FK]. At 13:25:51, a technician inadvertently bumped the Brookridge line test trip pushbutton. This action sent a trip signal to breakers 1690 and 1691 [FK,BKR] (Refer to Figure 1). Both breakers (1690 and 1691) tripped open; this action alone would only have de-energized the Brookridge line. However a fault detector relay [FK,RLY] in breaker 1691 failed which caused the breaker to indicate closed (even though it was open). The fault detector scheme opened breaker 1692 [FK,BKR] to clear the indicated fault. This action caused a loss of off-site power to the Unit #3 Start-up Transformer.

The loss of power to the Unit #3 Start-up Transformer was caused by a combination of a fault detector relay failure and personnel error. A non-licensed utility employee (relay technician) inadvertently bumped a test trip circuit pushbutton while performing testing. Additionally a fault detector relay associated with breaker 1691 failed. During post-event troubleshooting a stuck contact was found in the fault detector relay which caused the relay not to actuate as required.

Florida Power Corporation (FPC) is reviewing off-site power supply configurations. Corrective action deemed necessary to improve off-site power will be pursued. FPC is considering removal of the circuit trip test button from the breaker testing scheme for the off-site power supply breakers.

The fault detector relay associated with breaker 1691 was tested and found to have a stuck contact. The relay was recalibrated and now functions correctly. A work order was generated which will change out this type of relay to a more state of the art type relay during the next refueling outage.
