Detroit  
Edison

Subject: Licensee Event Report (LER) No. 89-017-00

FACILITY NAME (1) Fermi 2										DOCKET NUMBER (2) 0 5 0 0 0 3 4 1 1 OF 0 9										PAGE (3) 1	
TITLE (4) Revised Feedwater Line Break Analysis																					
EVENT DATE (5)				LER NUMBER (6)				REPORT DATE (7)				OTHER FACILITIES INVOLVED (8)									
MONTH	DAY	YEAR	YEAR	SEQUENTIAL NUMBER	REVISION NUMBER	MONTH	DAY	YEAR	FACILITY NAMES					DOCKET NUMBER(S)							
0	8	1	0	8	9	8	9	1	N/A					0 5 0 0 0							
0	8	1	0	8	9	0	1	7	N/A					0 5 0 0 0							
OPERATING MODE (9)				THIS REPORT IS SUBMITTED PURSUANT TO THE REQUIREMENTS OF 10 CFR § (Check one or more of the following) (11)																	
1				20.402(b)				20.406(c)				50.73(e)(2)(iv)				73.71(b)					
POWER LEVEL (10)				20.406(e)(1)(i)				50.36(c)(1)				50.73(e)(2)(v)				73.71(c)					
9 9				20.406(e)(1)(ii)				50.36(c)(2)				X 50.73(e)(2)(vii)				OTHER (Specify in Abstract below and in Text, NRC Form 366A)

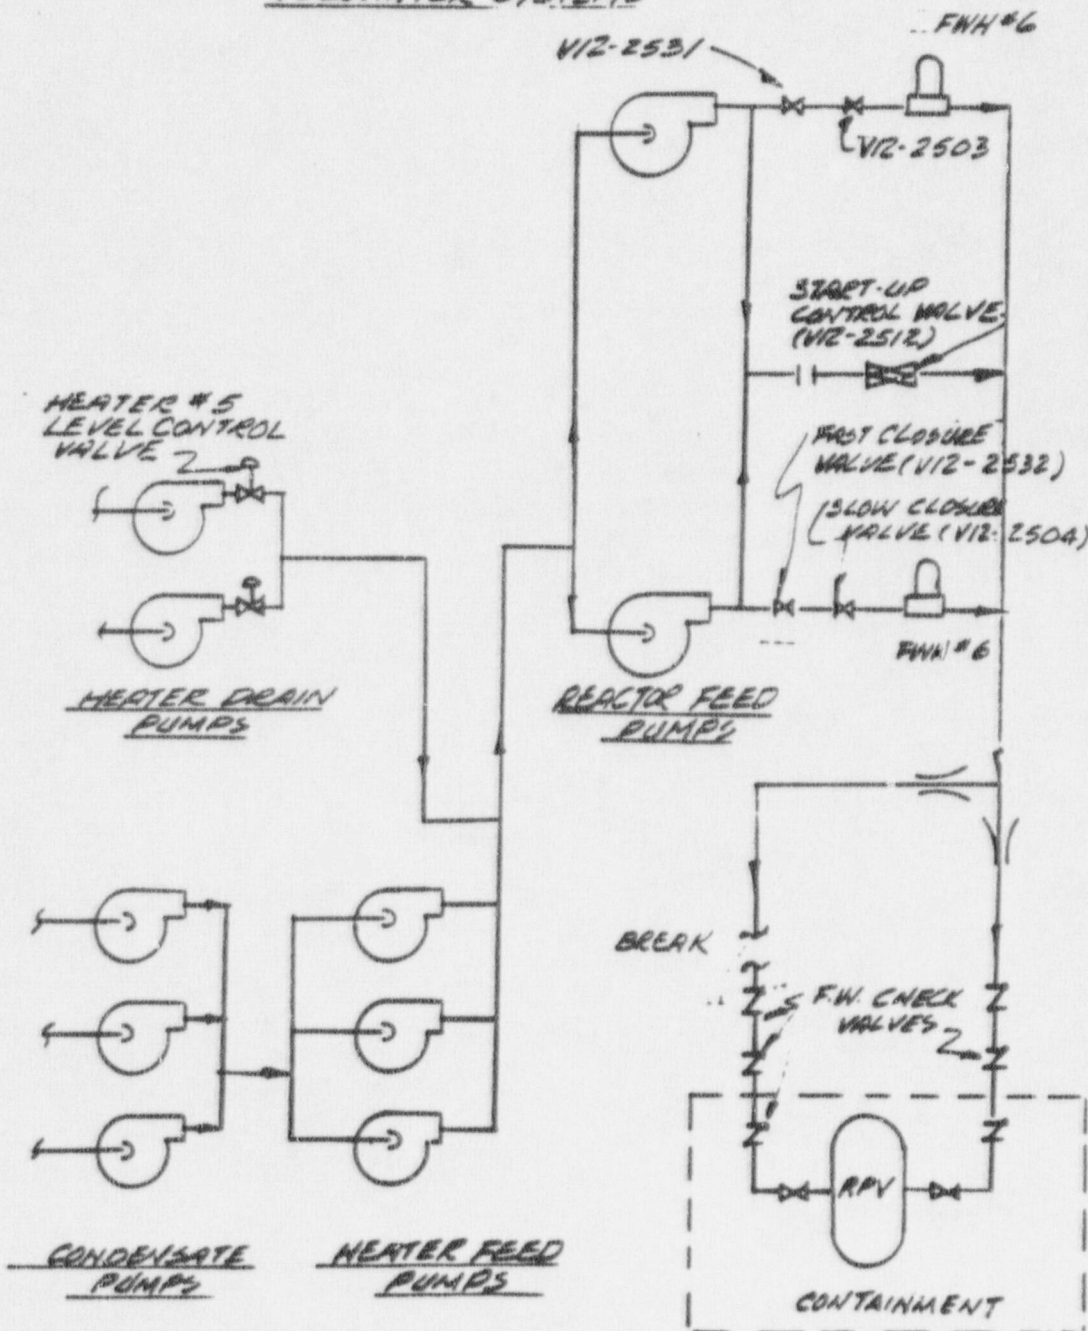
FIGURE 1  
SIMPLIFIED CONDENSATE  
FEEDWATER SYSTEMS

The new analysis of the feedwater line break scenario assumes failure of the feedwater startup control valve (TV) in the open position. This single failure was selected to maximize flooding in affected areas of the plant. The feedwater line break scenario with the single failure of the startup control valve is therefore more conservative. The feedwater line break would not isolate until the tripping of the condensate (SG) and heater feed pumps (P) on low hotwell level (SD). No operator action was assumed for the 8 1/2 minutes during which water flows through the postulated pipe break. Supporting documentation is provided in Tables I, II, and III, and the figure attached to this Licensee Event Report (LER).
