McGuire Nuclear Station Unit 2
Review of Susceptibility to an Event like the
McGuire Unit 1 Tube R18C25 Rupture
and Justification for Return to Power

Addendum to McGuire Unit 1 Justification for Return to Power

August 1989

Duke Power Company

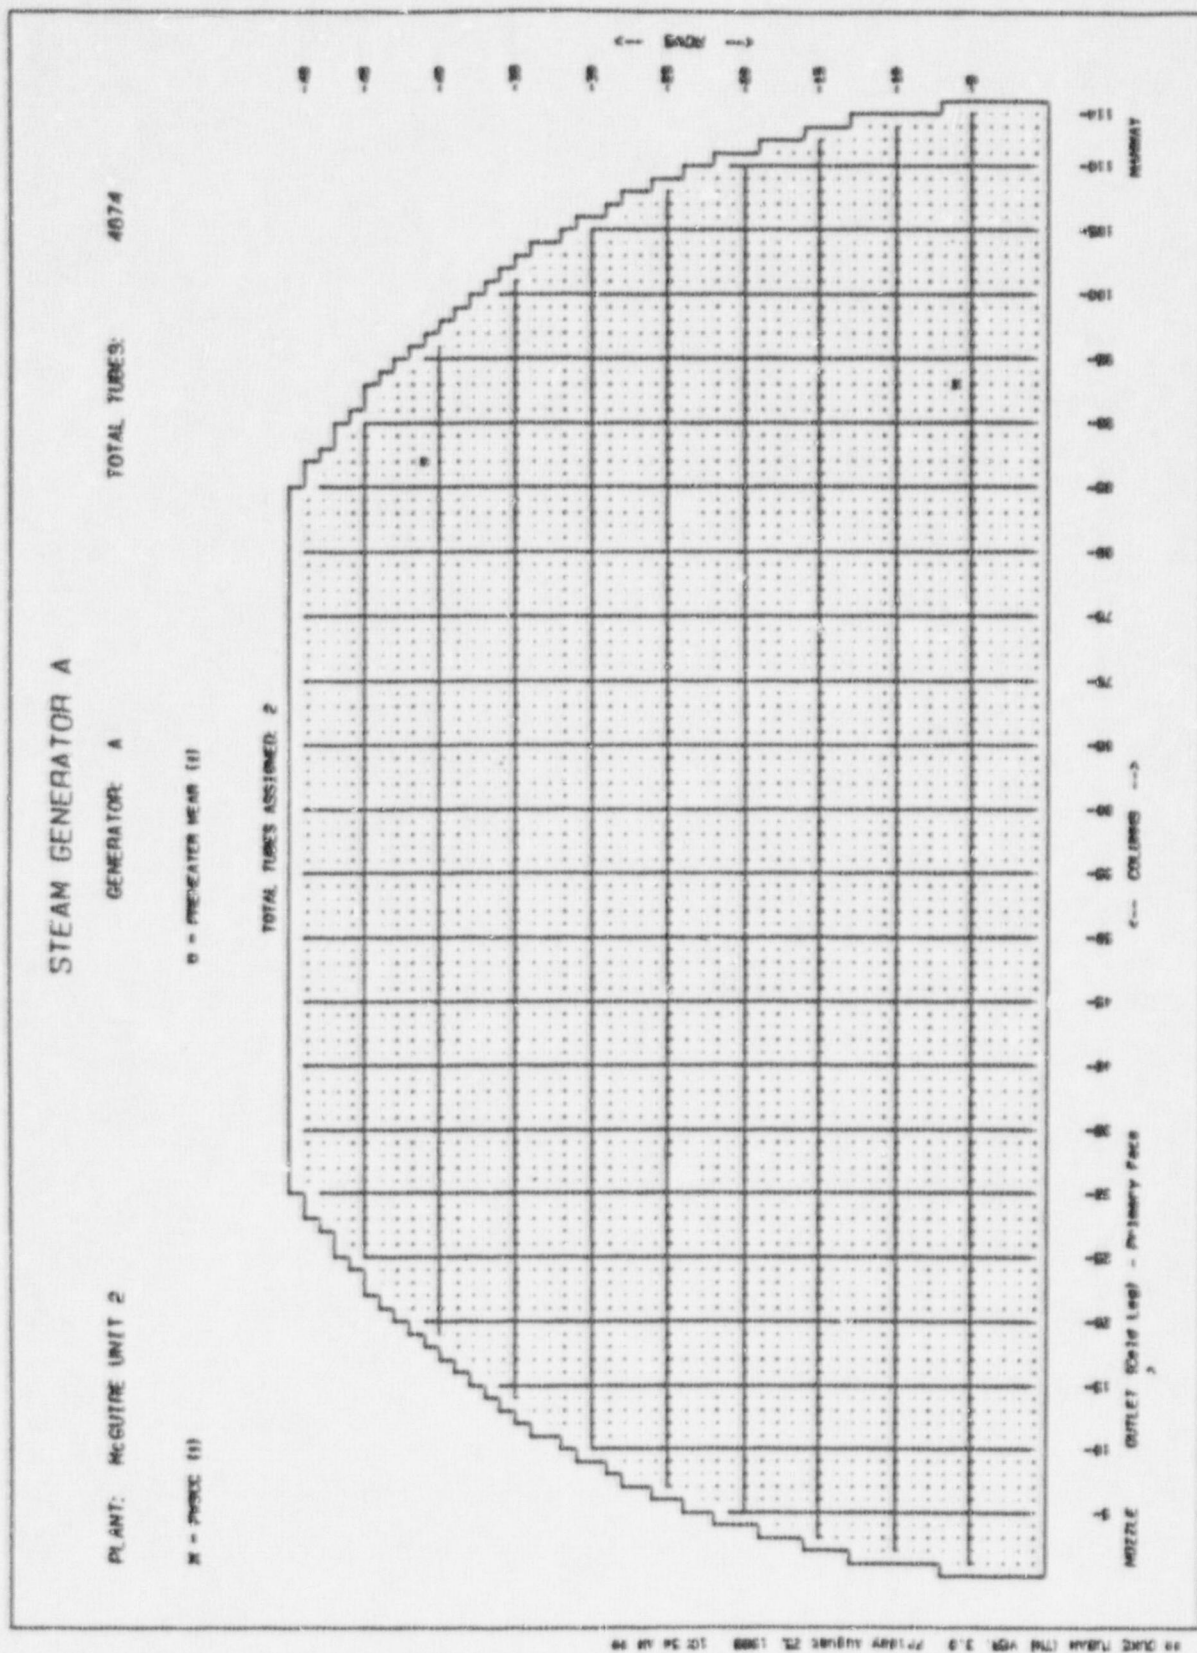
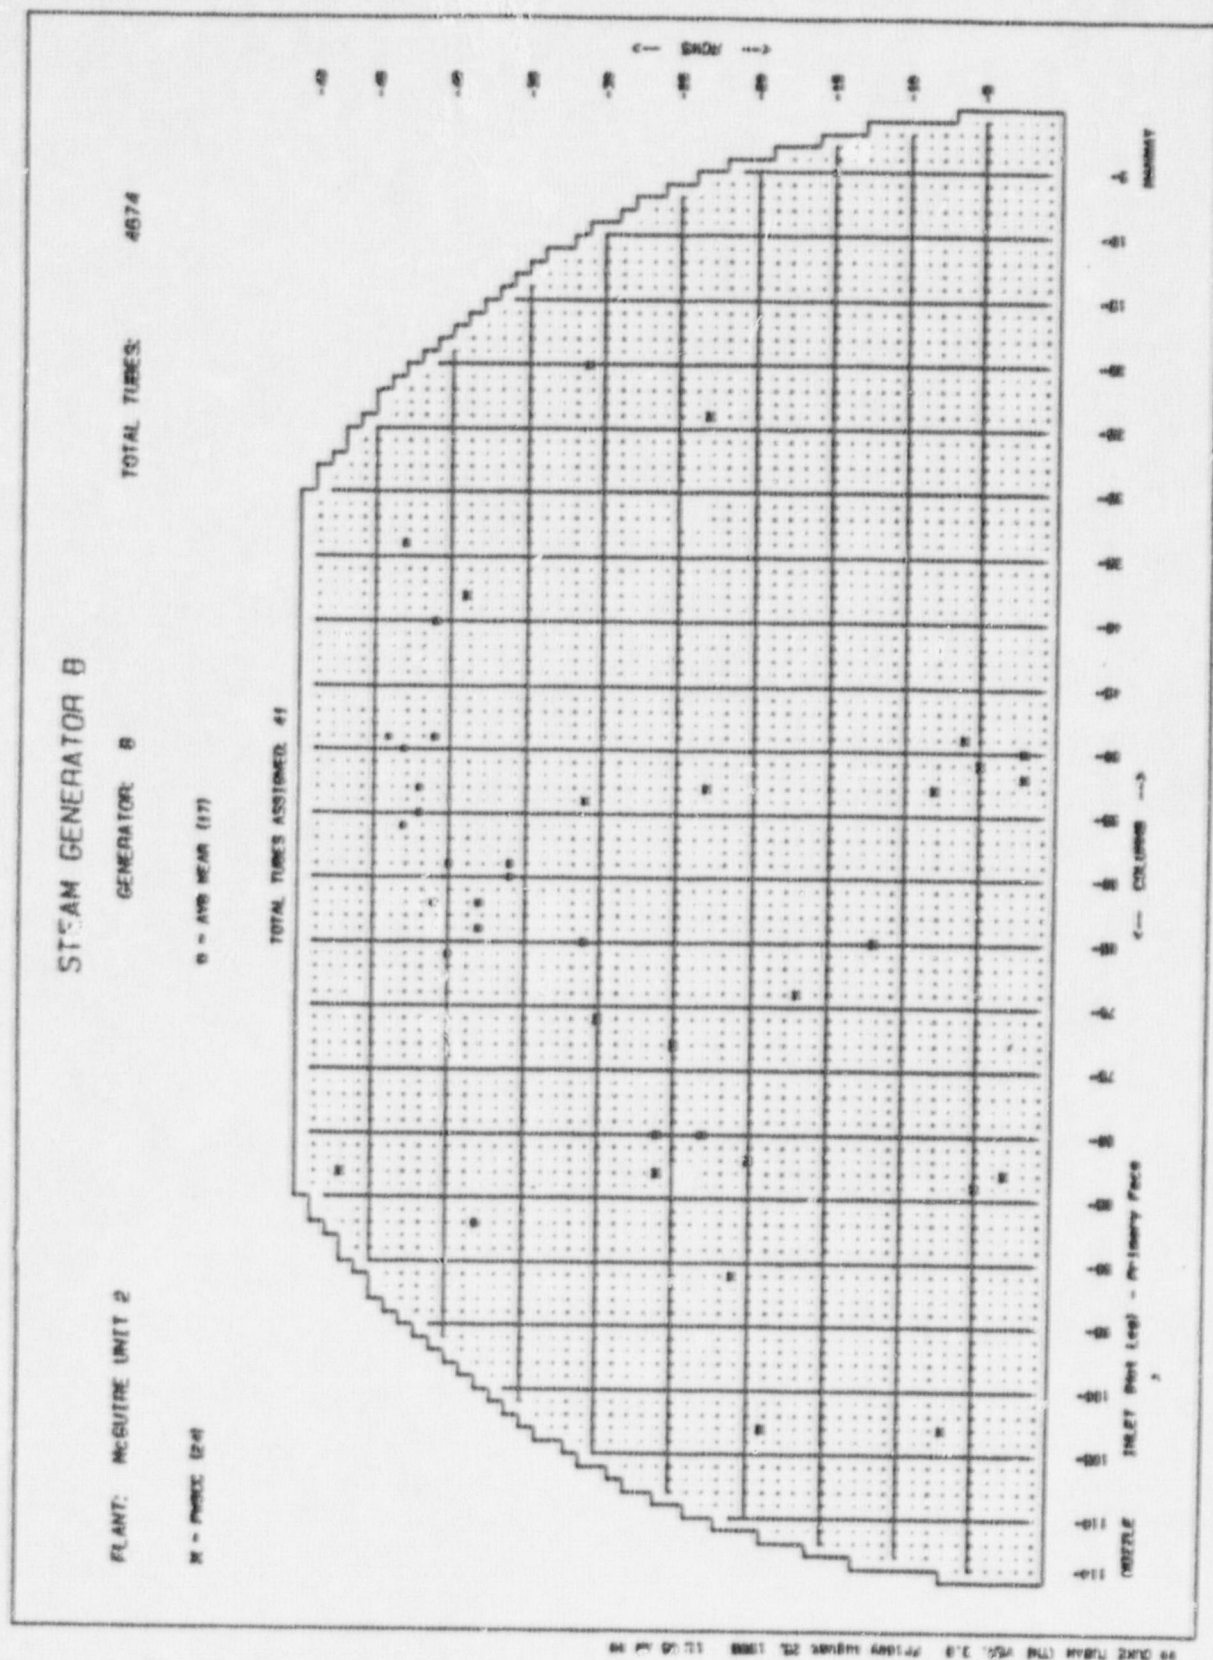
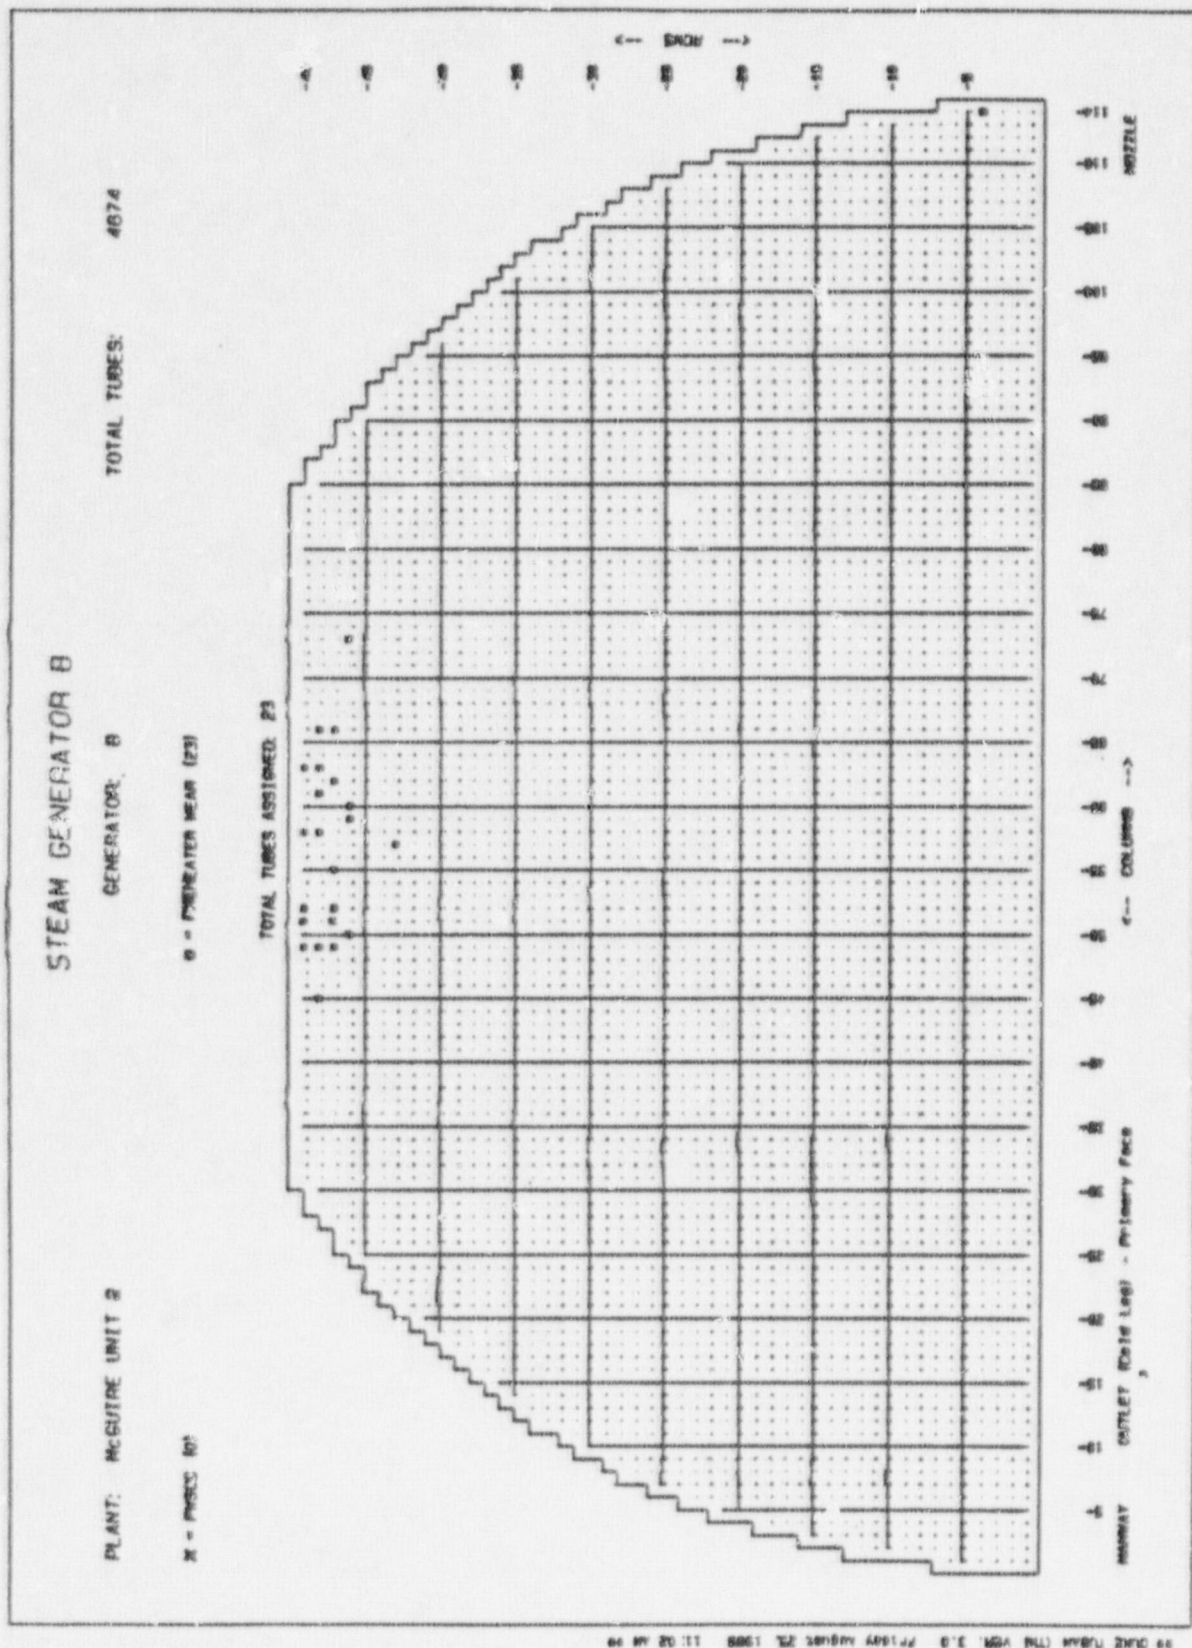
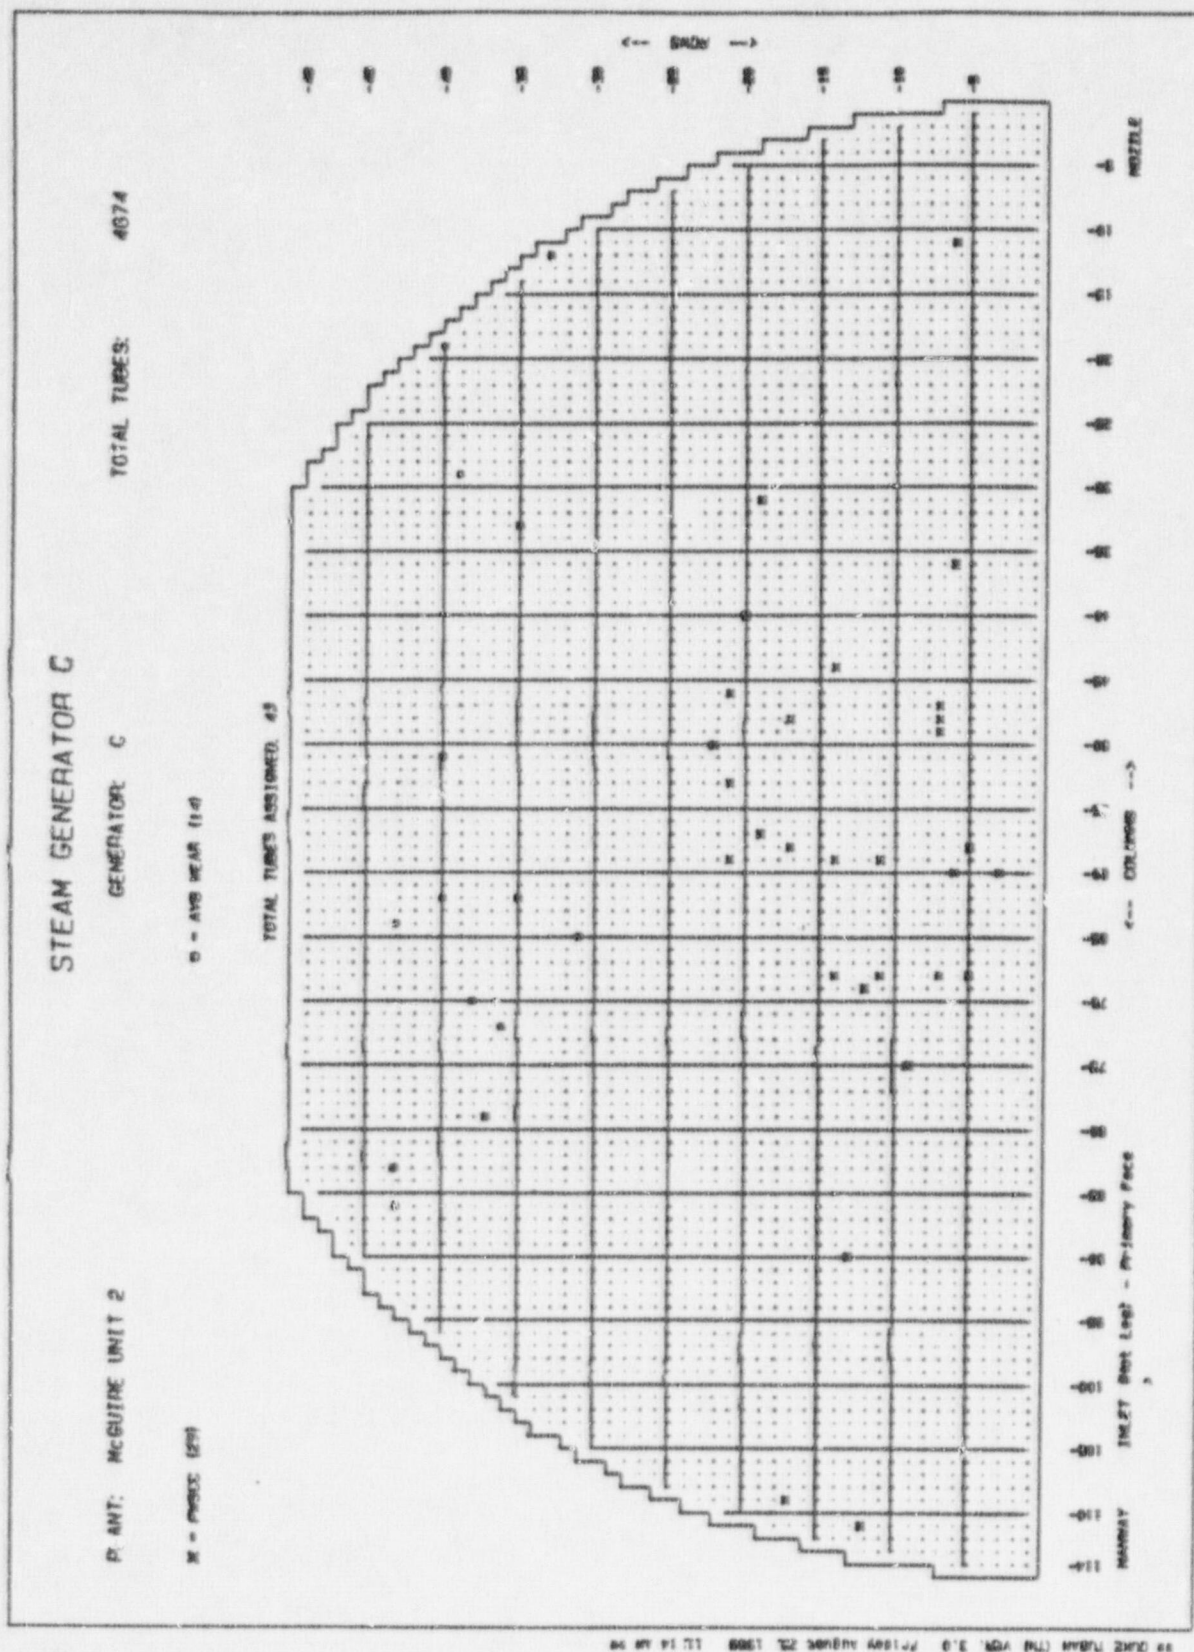
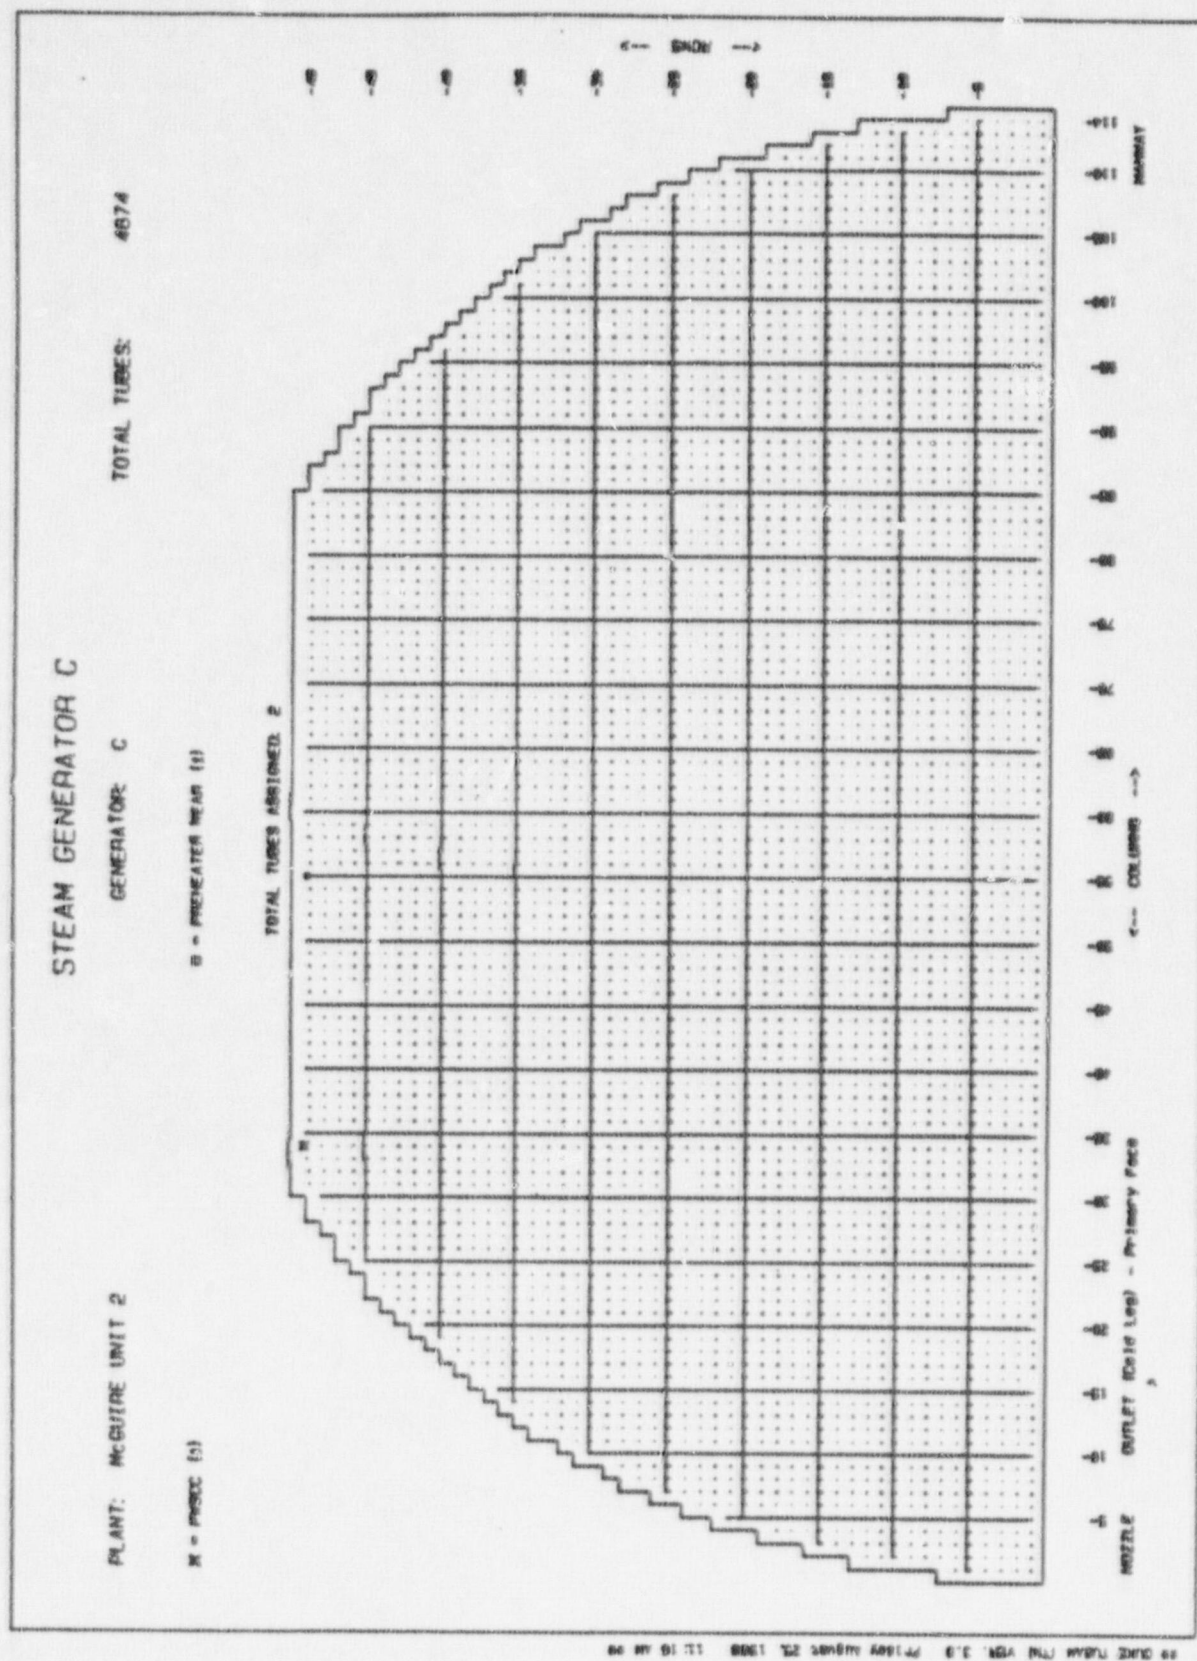
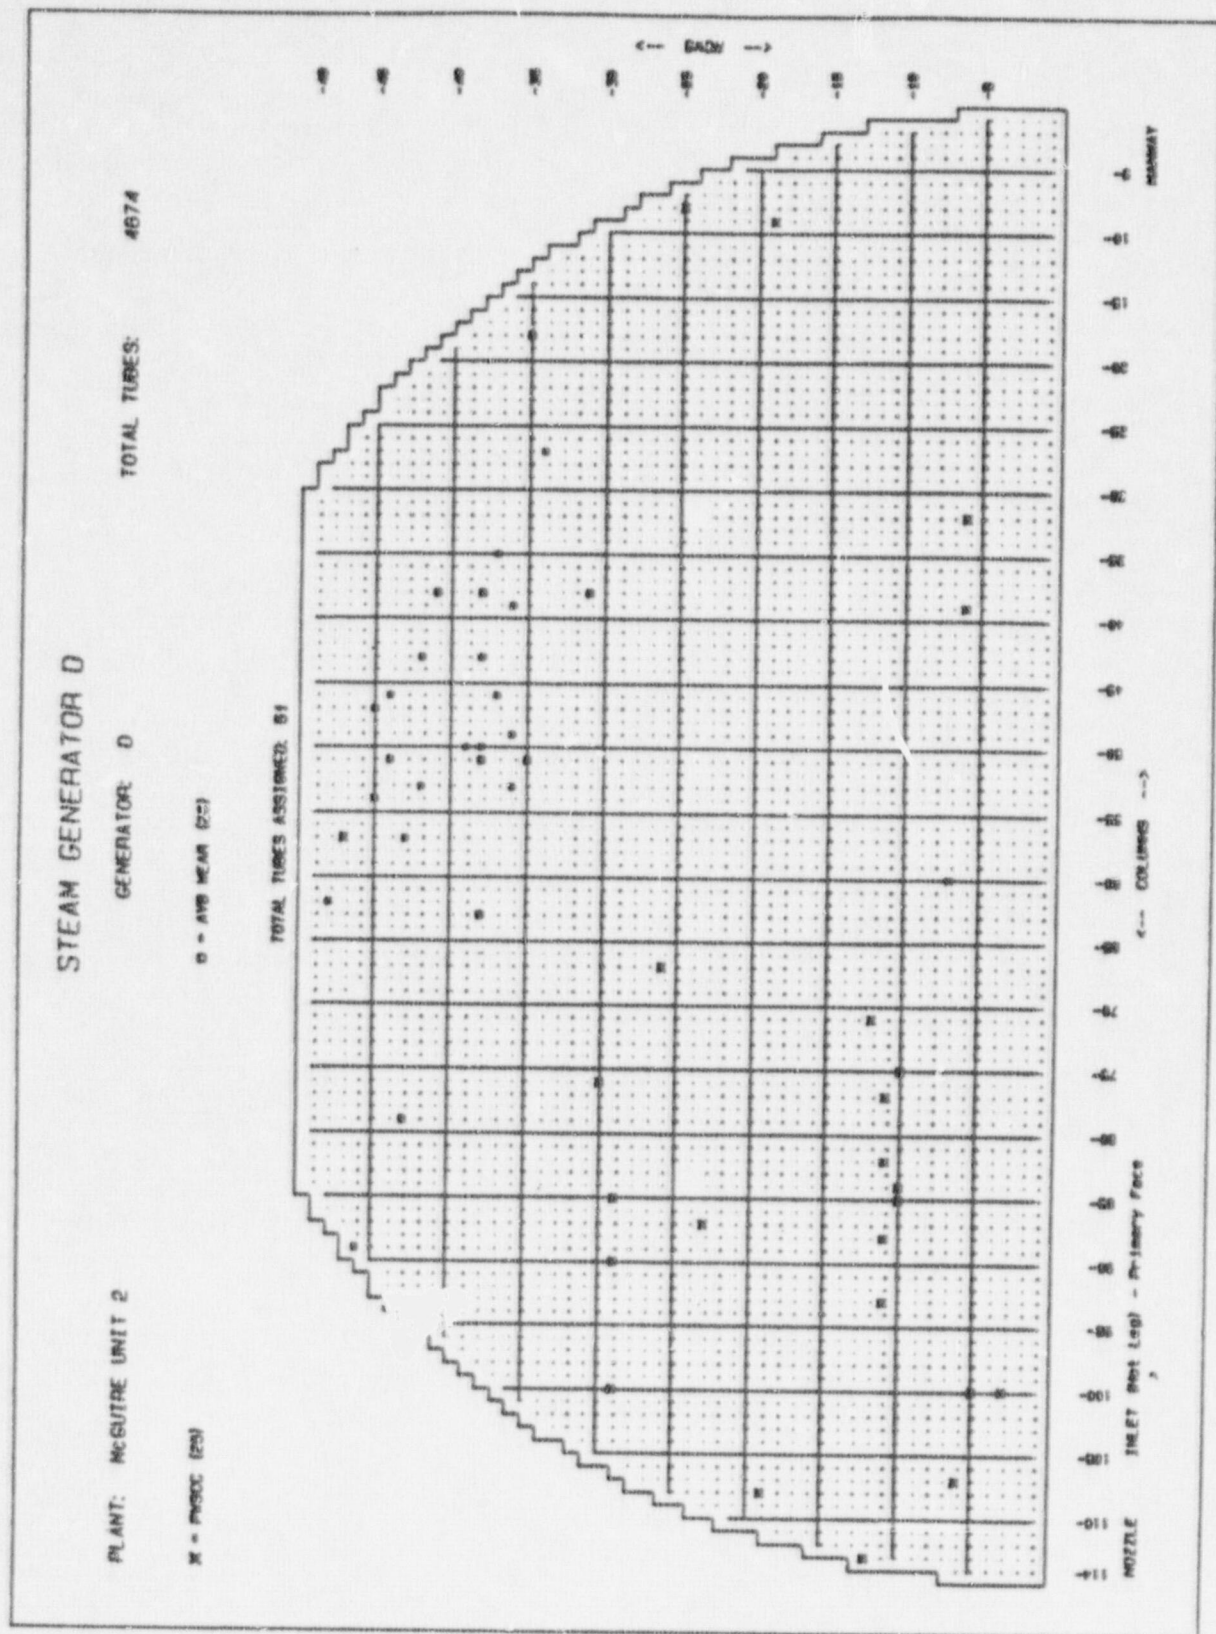
Tubesheet maps for the various operational degradation mechanisms are presented in Figures 5-1 through 5-8. Maps are shown for all four steam generators by hot-leg and cold-leg. A review of the maps shows that expansion zone PWSCC is randomly distributed throughout the tube bundle with most of the indications on the hot-leg as expected. AVB wear is considered a hot-leg degradation mechanism and tends to be distributed across all columns but is bounded by rows 20-45. Tube wear in the preheater section of the steam generator is for the most part confined to the outer two rows on the cold-leg side.

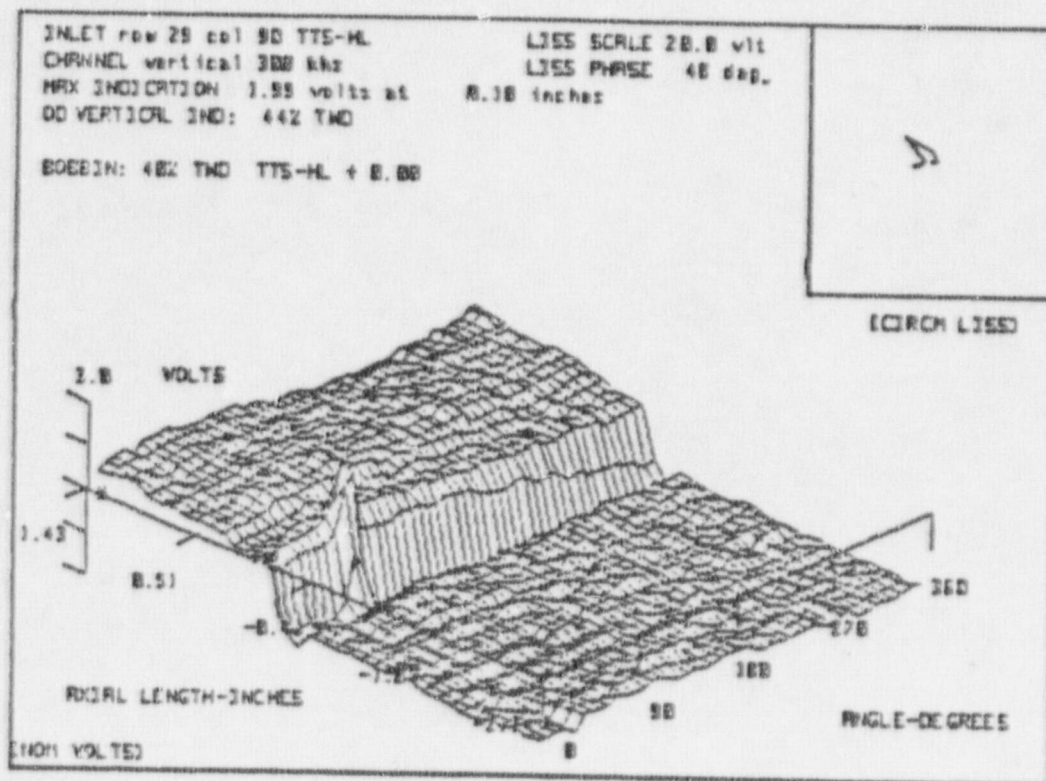
Figure 5-21. RPC Isometric of PWSCC at Roll Expansion

Typical RPC data from a bobbin coil indication identified within the F* region near the top of the tubesheet is shown in Figure 5-21. Review of the RPC isometric plot shows the presence of axially oriented linear indications in the roll expansion, characteristic of stress corrosion cracking.

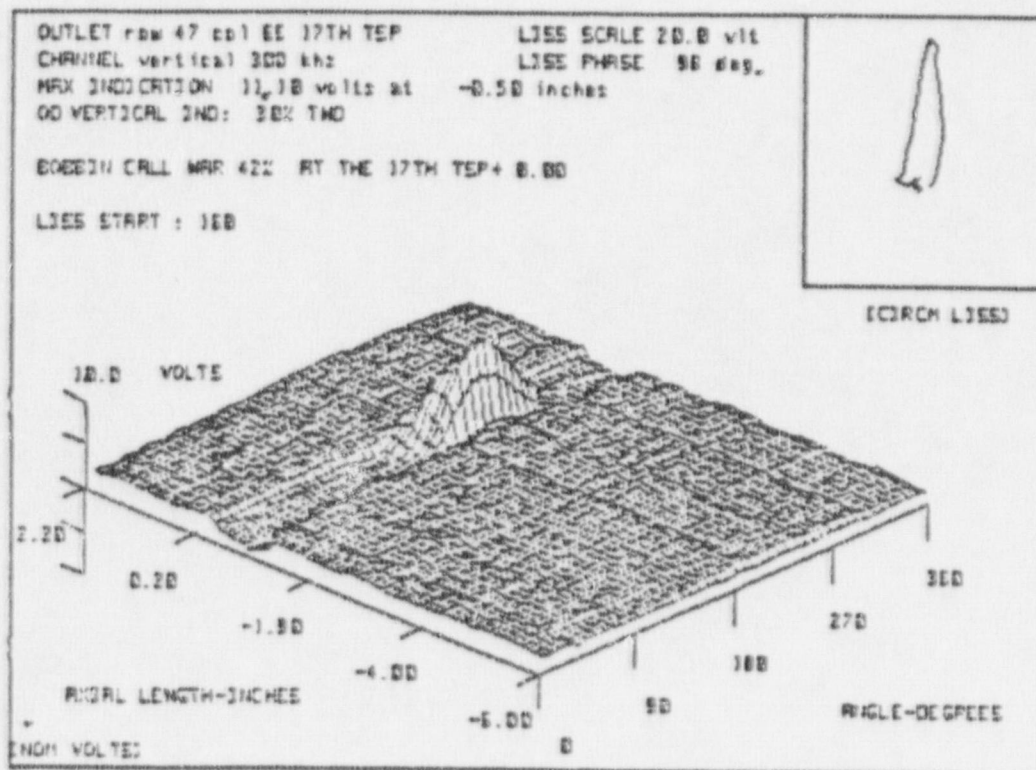
Figure 5-22. RPC Isometric of Preheater Wear Scar

An example of RPC data for tube wear within the preheater section is shown in Figure 5-22. Based on an extensive number of pulled tubes, these wear scars have been shown to be volumetric, sometimes tapered, and are bounded axially by the thickness of the support plate. As discussed in Reference 1, special wear scar standards are used to provide statistically conservative estimates of depth. The RPC data illustrated in Figure 5-22 is characteristic of volumetric wall loss of shallow depth, i.e. <20% through-wall, with axial tapering and an angular extent of approximately 90 degrees.

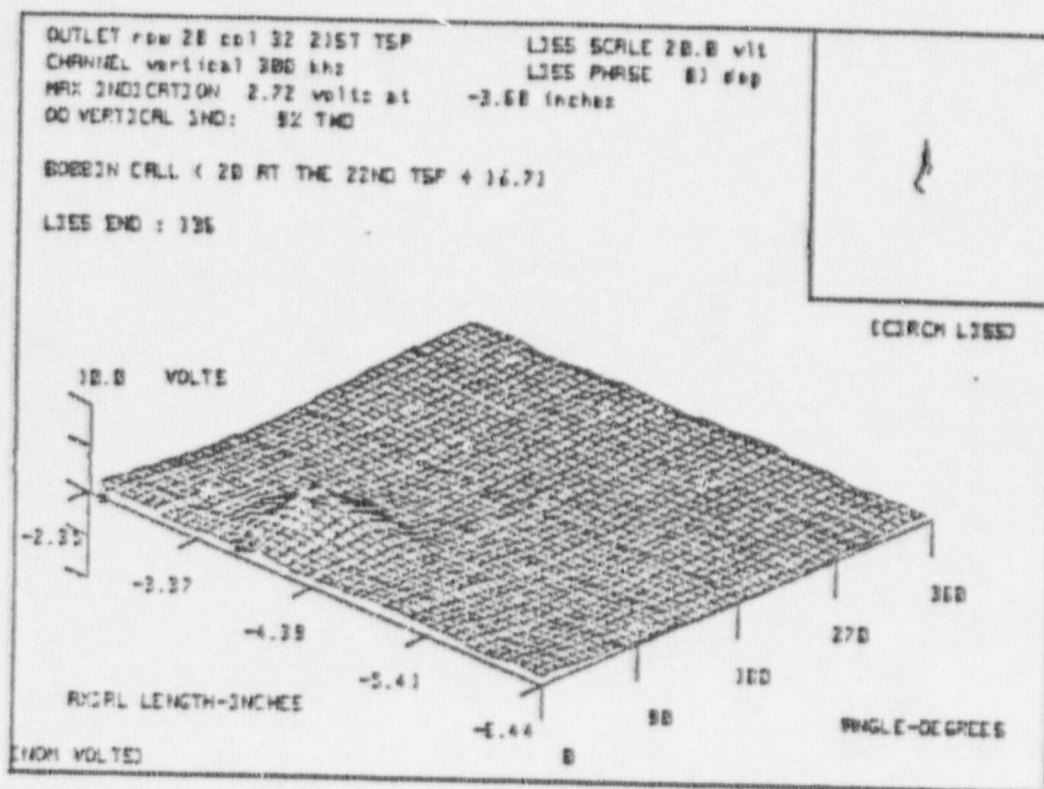
Figure 5-23. RPC Isometric of Free Span Buff Mark

So called buff or burnish marks are generally localized cosmetic repairs made to the tube during manufacturing to remove small pits or tube discoloration. These indications are generally localized and have been

observed in all regions of the steam generator; i.e., there is no preferred location for their occurrence. Depth estimates derived from absolute bobbin coil data show these types of discontinuities to be typically less than 20% through-wall; these depth estimates are supported by RPC data and by direct tube pull evidence, Reference 1. RPC data for a typical bobbin coil buff mark indication is shown in Figure 5-23. This particular indication was reported with the bobbin coil as <20% through-wall, located at the 22nd support plate +16.7 inches. Measured depth for this indication with the RPC was approximately 9% through-wall.

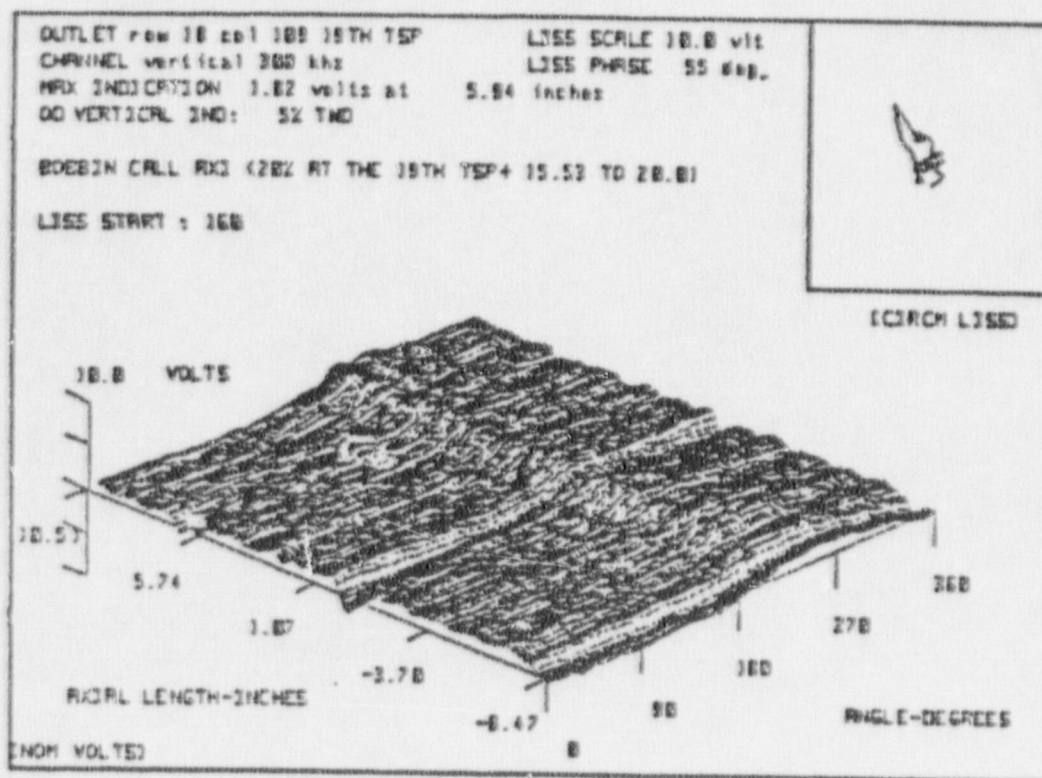
Figure 5-24. RPC Isometric of OD Axial Indications

Three additional classes of indications not attributed to operating related degradation were also observed during the McGuire Unit 2 inspection. As described in Reference 1, two of these classes are artifacts of tube manufacturing, e.g., buff marks and permeability variations, whereas the third class i.e., installation marks, is probably due to difficulties encountered during tube installation. All three signal classes are somewhat common in operating recirculating steam generators. All tubes reported to have axial indications were plugged.

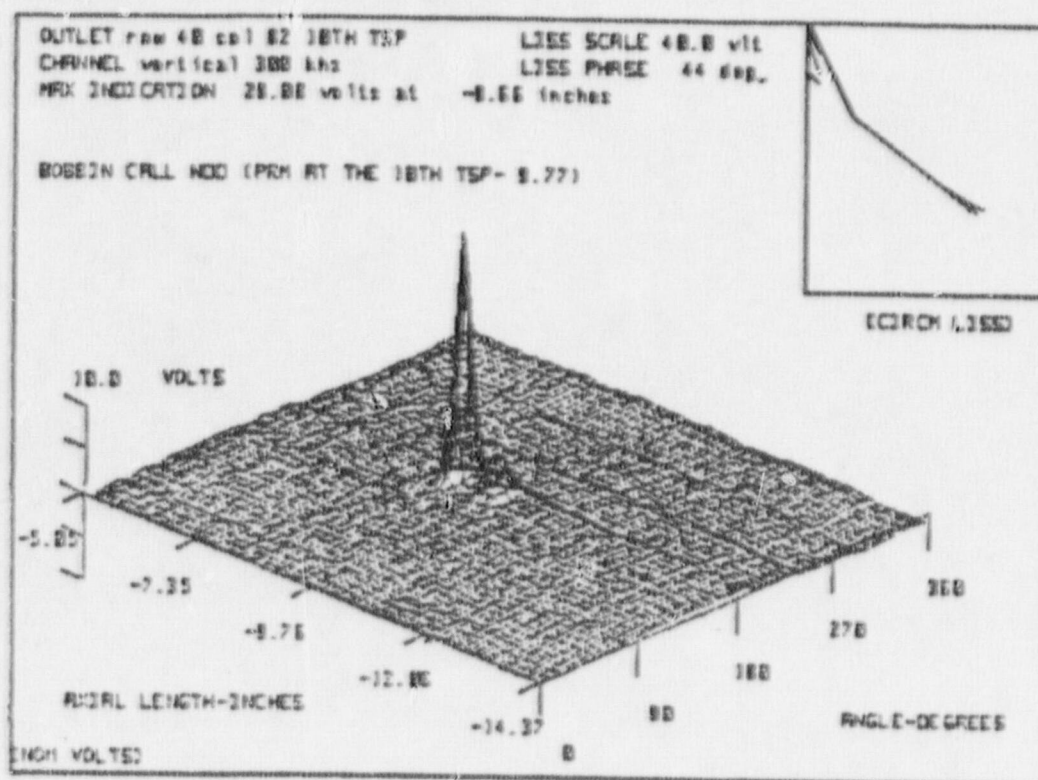
Figure 5-25. RPC Isometric of Permeability Indication

Probably the most common artifact eddy current indications related to tube manufacturing are "PV" signals; these signals are attributed to permeability variations within the tube wall. These indications sometimes exhibit signal features characteristic of tube wall degradation that has initiated from the tube inner surface. They can generally be distinguished from real tube wall degradation by the use of magnetic bias saturating coils which tend to suppress permeability variations. An example of RPC data from a permeability spot is shown in Figure 5-25.
