ARKANSAS POWER & LIGHT COMPANY

SUBJECT: Arkansas Nuclear One - Unit 1
Docket No. 50-313
License No. DPR-51
Licensee Event Report No. 50-313/89-004-00

LICENSEE EVENT REPORT (LER)

FACILITY NAME (1) Arkansas Nuclear One, Unit One DOCKET NUMBER (2) PAGE (3)
05000313110F06TITLE (4) Inadequate Design Change Process Results in the Design Temperature of the High Pressure
Injection System Piping Being Exceeded Due to Reactor Coolant System Backleakage Through
a Failed-Open Check Valve

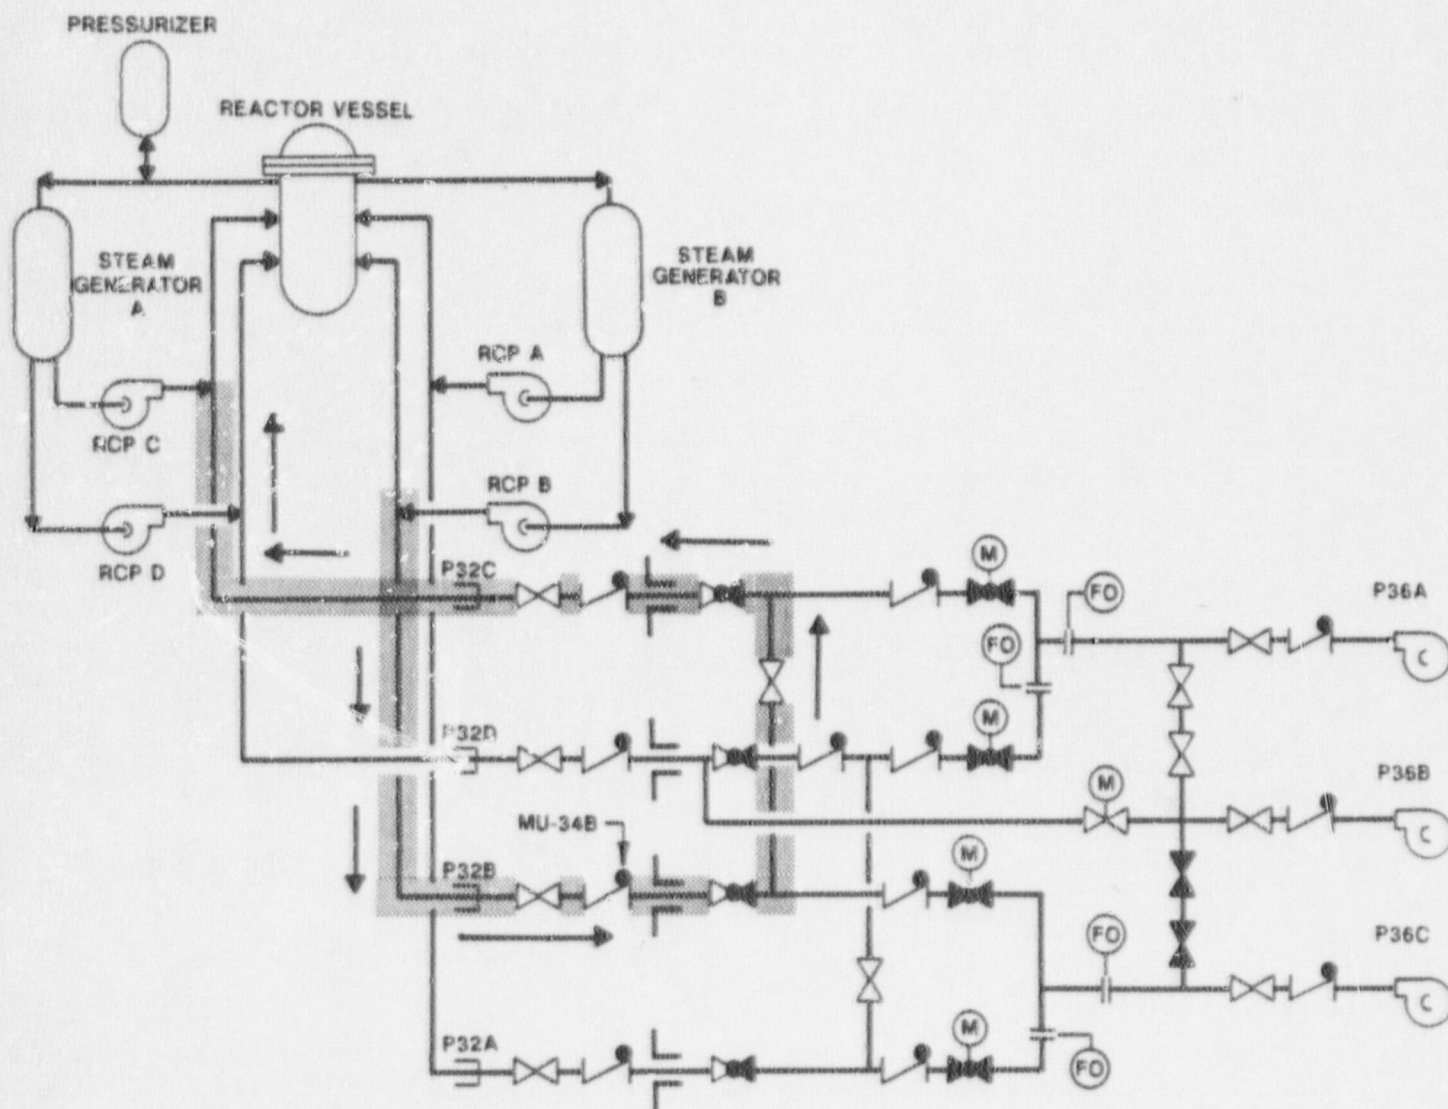
When HPI flow was secured two and one-half minutes later, a check valve, MU-34B [BQ-V], in the 'B' HPI line failed to reseal. Because 'B' RCP continued to run after the plant trip, a pressure differential was developed between the 'B' HPI line containing the failed-open MU-34B check valve and the 'C' HPI line. These conditions allowed reactor coolant to backflow (i.e., backleakage) into the 'B' HPI line, through the failed-open check valve, into a penetration room outside the Containment Building, through the HPI 'BC' loop crossover line, and then back into the RCS through the 'C' HPI line. (See Figure 1 for a diagram of the flow path.) The RCS backleakage condition was discovered when an Operator was dispatched to investigate a smoke alarm caused by the melting of a piece of tape left on one of the affected HPI lines. Backleakage flow through the HPI system was stopped when the two idle RCPs were restarted.

RCS Backleage into HPI System
