Commonwealth Edison
LaSalle County Nuclear Station
Rural Route #1, Box 220
Marseilles, Illinois 61241
Telephone 815/357-6761

LICENSEE EVENT REPORT (LER)

LaSalle County Station Unit 2

Primary Containment Isolation During Instrument Surveillance Testing of LIS-MS-401

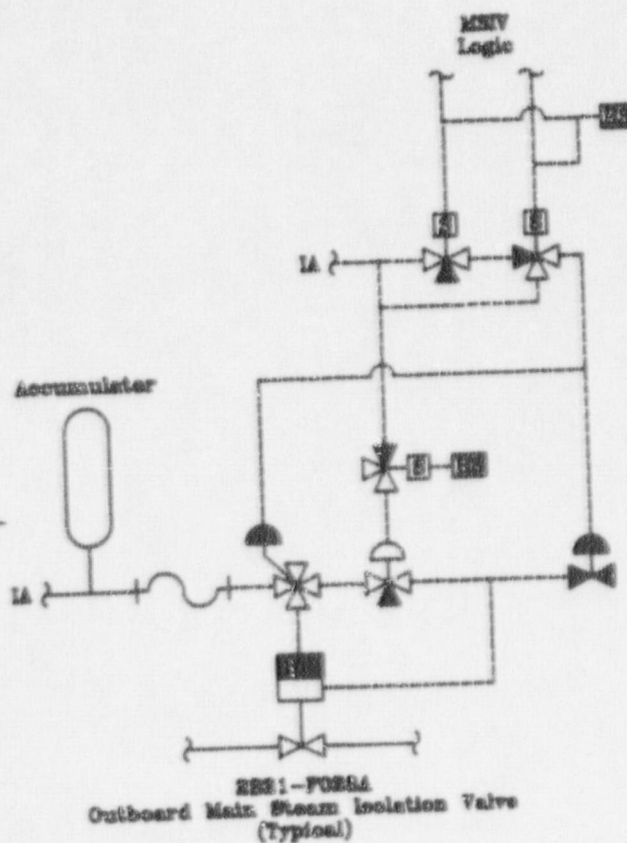
The Group 1 isolation logic (PCIS) [JM] is "one-out-of-two-taken-twice." The Main Steam line low pressure (854 psig) isolation signal is bypassed when the reactor mode switch is not in the Run position. (Refer to attached simplified schematic of one subchannel.)
