LICENSEE EVENT REPORT (LER)

FACILITY NAME (1) Calvert Cliffs Unit 2										DOCKET NUMBER (2) 0 5 0 0 0 3 1 1 8										PAGE (3) 1 OF 6				
TITLE (4) Plant Shutdown Resulting From an Air Leak on Feedwater Regulating Valve Caused by Failure to Identify the Need to Perform Adequate Preventive Maintenance																								
EVENT DATE (5)			LER NUMBER (6)					REPORT DATE (7)			OTHER FACILITIES INVOLVED (8)													
MONTH	DAY	YEAR	YEAR	SEQUENTIAL NUMBER	REVISION NUMBER	MONTH	DAY	YEAR	FACILITY NAMES						DOCKET NUMBER(S)									
0	3	0	7	8	9	8	9	0	0	3	0	0	0	4	0	6	8	9	0 5 0 0 0					
OPERATING MODE (9)			THIS REPORT IS SUBMITTED PURSUANT TO THE REQUIREMENTS OF 10 CFR §. (Check one or more of the following) (11)																					
POWER LEVEL (10)			20.402(b)					20.405(c)					50.73(a)(2)(iv)					73.71(b)						
1			20.405(a)(1)(i)					50.36(c)(1)					50.73(a)(2)(v)					73.71(c)						
1			20.405(a)(1)(ii)					50.36(c)(2)					50.73(a)(2)(vii)					OTHER (Specify in Abstract below and in Text, NRC Form 366A)

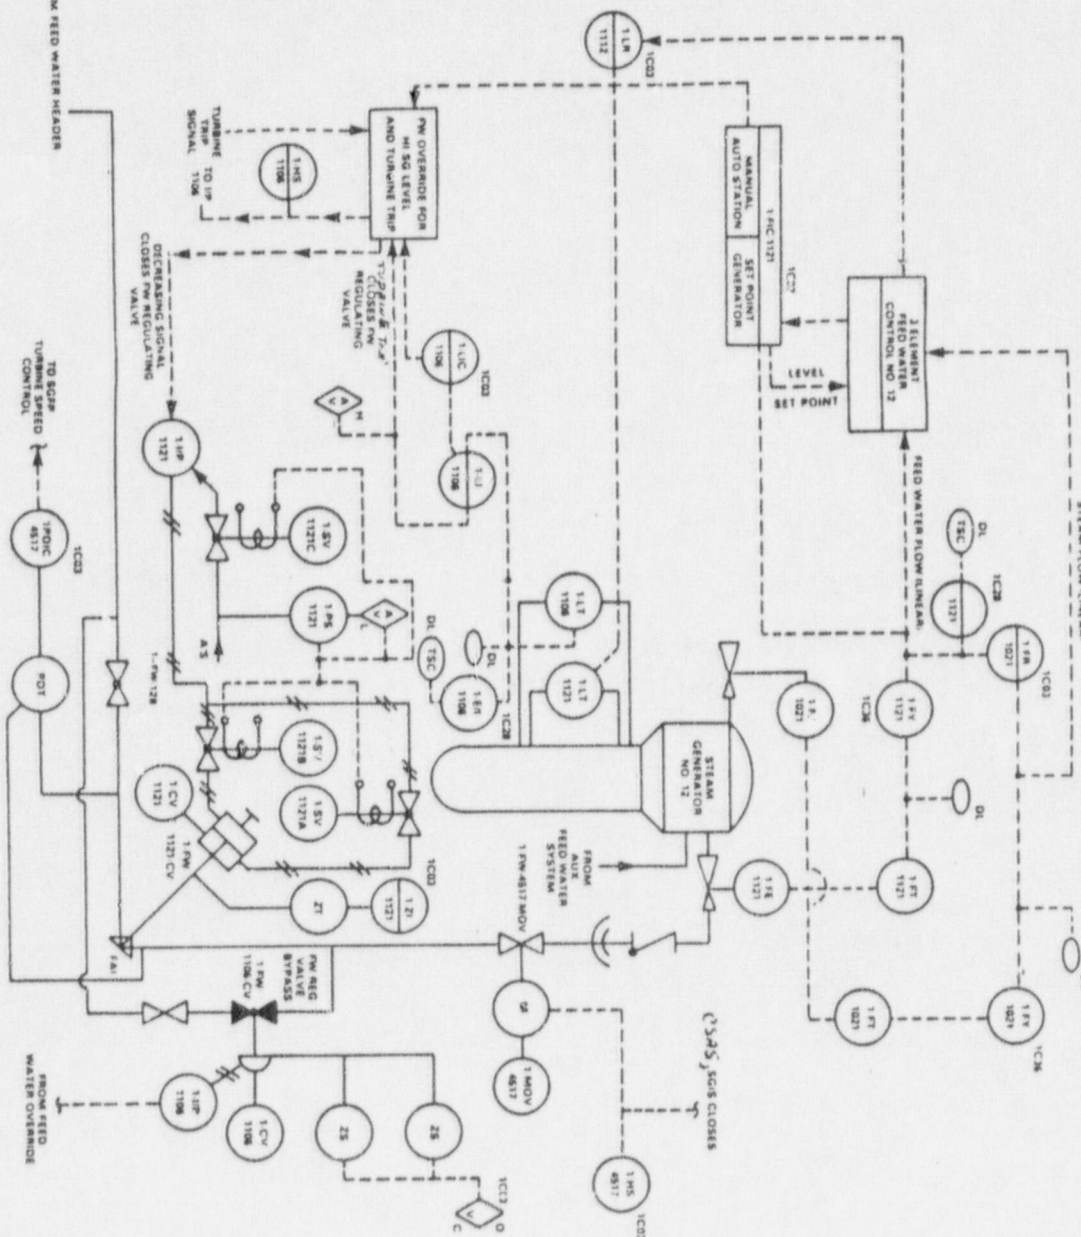
DIAGRAM

At approximately 1144, the #22 SG level lowered to approximately minus (-)31 inches due to an air leak on the actuator positioner for the #22 SG FRV (see diagram). The Reactor Protective Systems (RPS) pretrip alarms for Channel A, B, C, and D for low SG level were received. No RPS or Engineered Safety Features Actuation System (ESFAS) was manually or automatically started or actuated. No RPS or ESFAS actuation was required to place the plant in a stable condition.

The root cause of the event was the failure to identify the need to perform adequate preventive maintenance on the positioner for the #22 SG FRV. A neoprene gasket between the positioner pedestal and positioner housing was found brittle and cracked. The positioner pedestal gasket (Fisher Controls, part number 1H854703012) was replaced. Maintenance Technician actions throughout the event were deliberate and correct. Preventive Maintenance to verify proper operation of valve function was in place but it did not require periodic replacement of any gasket or o-rings. The Fisher Controls 3570 Series Pneumatic Valve Positioner Instruction Manual (Form 1837) does not specify any periodic replacement of gaskets or o-rings. However, it does recommend that when troubleshooting the positioner for sluggish or erratic operation, the o-rings and gaskets should be checked for wear or damage. This is our standard practice when troubleshooting mechanical devices. The local Fisher Controls representative was contacted to obtain an expected life for the gasket. No recommendation for periodic replacement of the gasket is available since these valves are designed and commonly used in environments such as out-door use and corrosive atmospheres or where air supply quality varies greatly. The best available recommendation was to base the periodic replacement on in-plant experience. The representative considered our installed environment as relatively benign since our air is of high quality and the valve is located in an area of constant temperature. Another vendor for valves that we use in containment environments, suggested four years as an acceptable period for o-ring or gasket replacement. However, this value is quite conservative as it assumes a post-LOCA environment during the four year period.

1. Develop a periodic preventive maintenance schedule for the positioner pedestal gaskets based on vendor recommendations and in-plant experience. A Reliability Centered Maintenance (RCM) project is currently underway and will incorporate RCM techniques in various plant systems. The FRVs will be included in this project based on an approach involving phased implementation of RCM to plant systems. Plant systems are selected for RCM application based on their importance ranking to reactor safety as reflected in the results of the CCNPP Unit 1 Interim Reliability Evaluation Program Report.
2. Inspect the #21 SG FRV positioner pedestal gaskets during the next plant shutdown. The Unit 1 FRVs, #11 and #12, had their positioner pedestal gaskets replaced on March 6, 1989 and January 11, 1989, respectively, during the performance of troubleshooting and corrective maintenance to their positioners.
