D'APPOLONIA

Project No. NM80-740

1980 Fourth Quarter Inspection Report
Tailings Dam
L-Bar Uranium Operations
Seboyeta, New Mexico

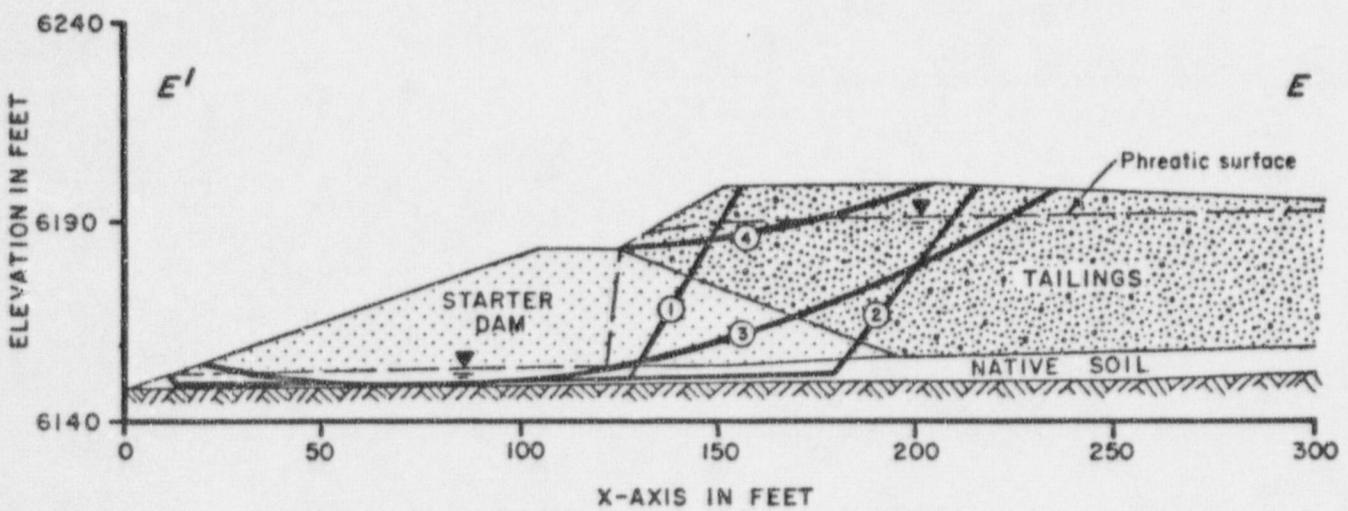
FIGURE 1
 TAILINGS DAM SECTION E-E'
 L-BAR URANIUM OPERATIONS
 STATIC SLOPE STABILITY
 CRITICAL FAILURE MODES
 PREPARED FOR
 SOHIO WESTERN MINING COMPANY
 SEBOYETA, NEW MEXICO

Each mode was analyzed using the generalized procedure of slices (Janbu method). The calculations were performed by computer with 100 potential failure surfaces analyzed for each mode. The results of analyses are presented on Figures 1, 2, and 3. Figure 1 shows the most critical static loading failure surface for each of the first four modes. Mode 1 has the lowest safety factor, 2.07 under static loading. Figure 2 shows the most critical failure surface for each of the first four modes under pseudo-static earthquake loading (0.1g maximum horizontal acceleration). Mode 4 has the lowest pseudo-static safety factor, 1.49. Figure 3 shows

FAILURE MODE	SAFETY FACTOR
①	2.07
②	2.19
③	2.24
④	2.09

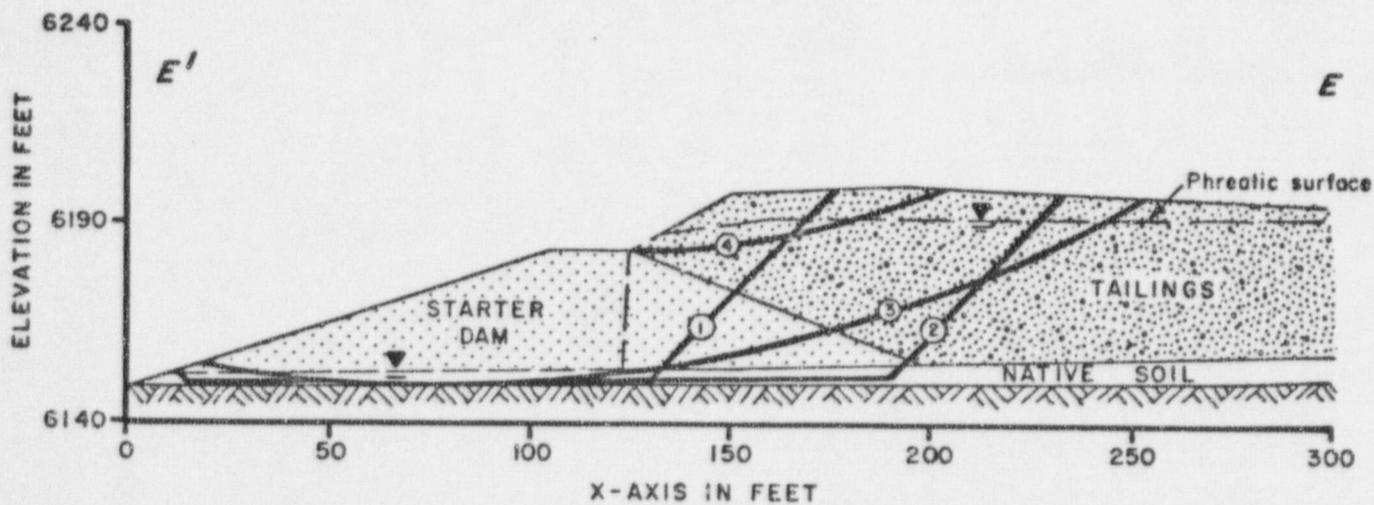
FIGURE 2
 TAILINGS DAM SECTION E-E'
 L-BAR URANIUM OPERATIONS
 PSEUDO-STATIC SLOPE STABILITY
 CRITICAL FAILURE MODES

FAILURE MODE	SAFETY FACTOR
①	1.56
②	1.67
③	1.65
④	1.49

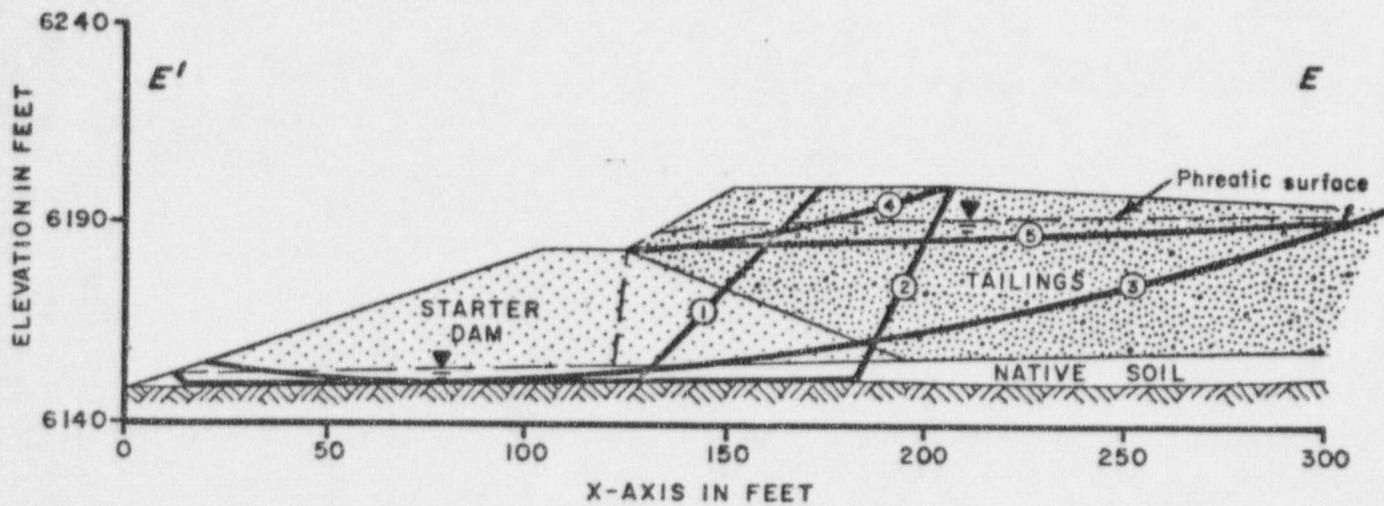
FIGURE 3
 TAILINGS DAM SECTION E-E'
 L-BAR URANIUM OPERATIONS
 STATIC SLOPE STABILITY WITH
 LIQUEFIED TAILINGS
 CRITICAL FAILURE MODES
 PREPARED FOR
 SOHIO WESTERN MINING COMPANY
 SEBOYETA, NEW MEXICO

the most critical failure surfaces under static loading with liquefaction. In this case mode 5 is most critical with a safety factor of 0.25, although mode 4 also indicates failure with a safety factor of only 0.73.

The present tailings dam configuration with the high phreatic surface in the tailings is very susceptible to liquefaction-induced failure. The full extent of the flow produced by liquefaction is not quantitatively assessible.

FAILURE MODE	SAFETY FACTOR
①	1.77
②	1.95
③	2.16
④	0.73
⑤	0.25

Although the visual inspection of the tailings dam revealed no evidence of instability under present conditions, the need for controlling seepage through the embankment, noted during the field inspection, is supported by the stability analyses. These analyses indicate that potential instability lies in the liquefaction susceptibility of the saturated tailings, not in static or pseudo-static loading conditions alone. The most effective method of reducing liquefaction potential is to reduce the thickness of saturated tailings, i.e., to lower the phreatic surface. Additional analyses, now in progress, will show that lowering the phreatic surface significantly below the present level should produce adequate stability against a liquefaction-induced failure.

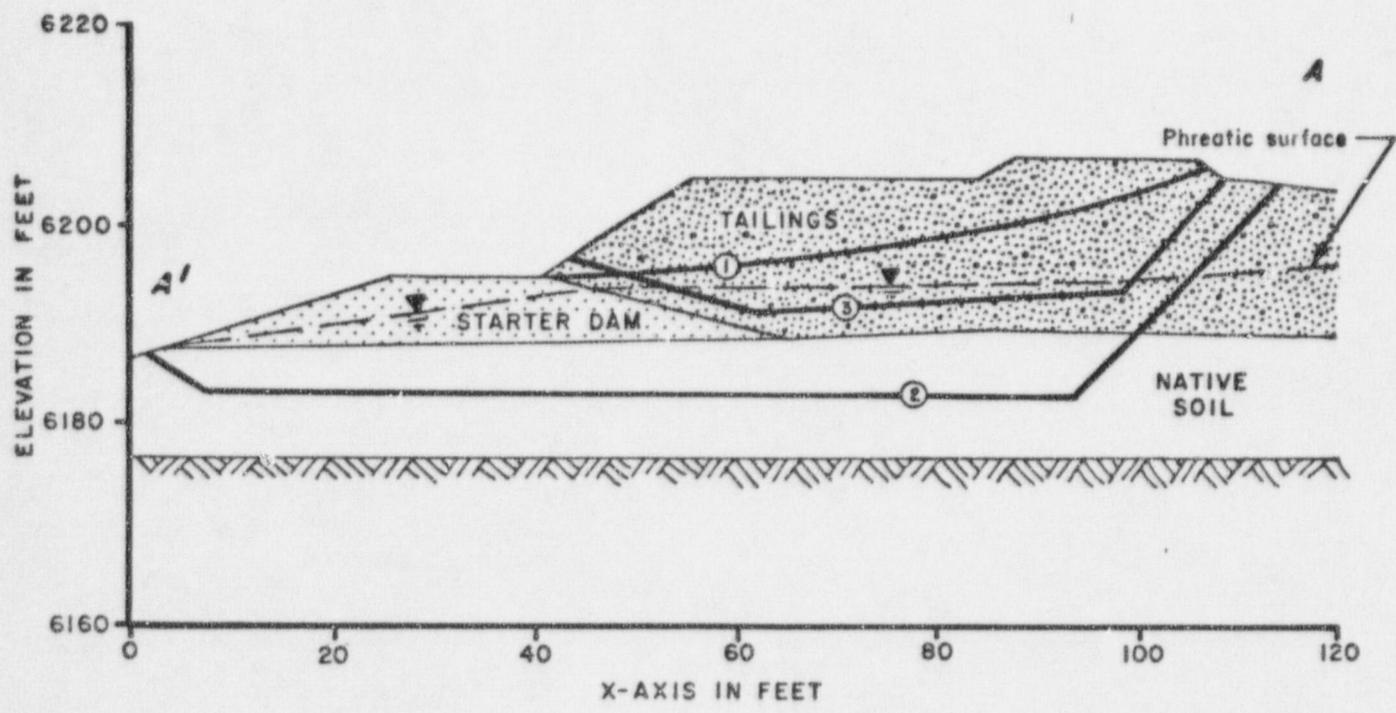
FIGURE 4
 TAILINGS DAM SECTION A-A'
 L-BAR URANIUM OPERATIONS
 STATIC SLOPE STABILITY WITH
 LIQUEFIED TAILINGS
 CRITICAL FAILURE MODES
 PREPARED FOR
 SOHIO WESTERN MINING COMPANY
 SEBOYETA, NEW MEXICO

In addition, Section A-A' (Woodward-Clyde, 1980) was investigated for stability under liquefaction conditions. Three modes of failure were investigated. The first was a circular arc in the tailings, the second was a wedge analysis of a sliding block through the native soil, and the third was a wedge analysis of a sliding block within the saturated tailings with an exit near the upstream crest. The third mode had the lowest factor of safety, 0.87, and was the only mode which failed under liquefaction conditions. Figure 4 shows the locations of the critical failure surfaces for all three modes.

FAILURE MODE	SAFETY FACTOR
①	2.92
②	5.20
③	0.87
