SOUTHERN CALIFORNIA
EDISON

Subject: Docket Numbers 50-361 and 50-362
Response to Inspection Report 98-05 Regarding Linestarters
San Onofre Nuclear Generating Station, Units 2 and 3

Licensee Event Report (LER) 1998-003 (References 2 and 3), described the discovery on February 5, 1998, of a Unit 2 jammed reversing linestarter mechanical interlock associated with valve 2HV9305. The discovery was made during a planned replacement of the interlock. Based on the condition of the interlock when it was removed, SCE assumed that the valve would not have opened upon demand.

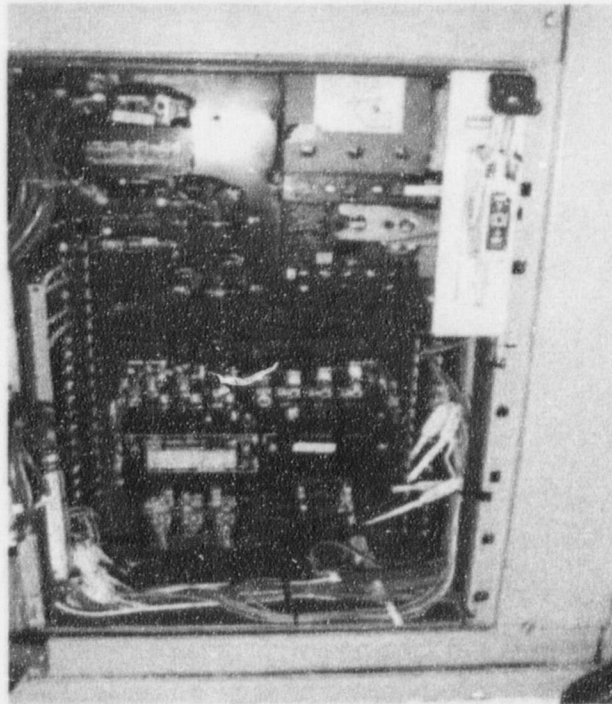
Figure 2a
MCC CUBICLE WITH LINESTARTER

Mechanical Interlock
