10CFR Part 21 Formal Notification: P21-06032020, Rev. 1

Subject: Failures of Size 1 and 2 Freedom Series Auxiliary Contacts

DUKE Harris Nuclear Plant

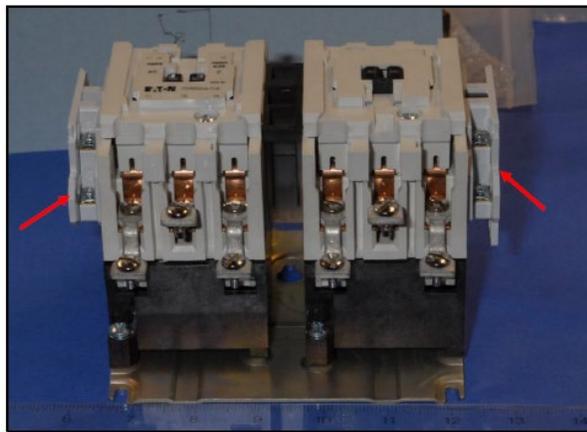
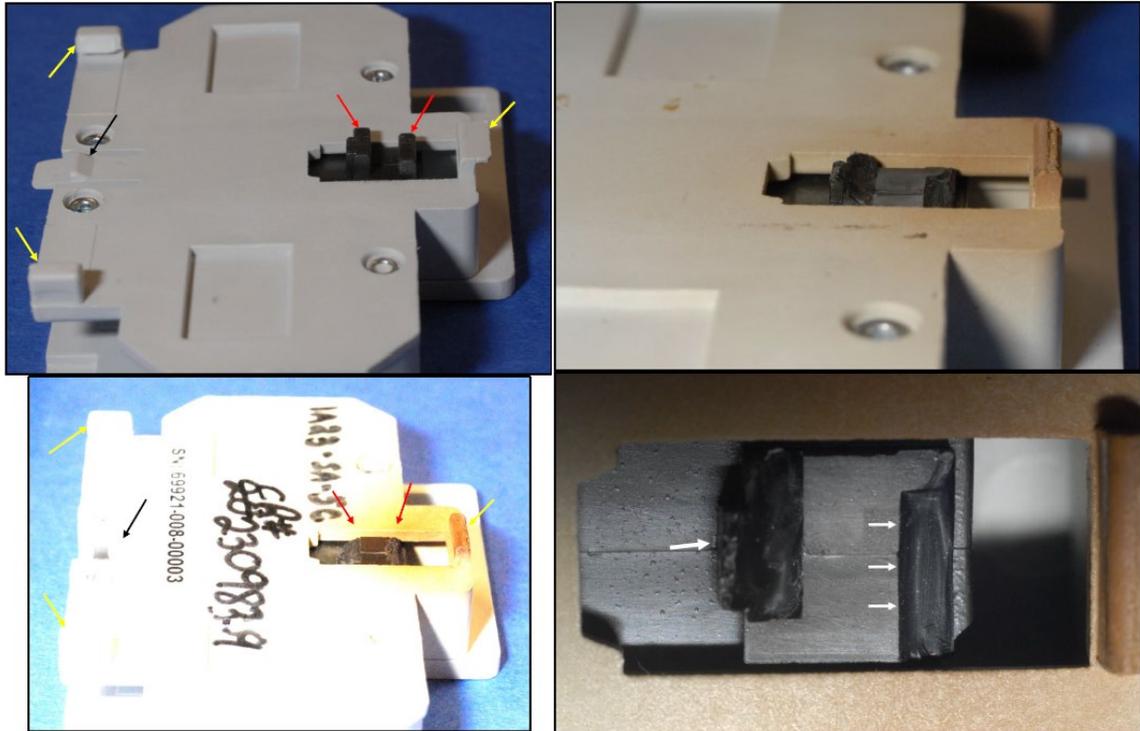
The nature of the defect is the pre-mature aging of the component within the auxiliary contact mechanism that is adjacent to the operating coil. The starter coil is potentially being subjected to voltages of a nature that elevates the temperature within the starter adjacent to the auxiliary contacts.

The root cause of the degraded component is due to the increased voltage and the overall temperature of the starter coil at the elevated voltage. This elevated voltage and temperature has degraded the mechanism of the auxiliary contact operator to a point to which it has become separated from the parent component. See example figures below.

It is recommended that the starters and coils be replaced in the applications where the units are being operated in a continuous duty application. It is also recommended that the control transformer be replaced with a true 4:1 ratio transformer. Paragon/NLI has developed a true 4:1 ratio transformer that will provide additional mitigation of this potential over-voltage condition. Replacing the transformer with a true 4:1 ratio, reduces the control voltage that is being applied to the control circuit in a manner that will not prevent the unit from providing a sufficient voltage during a degraded voltage condition, and also will not subject the components to a voltage above the ratings when the supply voltage is operated above the nominal 480 VAC bus voltage.
