STEAM GENERATOR TUBE INSPECTION DISCUSSION POINTS
Palisades 2020 Inspection (1R27)

The following discussion points have been prepared to facilitate the conference call arranged with the licensee to discuss the results of the steam generator (SG) tube inspections to be conducted during the upcoming fall 2020, Palisades Nuclear Plant, refueling outage. This conference call is scheduled to occur towards the end of the planned SG tube inspections, but before the inspections and repairs are completed.

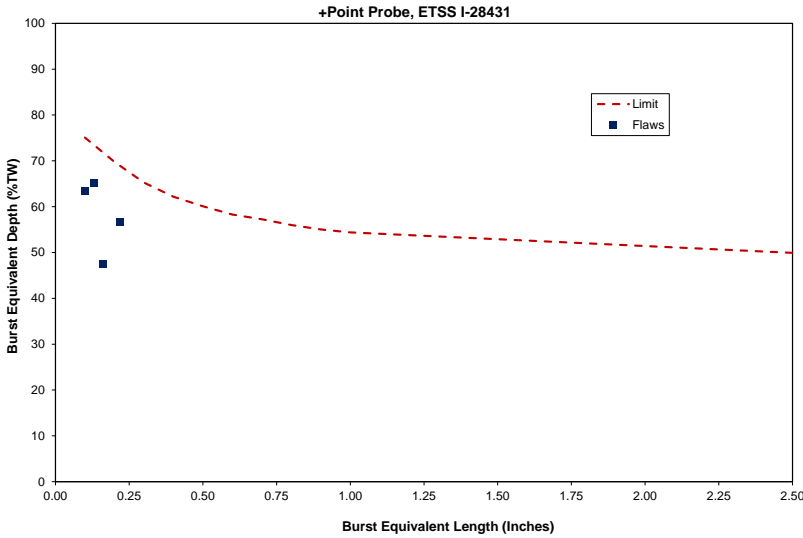
SGA

- Axial ODSCC at TSH

- Circ ODSCC at TSH. Max indication parameters (not the same indication):
 - Voltage: 0.81 V
 - Circumferential extent: 0.71" (109 degrees)
 - Depth: 78 %TW
 - PDA: 7.44
 - SIPC and AILPC criteria satisfied
- Tube support wear:
 - Max depth: 41 %TW
 - SIPC and AILPC criteria satisfied
- Historical (carryover from previous inspection) foreign object wear flaws
 - Max depth: TBD %TW
 - SIPC and AILPC criteria satisfied
- No newly-identified foreign object wear flaws

All stress corrosion cracking (SCC) indications will be plugged. Any circumferential SCC indications near the top-of-tube sheet (TTS) will be stabilized and plugged. C depth is applicable to the HL and CL.*

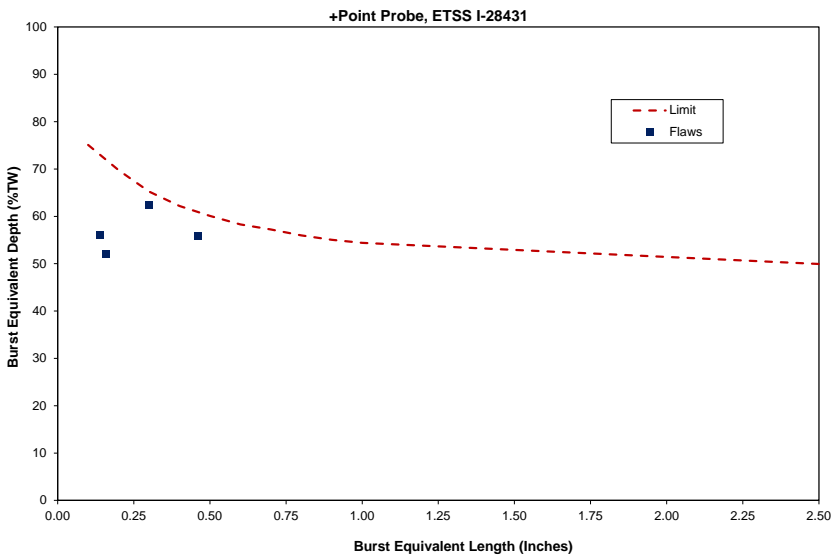
SG B

- Axial ODSCC at TSH

- Axial PWSCC within tube sheet:
 - Max Voltage: 0.52 V
 - Max Length: 0.14"
 - Max Depth: 42.9 %TW
 - SIPC and AILPC criteria satisfied
- Circ ODSKC at TSH. Max indication parameters (not the same indication):
 - Voltage: 0.84 V
 - Circumferential extent: 0.79" (116 degrees)
 - Depth: 53 %TW
 - PDA: 6.73
 - SIPC and AILPC criteria satisfied
- Tube support wear:
 - Max depth: 40 %TW
 - SIPC and AILPC criteria satisfied
- Historical (carryover from previous inspection) foreign object wear flaws
 - Max depth: 23 %TW
 - SIPC and AILPC criteria satisfied
- No newly identified foreign object wear flaws

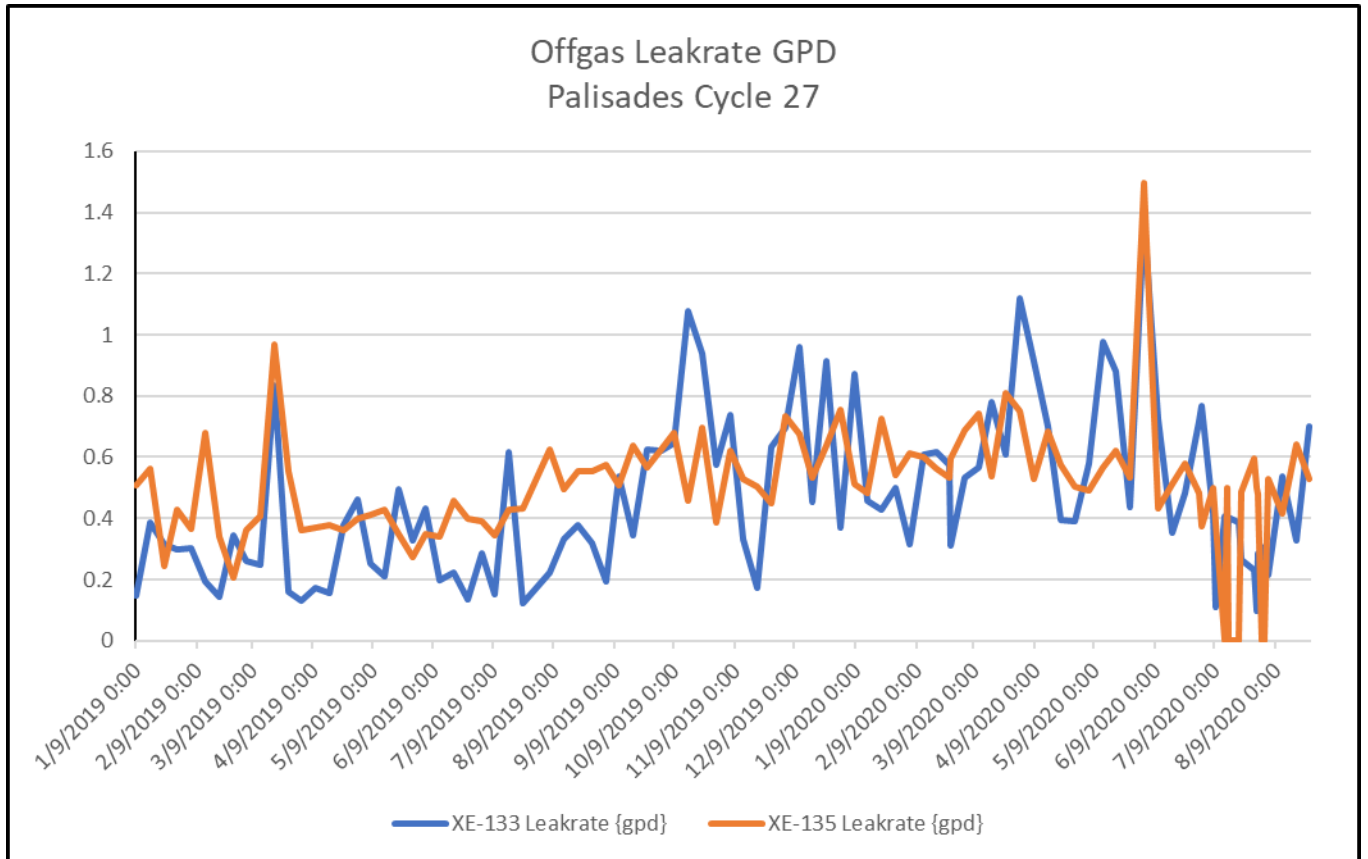
Attachment 1 Primary to Secondary Leakage

Refer to attached Primary to Secondary Leak Rate for Operational Cycle 27 Primary to Secondary Leak Rate graph. Leakage has been minimal all cycle.
