**Supplement to Request for Relief Related to American Society of Mechanical Engineers (ASME)  
Code Case N-729-6 Supplemental Examination Requirements, ISIR-5-04**

Enclosure: Final Photographs of the CNP Unit 1 Reactor Vessel Closure Head (RVCH)

**Final Photographs of the CNP Unit 1 Reactor Vessel Closure Head (RVCH)**

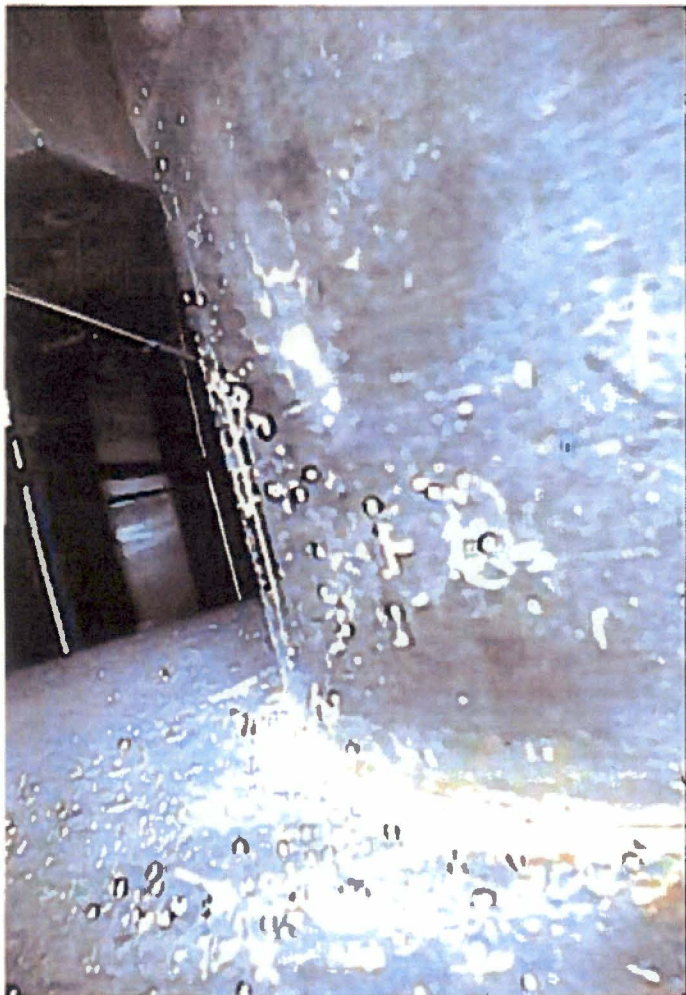
U1C30 RVCH Inspection Photos  
Penetration Number 1

As Found Photo

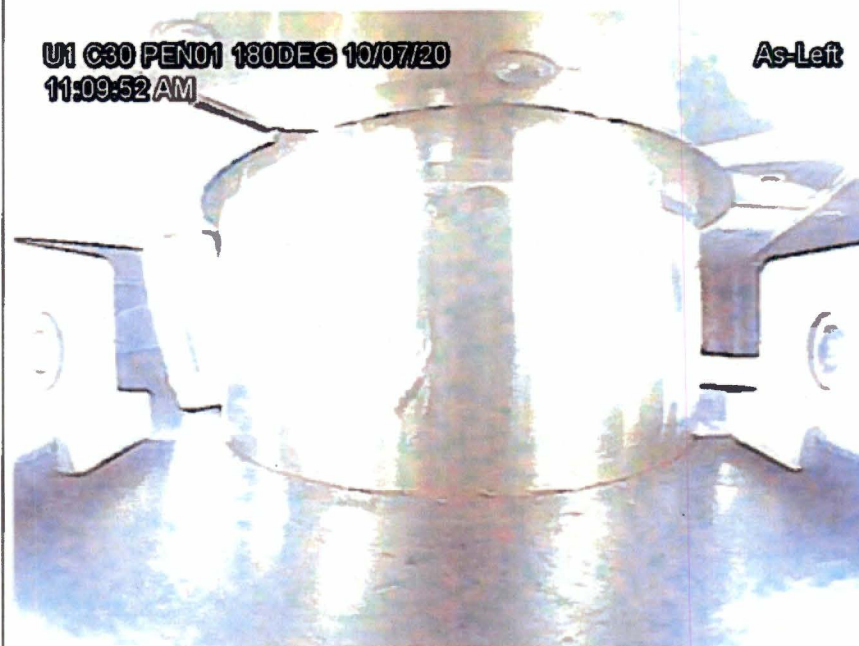
As Left Photo

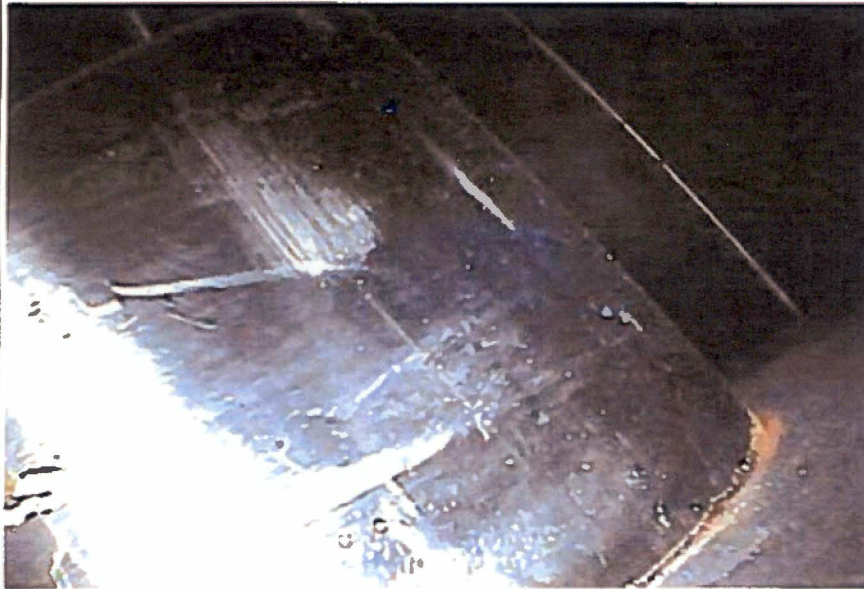
U1C30 RVCH Inspection Photos  
Penetration Number 7

As Found Photo

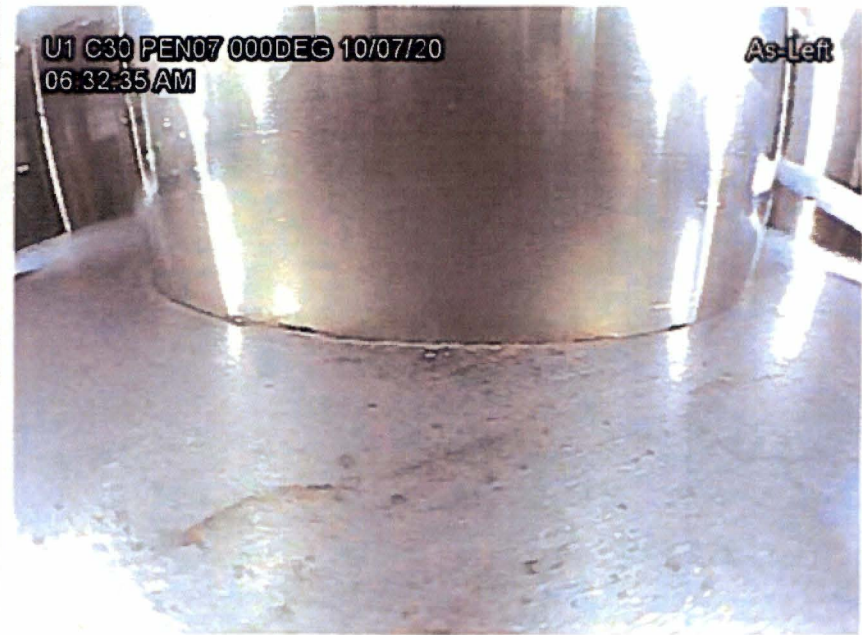
As Left Photo

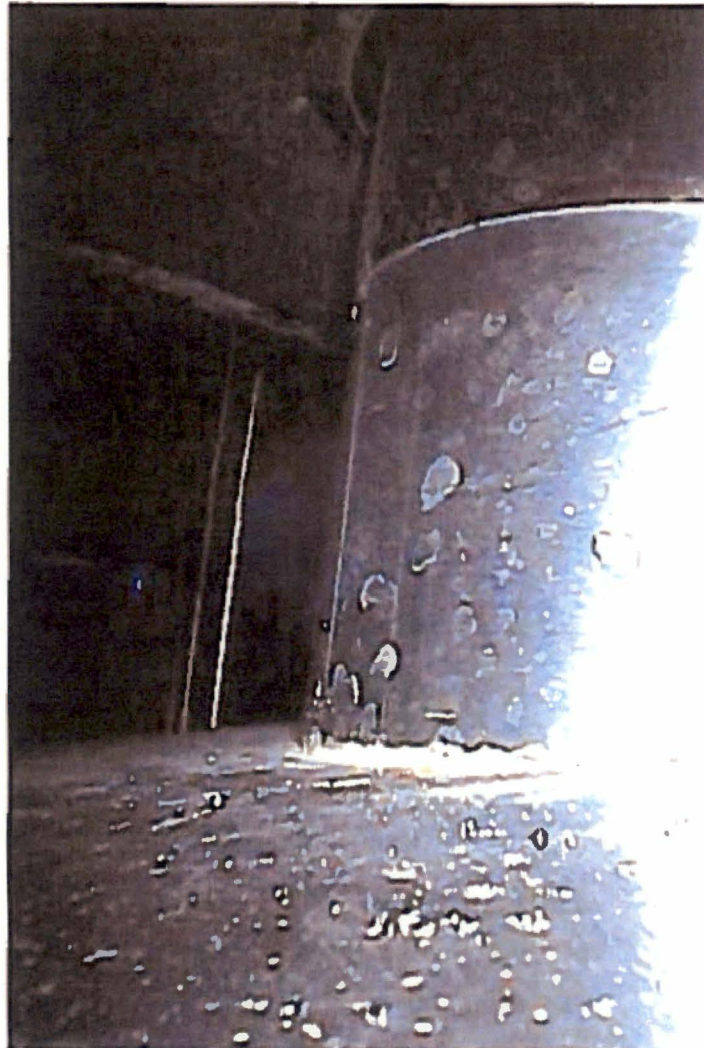
U1C30 RVCH Inspection Photos  
Penetration Number 8

As Found Photo

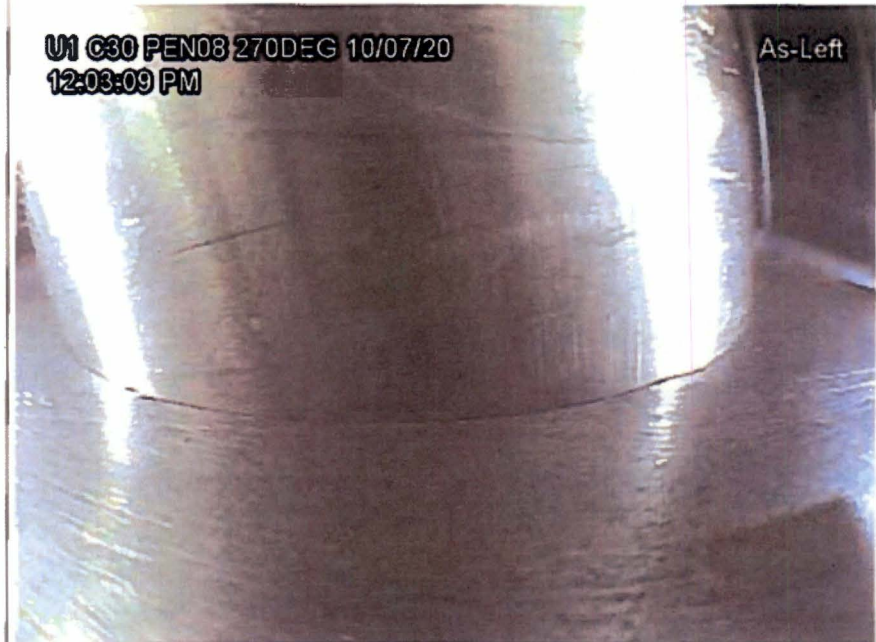
As Left Photo

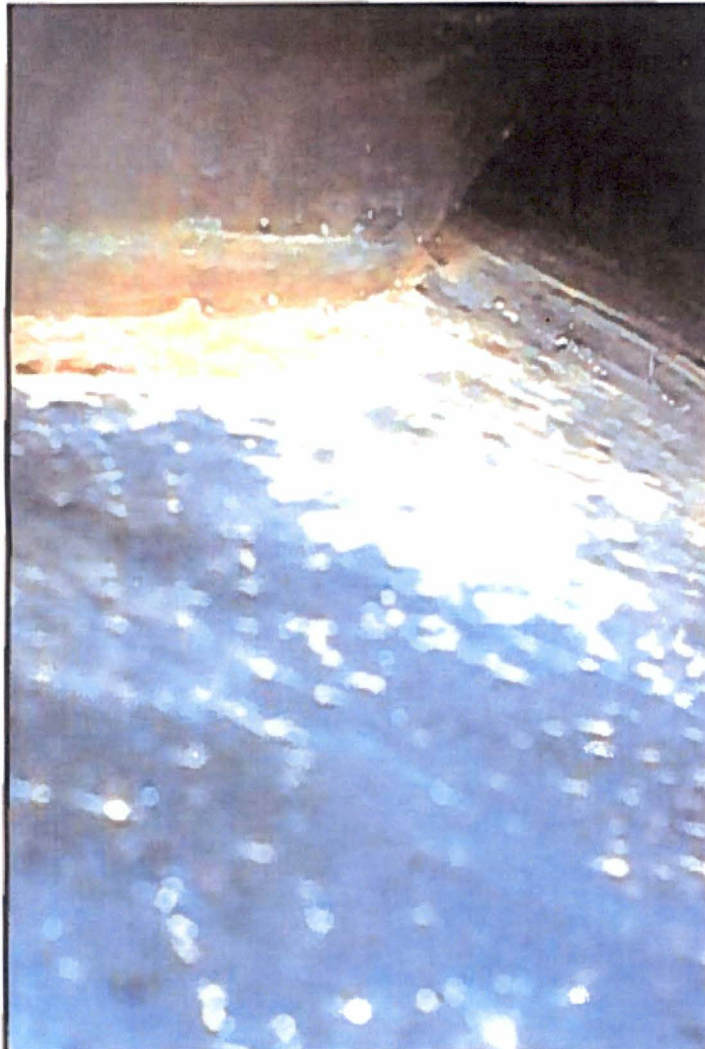
U1C30 RVCH Inspection Photos  
Penetration Number 10

As Found Photo

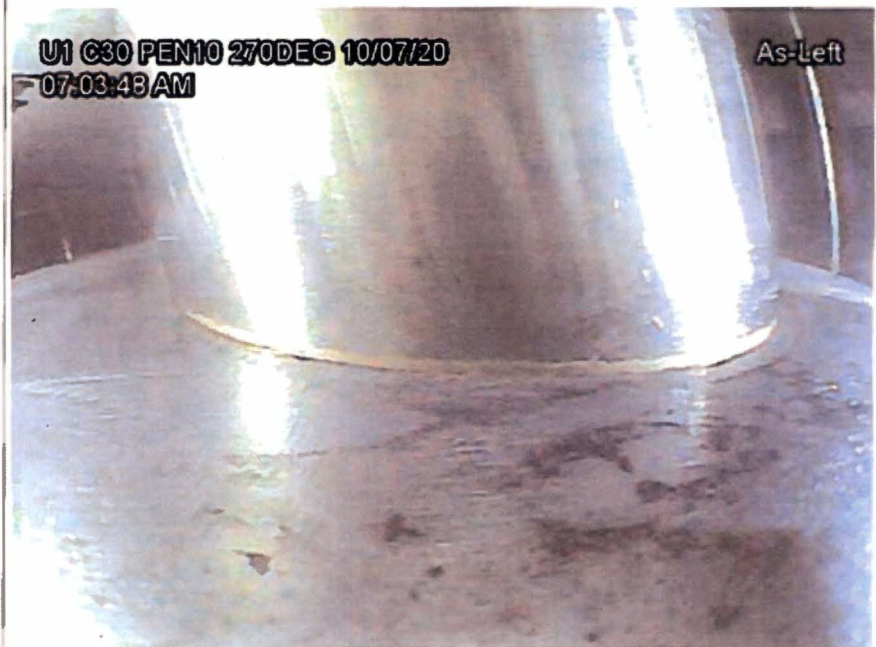
As Left Photo

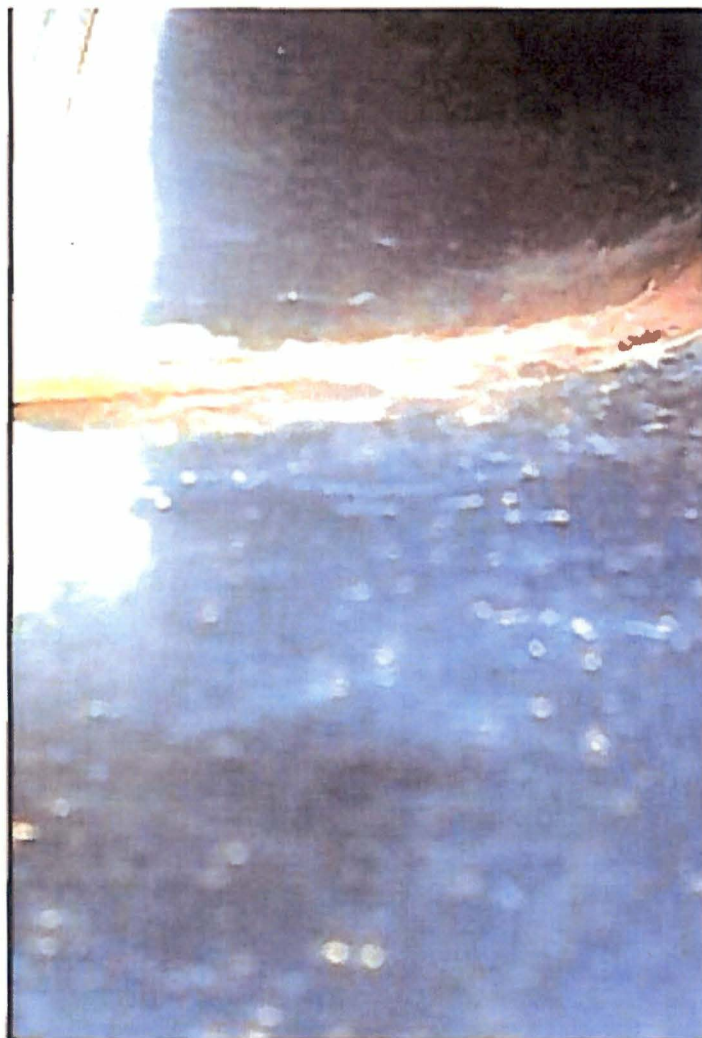
U1C30 RVCH Inspection Photos  
Penetration Number 22

As Found Photo

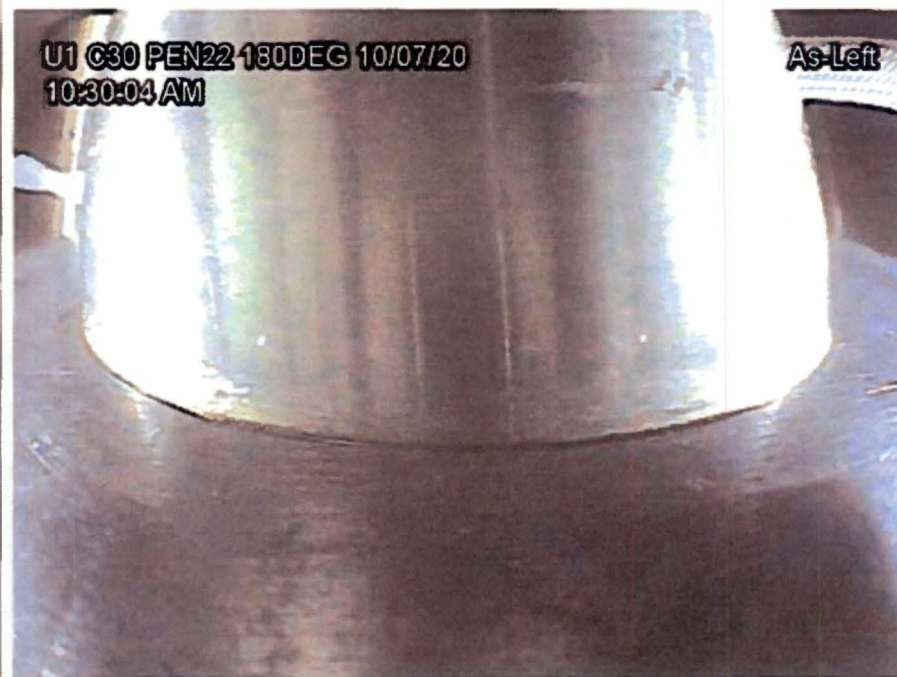
U1 C30 PEN22 180DEG 10/07/20  
10:30:04 AM

As Left Photo

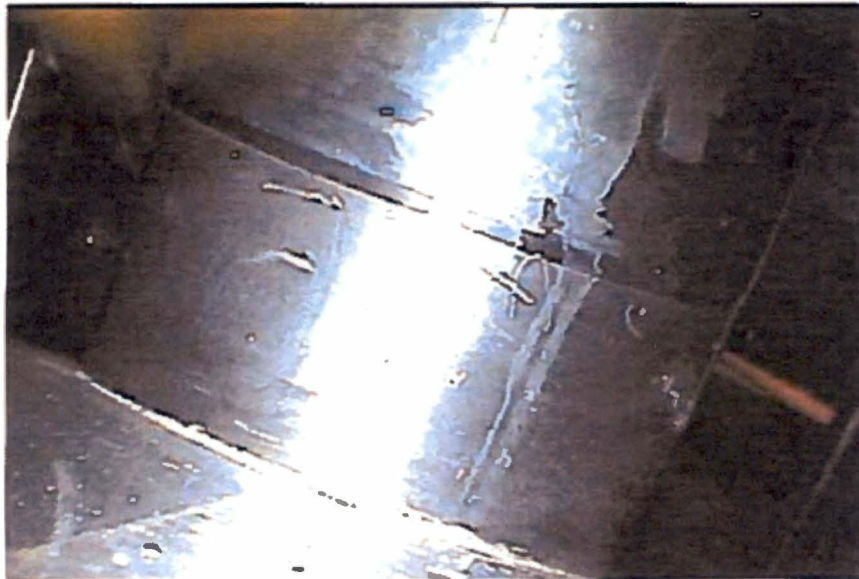
U1C30 RVCH Inspection Photos  
Penetration Number 23

As Found Photo

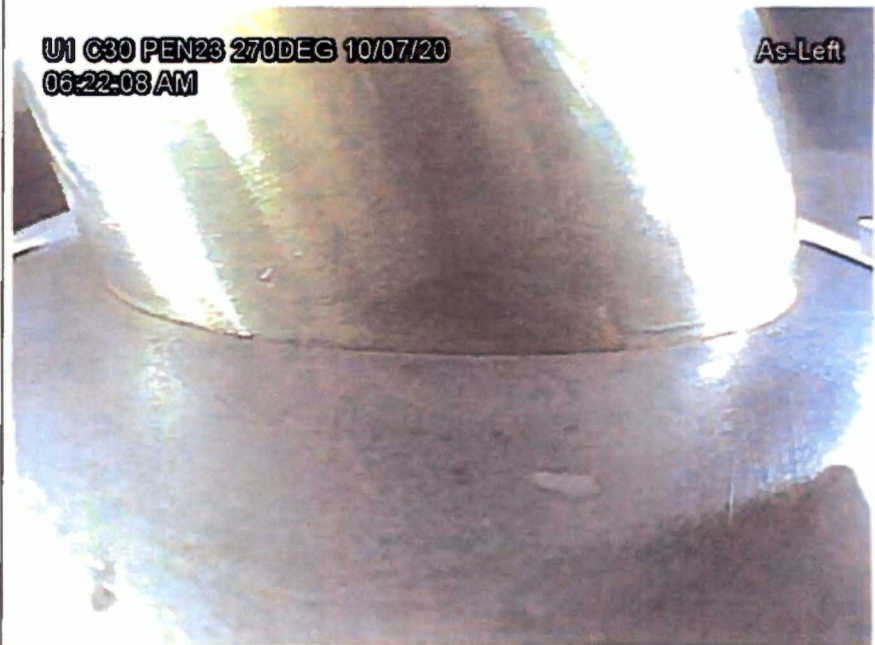
As Left Photo

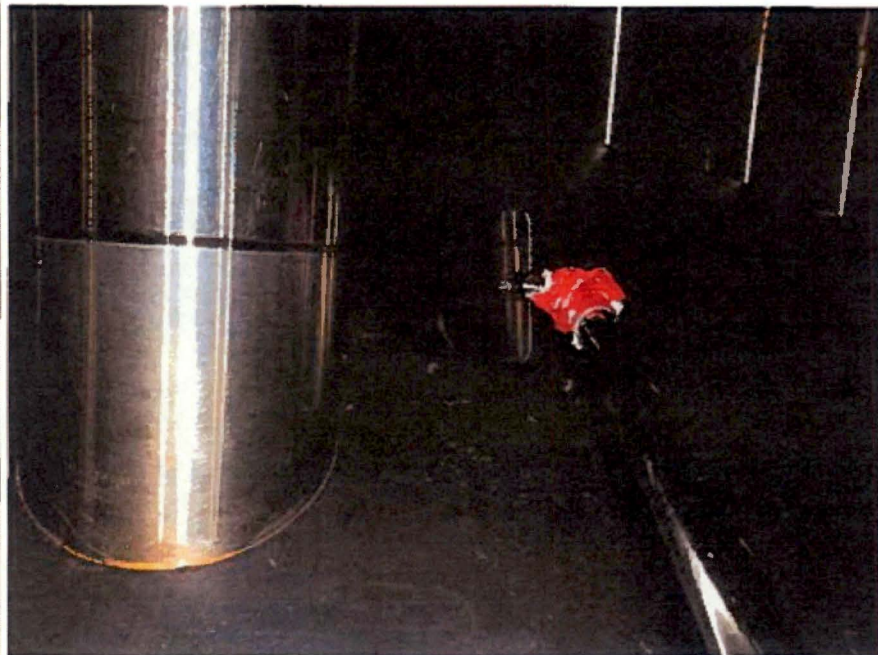
U1C30 RVCH Inspection Photos  
Penetration Number 39

As Found Photo

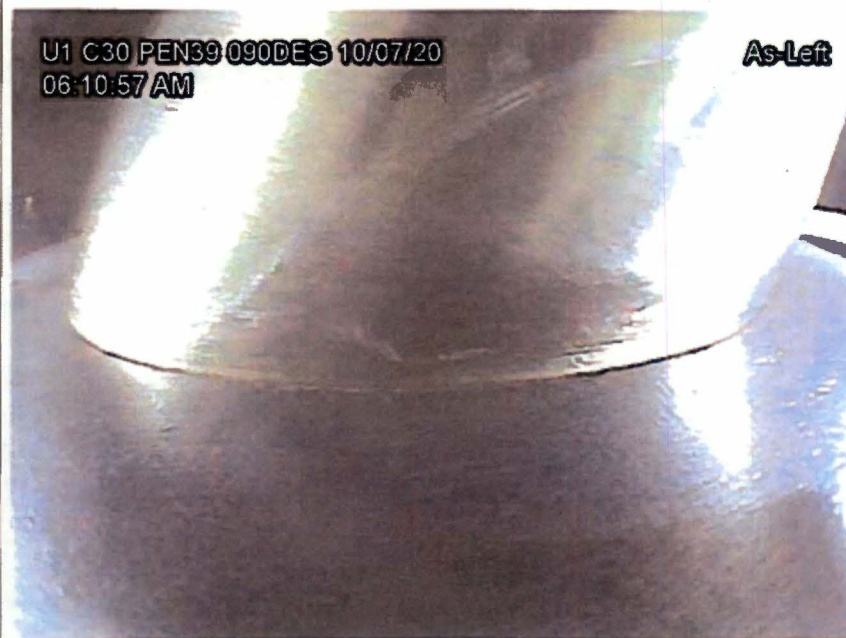
As Left Photo

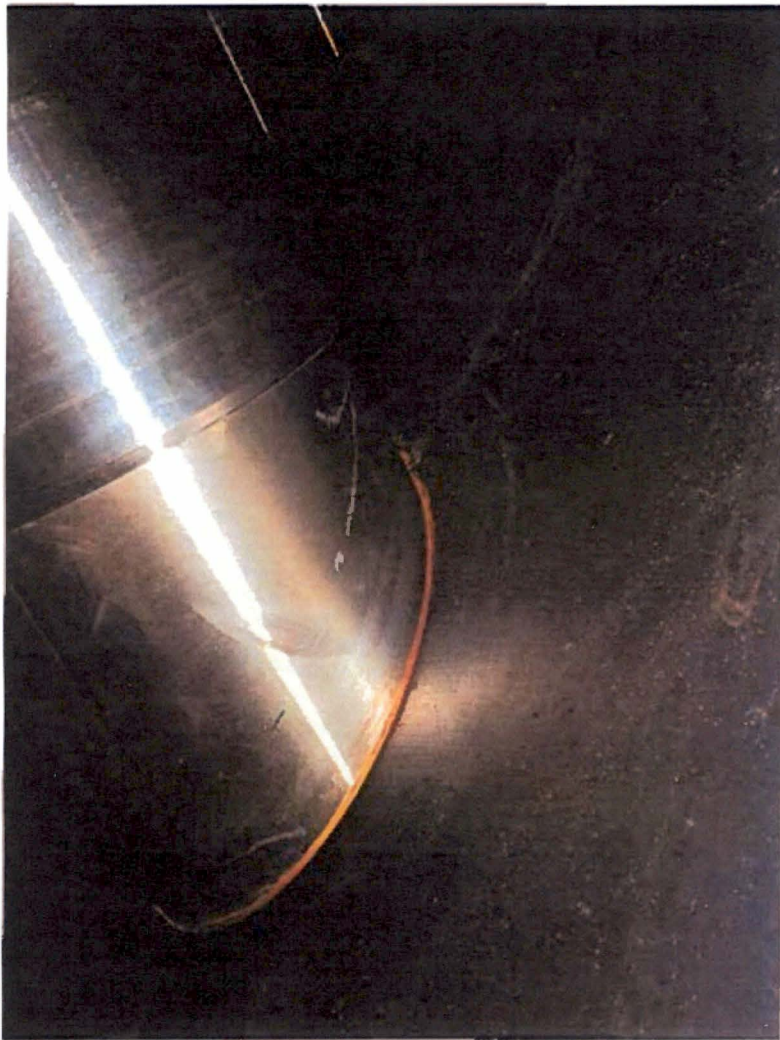
U1C30 RVCH Inspection Photos  
Penetration Number 46

As Found Photo

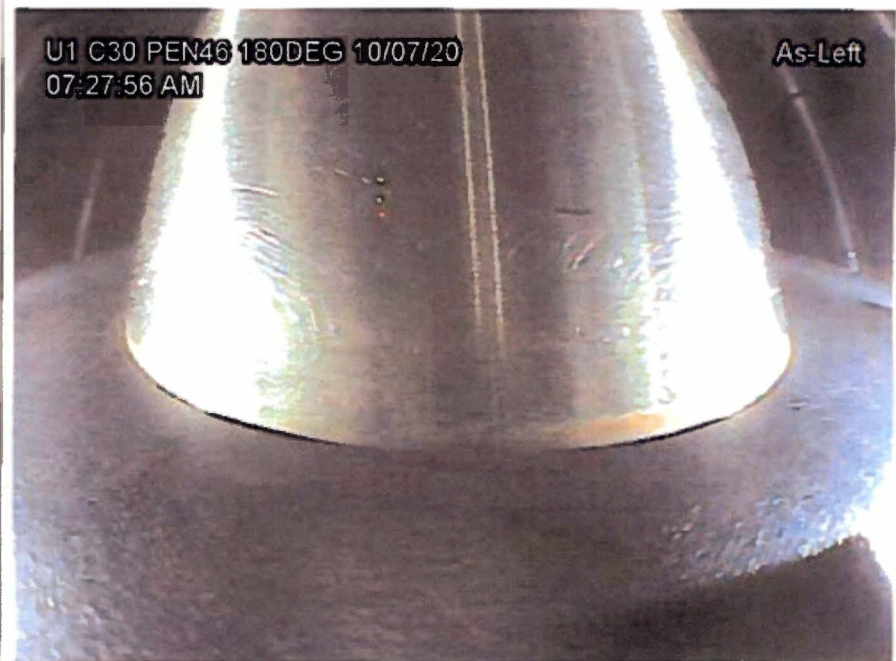
As Left Photo

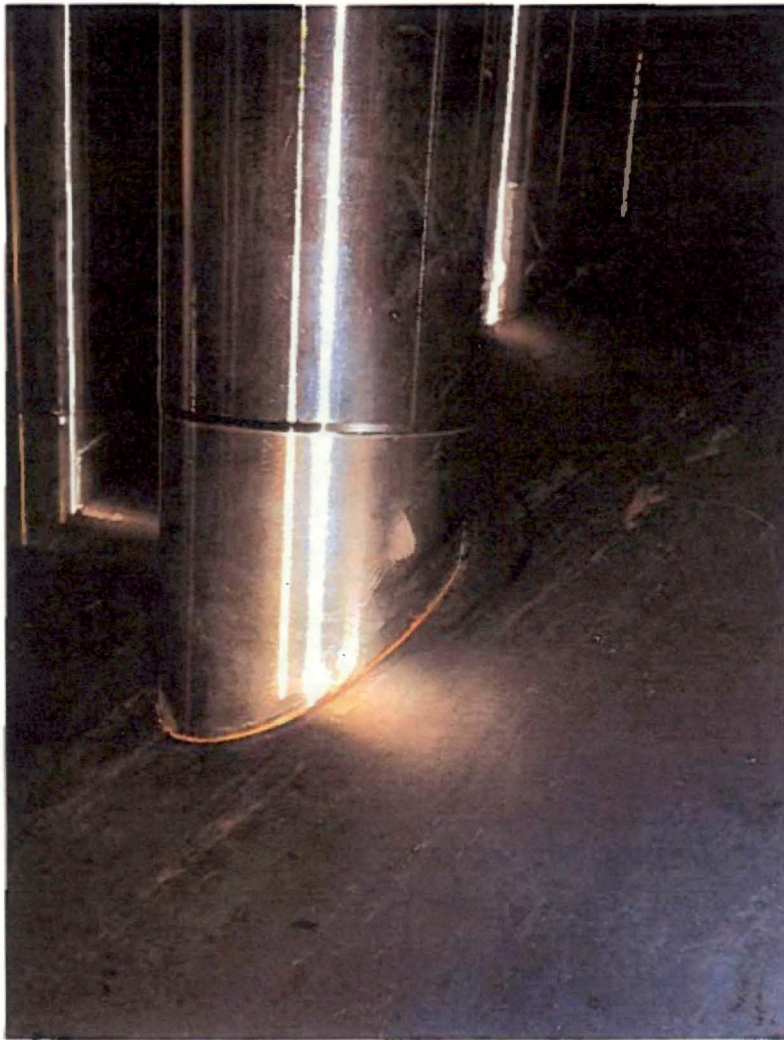
U1C30 RVCH Inspection Photos  
Penetration Number 59

As Found Photo

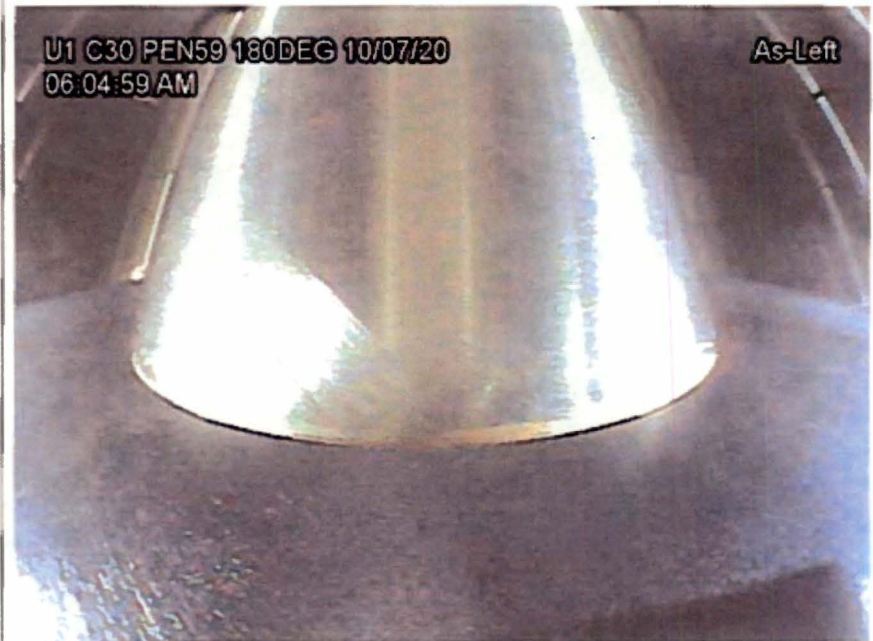
As Left Photo

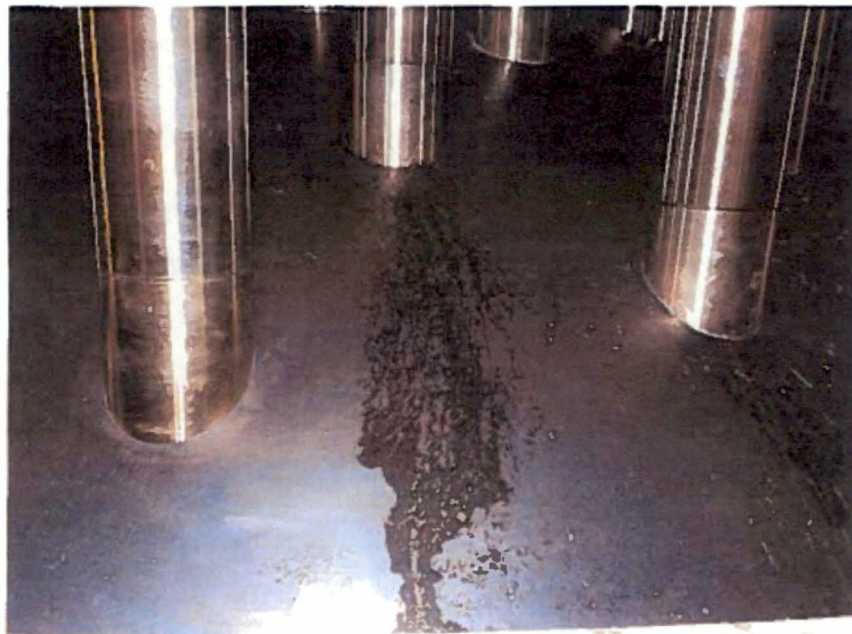
U1C30 RVCH Inspection Photos  
Penetration Number 62

As Found Photo

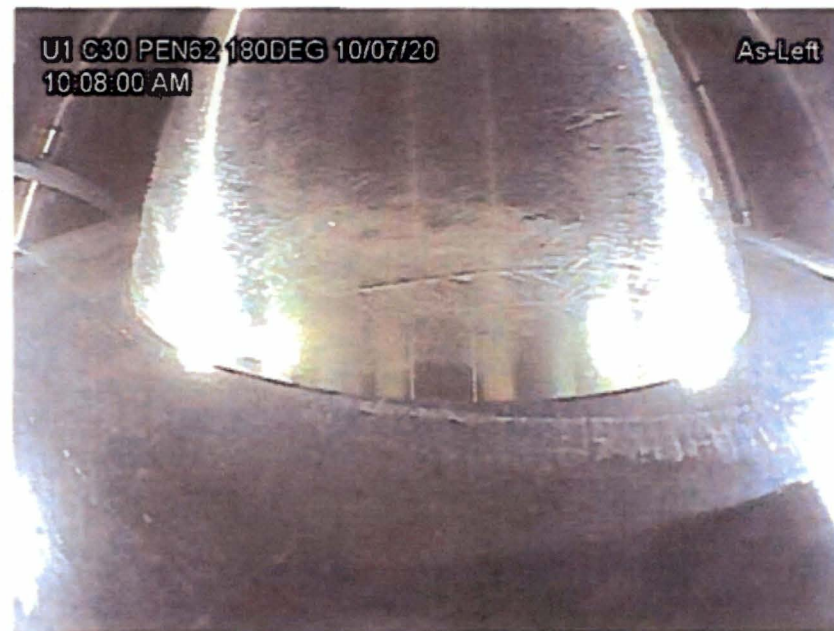
As Left Photo

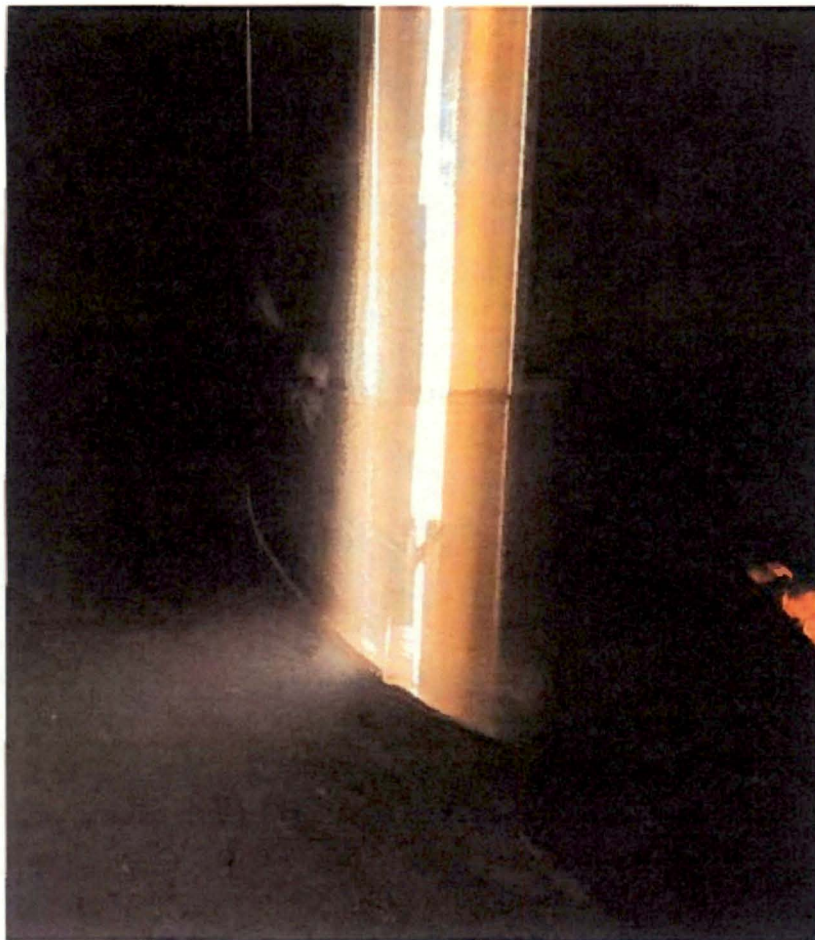
U1C30 RVCH Inspection Photos  
Penetration Number 64

As Found Photo

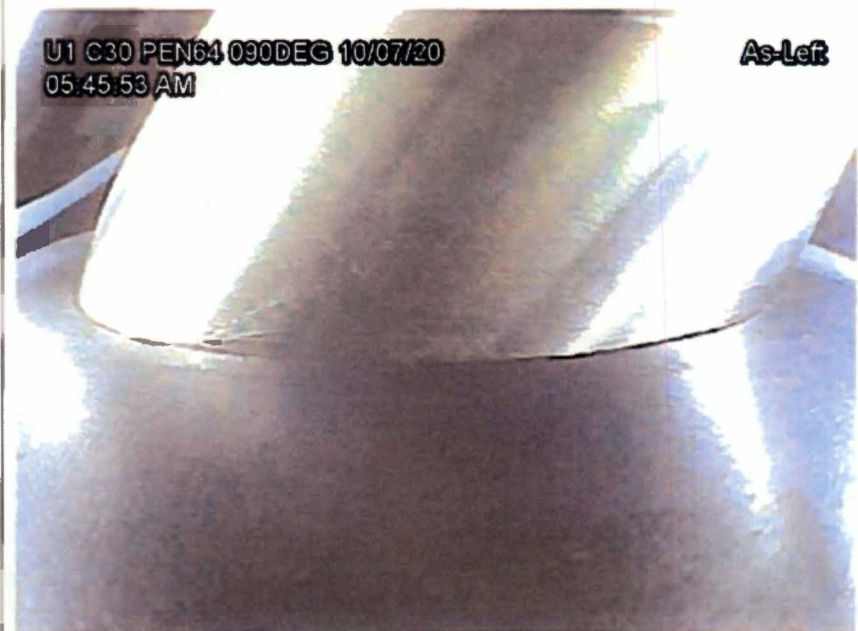
As Left Photo

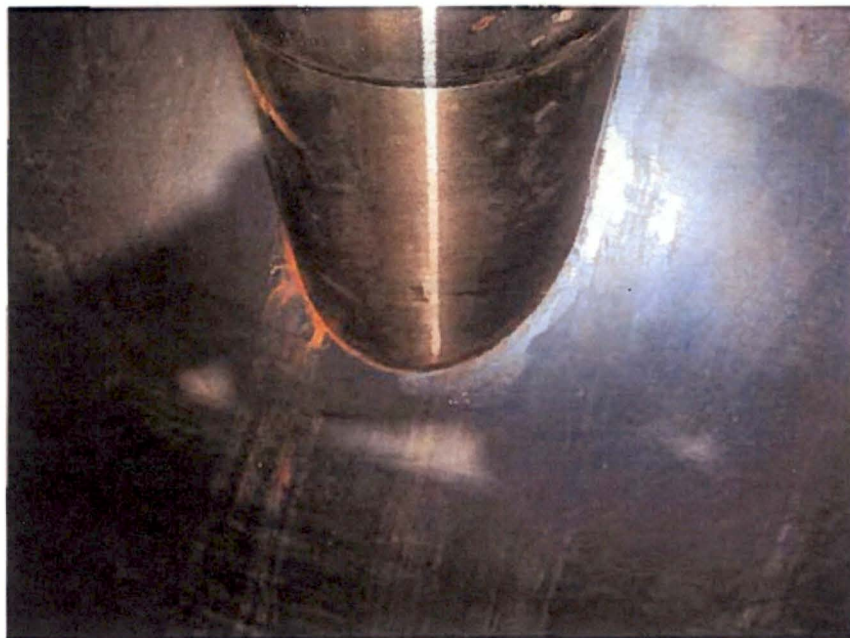
U1C30 RVCH Inspection Photos  
Penetration Number 70

As Found Photo

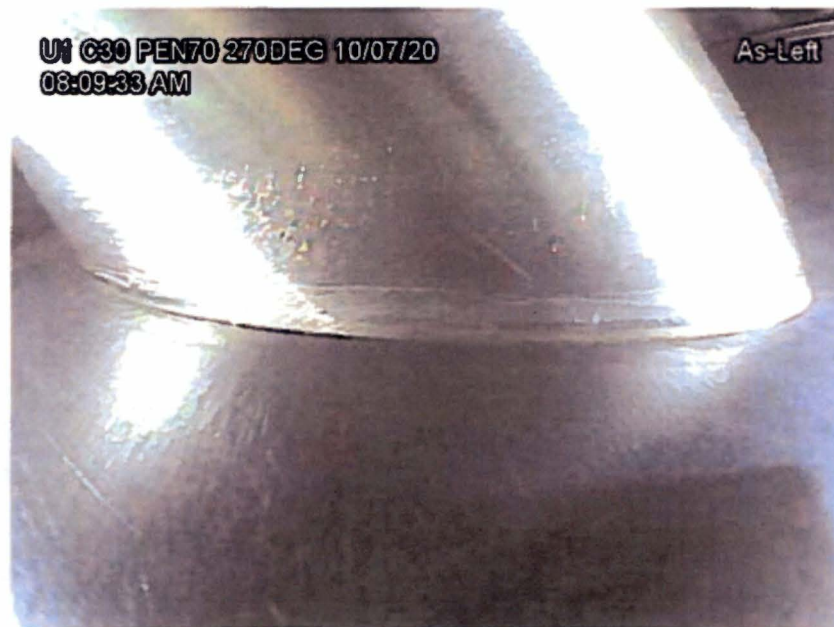
As Left Photo

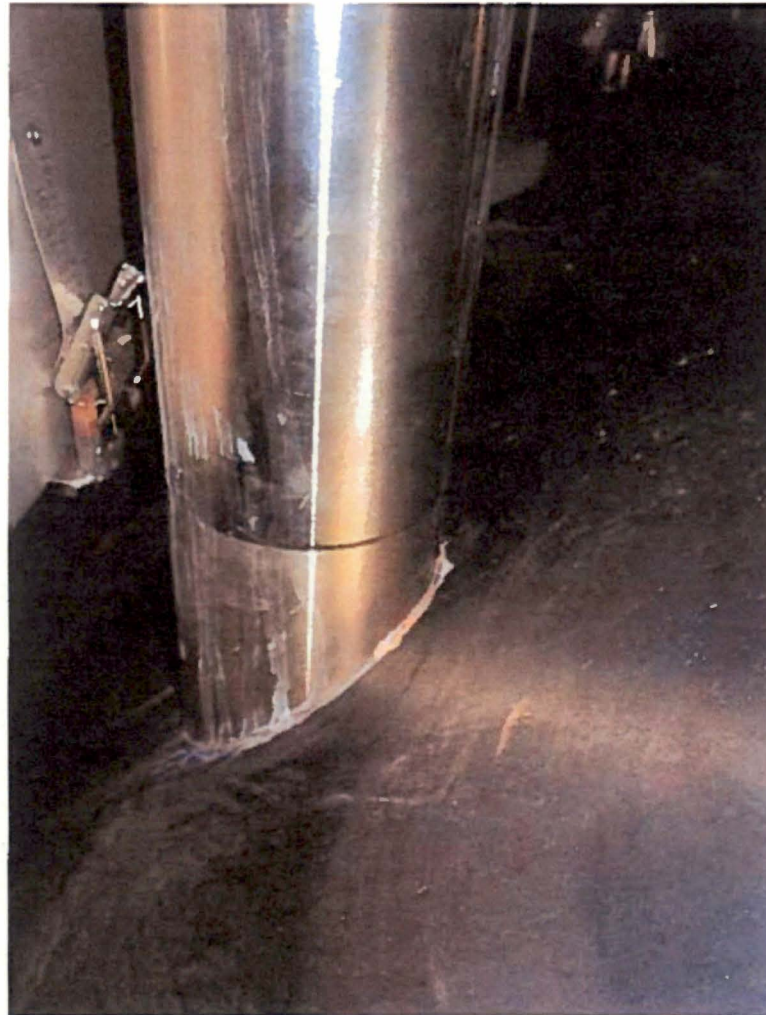
U1C30 RVCH Inspection Photos  
Penetration Number 74

As Found Photo

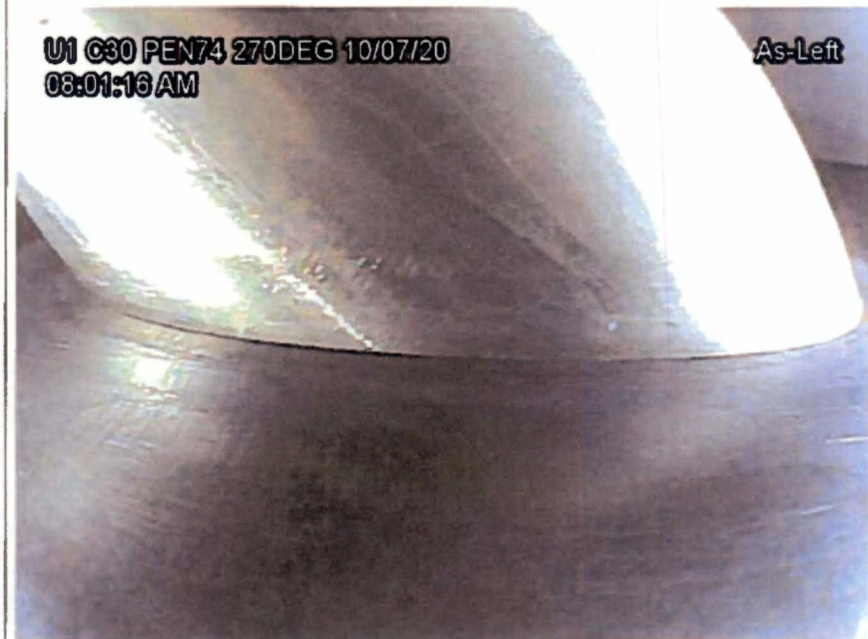
As Left Photo

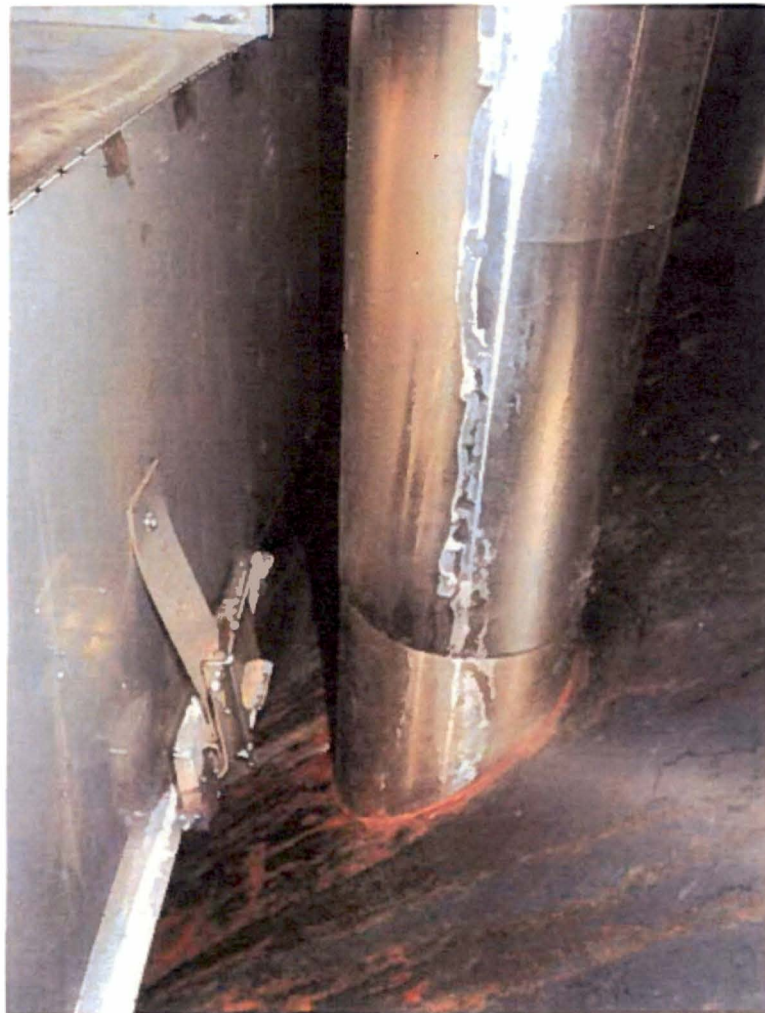
U1C30 RVCH Inspection Photos  
Penetration Number 75

As Found Photo

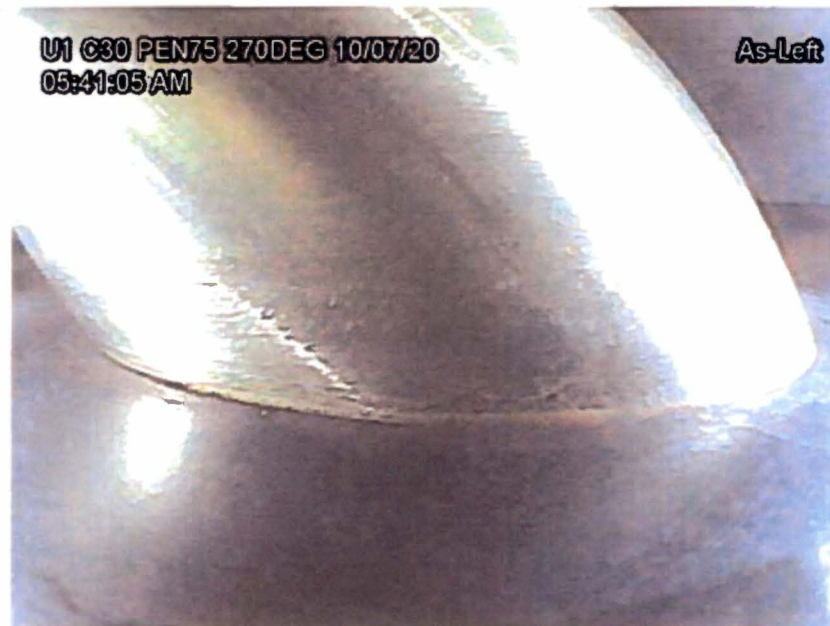
As Left Photo

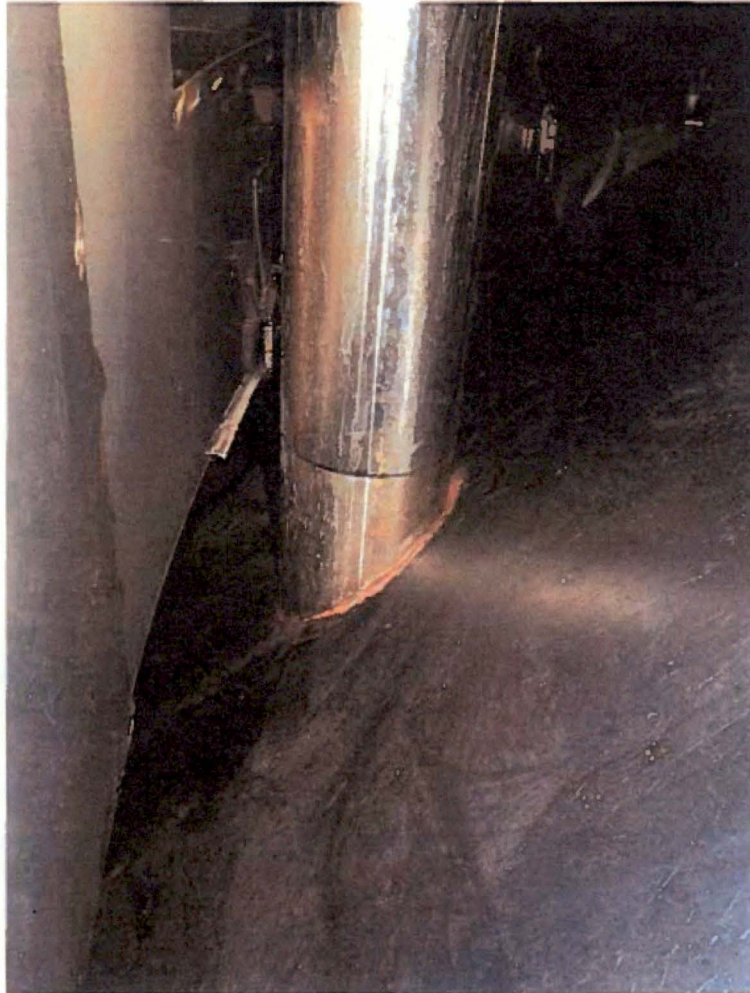
U1C30 RVCH Inspection Photos  
Penetration Number 76

As Found Photo

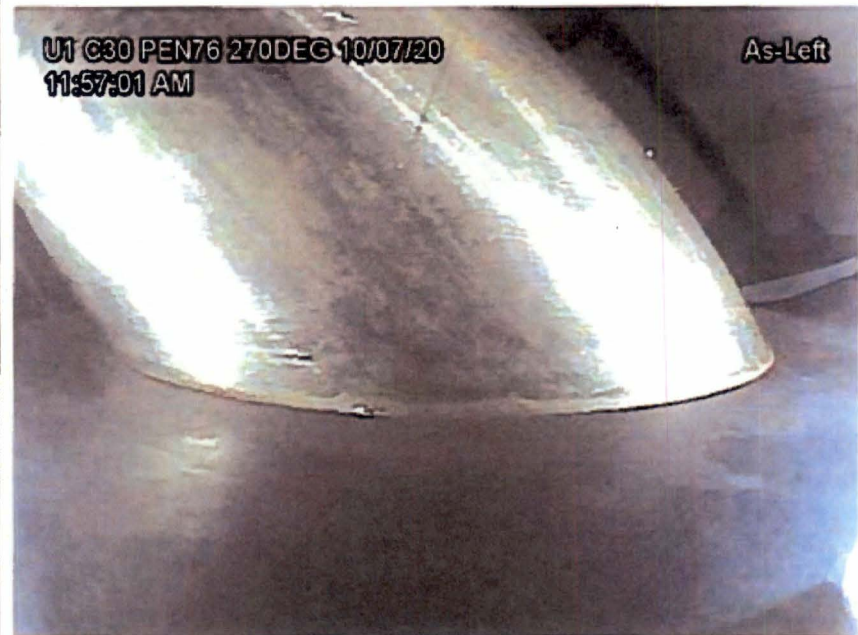
As Left Photo

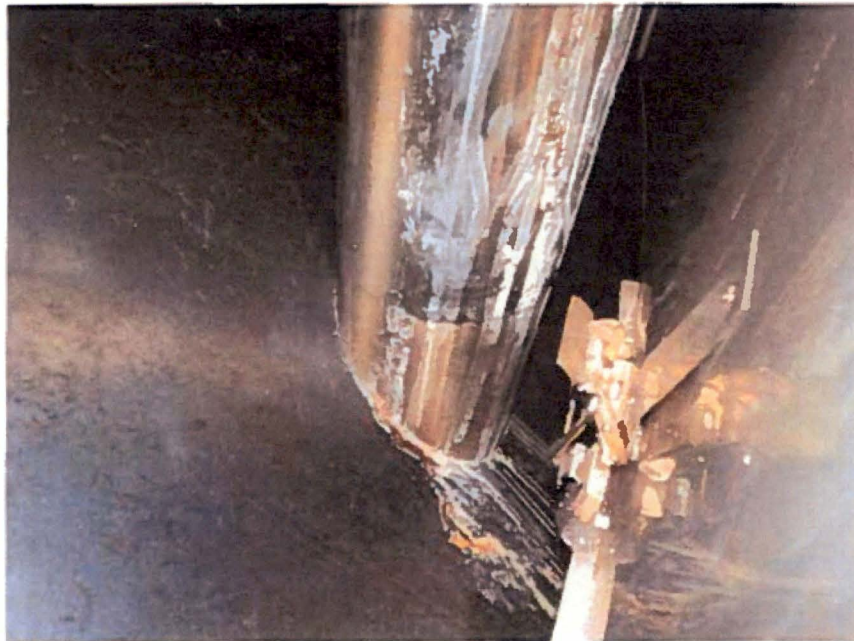
U1C30 RVCH Inspection Photos  
Penetration Number 77

As Found Photo

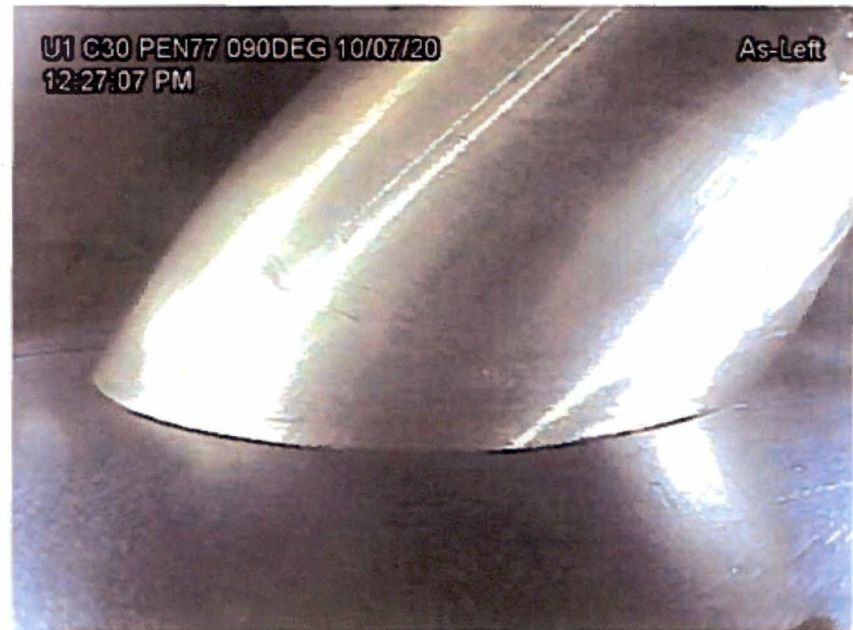
As Left Photo

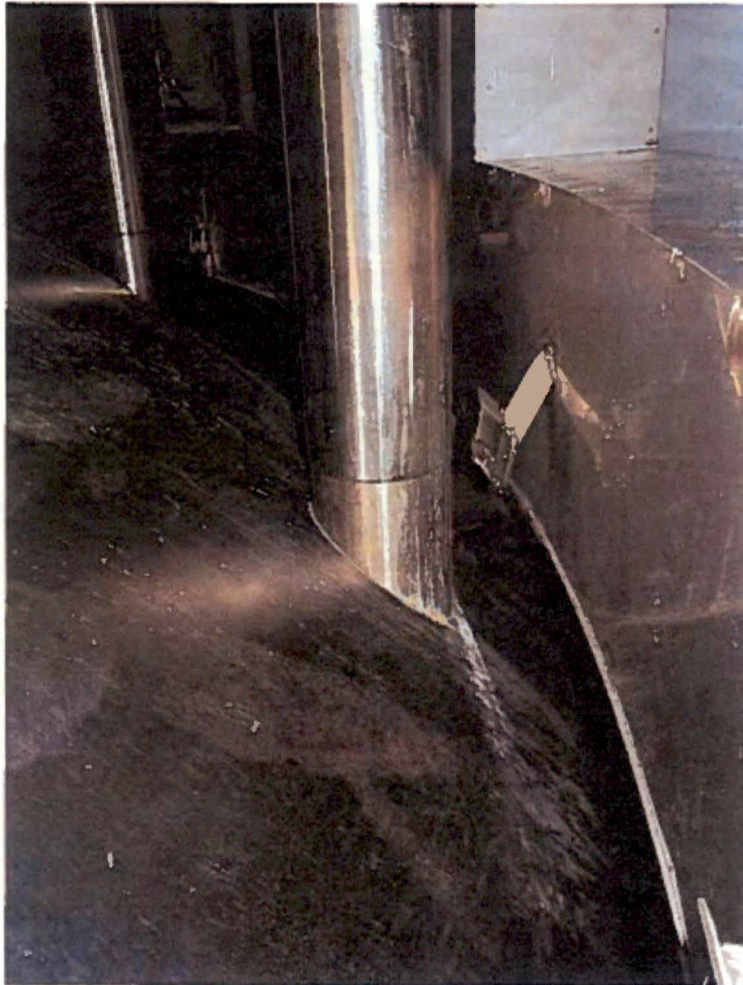
U1C30 RVCH Inspection Photos  
Penetration Number 79

As Found Photo

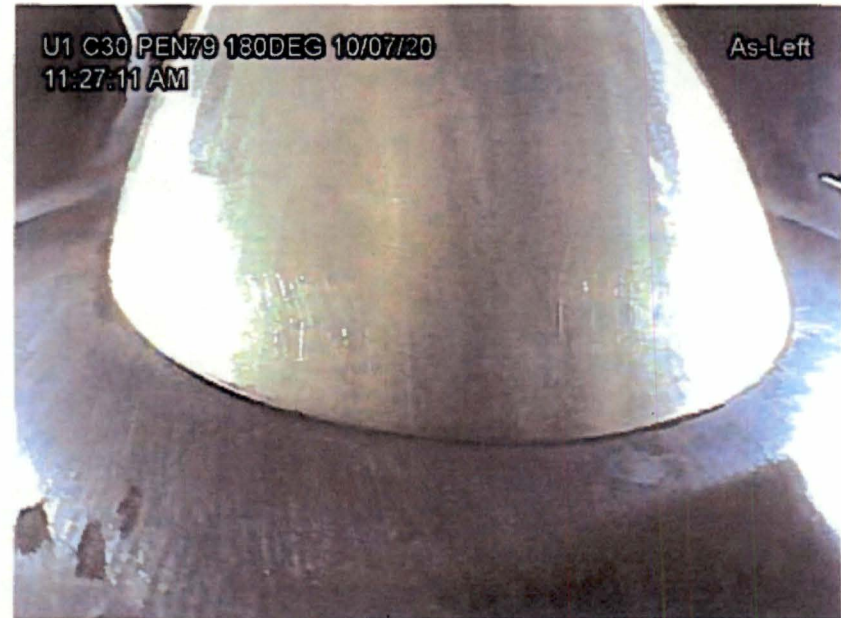
As Left Photo

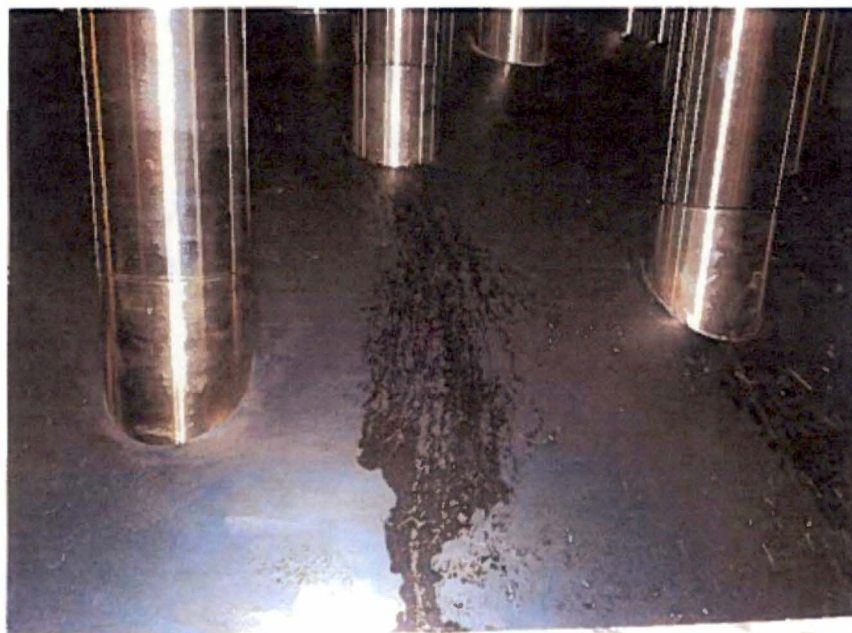
# U1C30 RVCH Inspection Photos RVCH Surfaces

As Found Photo

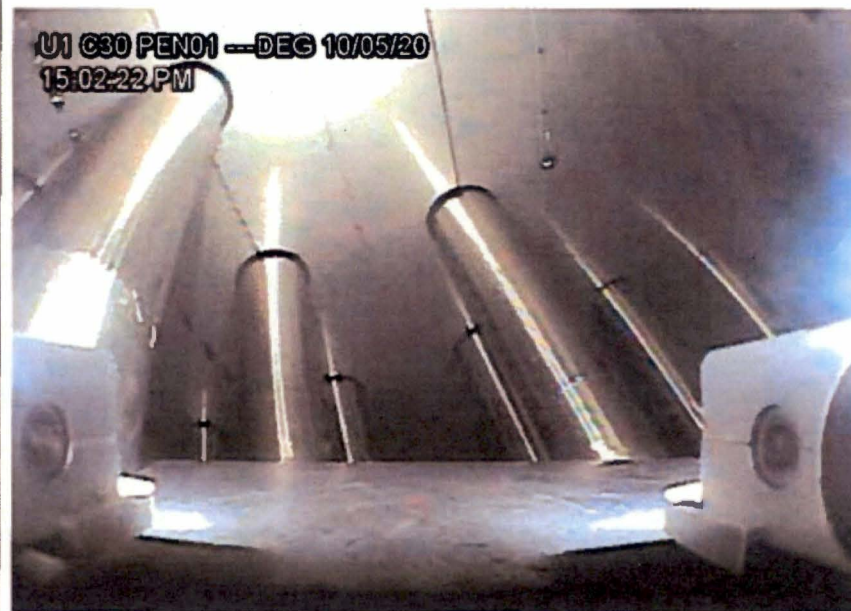
As Left Photo
