Shearon Harris Nuclear Power Plant, Unit 1
Docket No. 50-400/Renewed License No. NPF-63

Subject: Relief Request, Service Water Pinhole Leak in a Socket Weld, Inservice Inspection Program, Fourth Ten-Year Interval

Service Water Pinhole Leak in a Socket Weld,
Inservice Inspection Program, Fourth Ten-Year Interval

Relief Request in Accordance with 10 CFR 50.55a(z)(2)

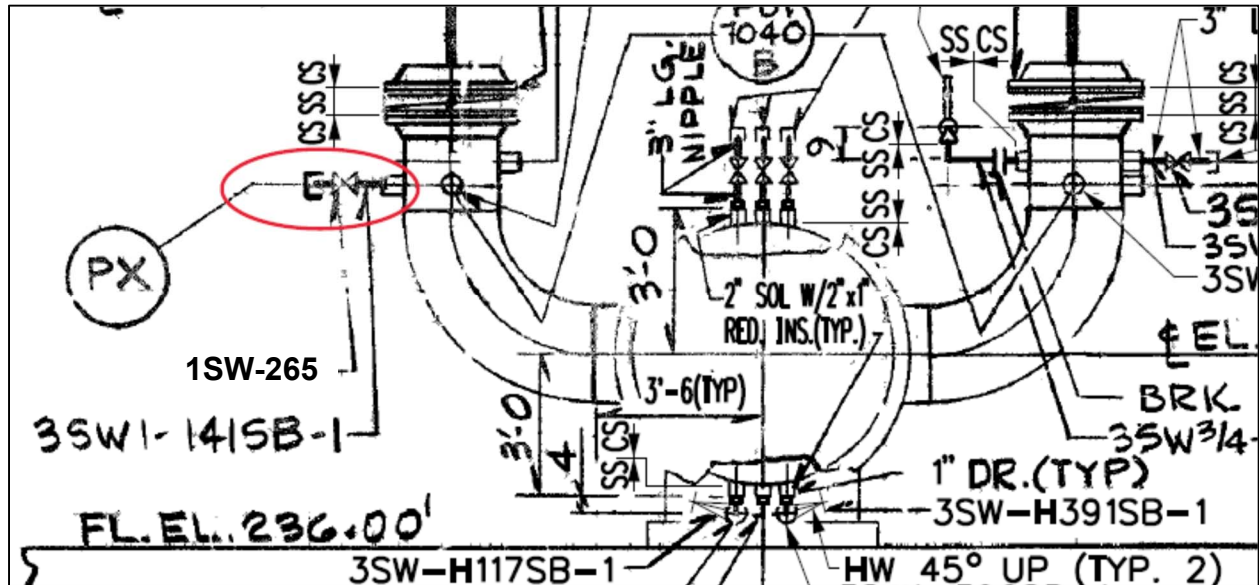
Figure 1: Drawing of the Flaw Location

On September 20, 2020, HNP personnel identified a pinhole leak (flaw) in ESW piping line 1SW1-141SB-1 during operator rounds, due to weepage coming from the flaw. The piping that contains this flaw is a connection line for a pressure transmitter located at the outlet of the 'B' Component Cooling Water (CCW) System heat exchanger off the ESW return line, 3SW24-73SB-1, between the return line and the associated root valve, 1SW-265. The flaw is in the welded joint at the 1 inch socket, attached to the ESW returned header, and appears to be at the stop-start interface of the socket weld. A drawing of the flaw location and photographs of the flaw are shown in Figures 1 and 2 of this enclosure.

The flaw appears to be at the stop-start interface of the socket weld and is likely the result of a lack of fusion or other defect at this location following installation. The result would be a small crevice created between the inner diameter and outer diameter of the weld and sockolet interface, which would permit stagnant water between the outer diameter of the pipe and the inside diameter of the sockolet fitting. This defect could be a result of impurities, work practices or workmanship. This is considered an isolated incident, with no programmatic or widespread deficiencies currently identified.

An accurate measurement of the pinhole diameter could not be obtained since the size of the pinhole leak is small (less than 1/16 inch diameter). The area of the leak was observed dripping at approximately 1 drop per minute. The flaw is a small hole that most likely extends in the radial direction from the pipe to outer edge of the coupling (from where there is stagnant water between the outer diameter of the pipe and the inside diameter of the sockolet fitting). The flaw was not a result of vibration. There was no vibration detected on line 3SW1-141SB-1 during a field walkdown with the system in service. A flaw diameter of 0.100 inches was used to further evaluate the defect. Ultrasonic testing (UT) measurements indicate some wall thinning, with pipe wall thickness varying between 0.150 inch and 0.167 inches around the pipe circumference. The lowest reading obtained was 0.137 inches at the root of the socket weld. There is no evidence that the flaw extends into the base metal.

Duke Energy proposes to defer the code repair of the identified flaw until the next planned outage of sufficient duration, but no later than the next refueling outage, currently scheduled to begin in April 2021. During the interim period, augmented inspections will be performed at a three-month frequency to detect changes in the condition of the identified defect. This testing will use suitable nondestructive examination methods, including UT. Additionally, a qualitative assessment of leakage will be performed at least once a week during plant walkdown inspections to determine if there is additional degradation of structural integrity.
