Subject: 10CFR Part 21 Notification for a Curtiss-Wright supplied Royce Compressor

**Subject: Duke Energy Carolinas, LLC (Duke Energy)
Robinson Nuclear Plant, Unit 2
Request for Determination of 10 CFR 21 Reportability**

References:	Robinson Condition Report:	02346430
	Robinson Equipment ID:	WCCU-1B
	Duke Energy Catalog ID:	73693939
	Manufacturer Part Number:	CG-040-NTA
	Manufacturer Serial Number:	KX 621167
	Duke Energy Purchase Order:	03096746
	Curtiss Wright Dedication Plan:	CJ15907-1

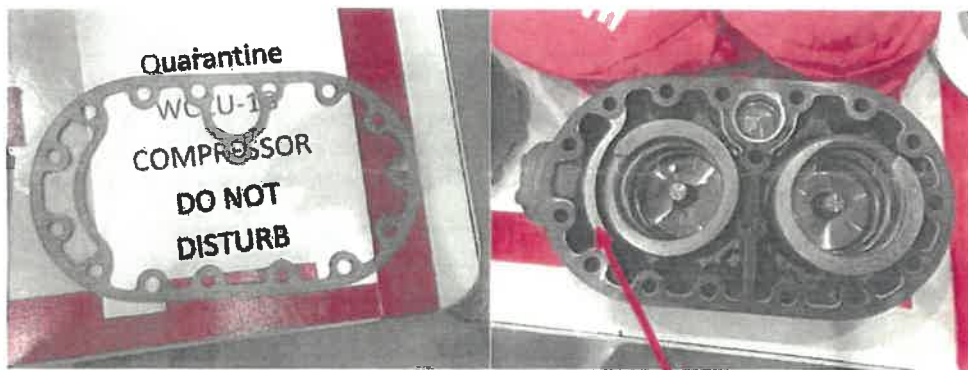
Based on details provided by Duke Energy, the compressor failed to provide effective cooling upon start up and subsequently overheated. See attached Duke Energy letter for complete description of the failure. Duke Energy's investigation of the failure determined that an incorrect head gasket had been installed, allowing a path for high pressure and temperature discharge refrigerant to return directly to the low pressure crank case.

During the investigative disassembly, the cylinder head gasket for cylinders 2 and 4 was found to be the wrong gasket for the CG-040-NTA model compressor. The compressor head gasket was replaced with the correct gasket. The WCCU units are purchased under the 10 CFR 50 Appendix B Safety Related processes.

Correct Gasket

As found factory installed gasket (incorrect)

The corrective action taken was to revise the dedication plan to enhance the gasket acceptance criteria and inspection process.
