DOMINION ENERGY NUCLEAR CONNECTICUT, INC.
MILLSTONE POWER STATION UNIT 2
SUPPLEMENT TO PROPOSED LICENSE AMENDMENT REQUEST TO REVISE THE
MILLSTONE UNIT 2 TECHNICAL SPECIFICATIONS FOR STEAM GENERATOR
INSPECTION FREQUENCY

**REVISED MILLSTONE UNIT 2 STEAM GENERATOR INTEGRITY CONDITION
MONITORING AND OPERATIONAL ASSESSMENT
REFUELING OUTAGE 2R24**

**DOMINION ENERGY NUCLEAR CONNECTICUT, INC.
MILLSTONE POWER STATION UNIT 2**

Refueling Outage (2R24)

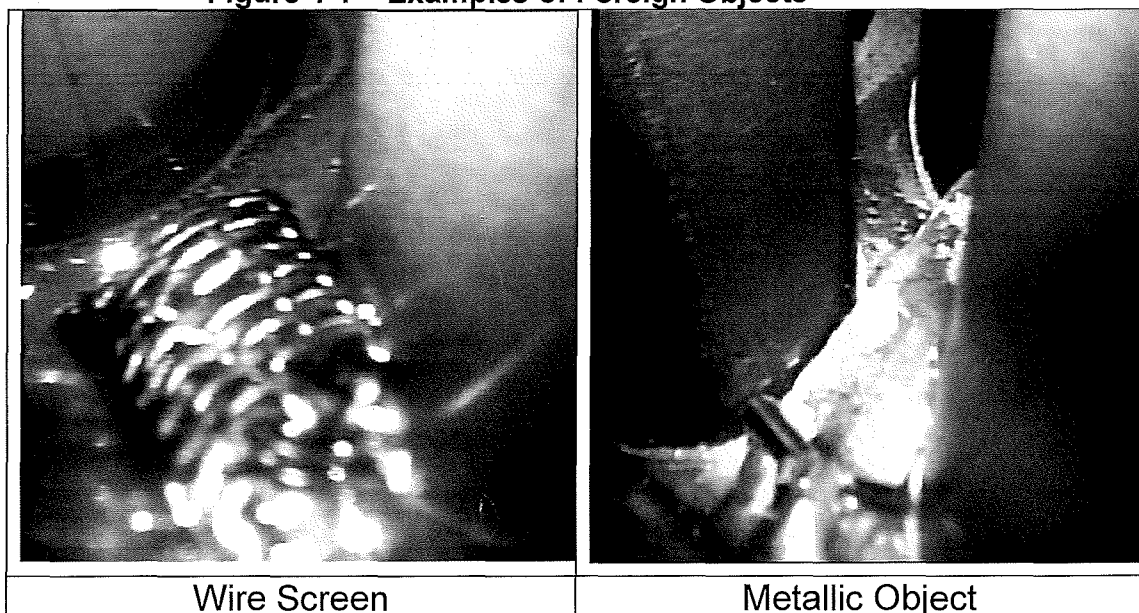
Figure 4-1 – Examples of Foreign Objects

During the 2R24 examination, any new confirmed Possible Loose Part (PLPs), PLP related indications, or new FO wear indications reported by the eddy current examination were investigated by the Secondary Side Inspection (SSI) crew as far as possible and any new objects identified by SSI within the tube bundle region were tested by the +Point™ eddy current technique. When possible the FO's were removed by FOSAR. The combined examinations were coordinated through the use of the LPT database. Some of the foreign objects identified during this inspection are shown in Figure 4-1 while Figure 4-2 shows foreign objects that were removed.

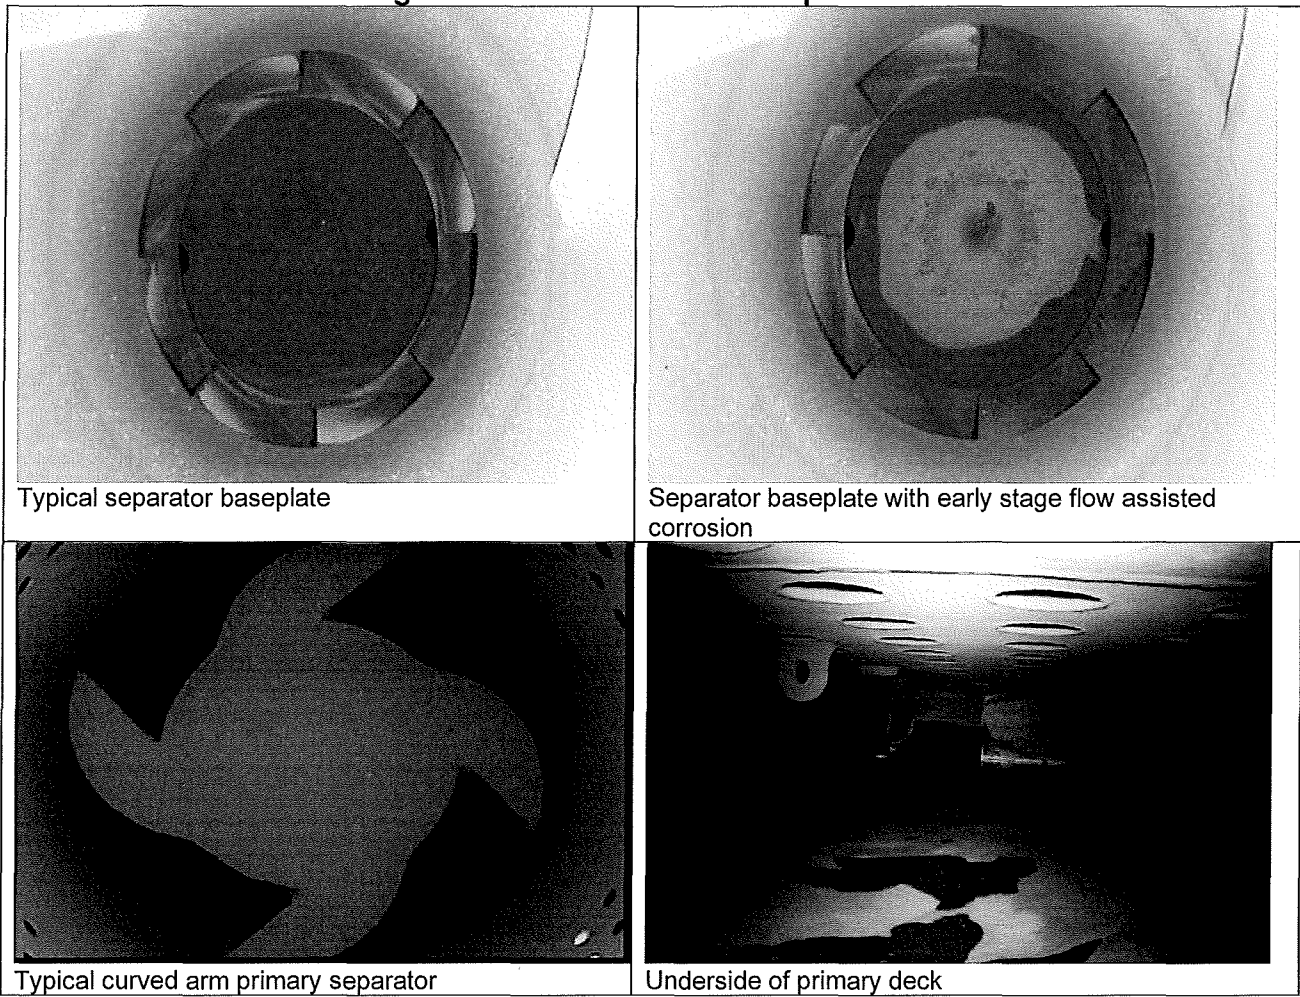
Figure 4-3 – Steam Drum Components

A visual examination of steam drum components was performed in SG25 and SG26. In the areas examined, sludge accumulation was light, with a harder underlying crystalline coating of sludge noted. Due to water clarity issues following refill after DMT, visual inspection of the U-bend structures (arch bars, J-tabs and fan bars) was not possible. Sludge deposits on the primary and secondary moisture separators were light and tightly adhering. Very little deposit was removed from these surfaces when rubbed with a gloved hand. The primary separators examined were in good condition with no evidence of material degradation. The curved arm assemblies within the primary separators were inspected and found to be in good condition. The edges of the steam outlet to the assemblies were sharp, indicating no noticeable flow assisted corrosion. Evidence of early stage flow assisted corrosion of the secondary moisture separators was noted. Severe degradation of these separators can eventually lead to the introduction of loose parts that may migrate to the tube bundle. However, based on limited operational wear observed through 2R24, significant structural degradation is not expected to occur over the next five cycles of operation. This condition should be monitored during future outages.

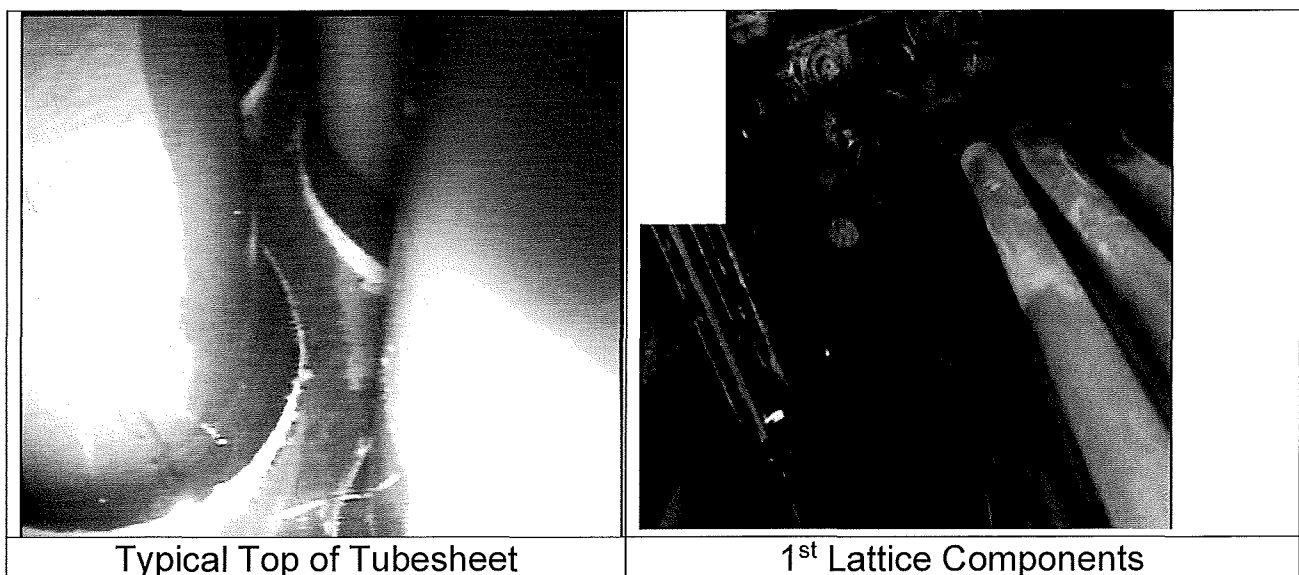
Figure 4-4 – Lower Bundle Components

Post-lancing visual examinations in SG25 and SG26 identified no loose sludge in the annulus at the top of tubesheet. The no-tube lane and staywell regions were clear as well. The blowdown flow holes in the tubesheet showed no evidence of flow induced erosion. Due to the application of DMT, a total of 2608 pounds of deposit was removed from SG 25 and a total of 2584 pounds of deposit was removed from SG 26 (See Table 4-2). The 1st support lattice, shroud, and shroud support components examined were in good condition. Jacking studs showed no indication of movement between the shell and shroud. (See Figure 4-4)

There was a light dusting of sludge noted in the annulus of both SGs. Discoloration of the outer surface of most tubes was noted. This was attributed to the application of DMT, and does not represent a deleterious condition. The no-tube lane and staywell area was clean and the blowdown flow holes showed no evidence of erosion. The 1st support lattice, shroud, and shroud support components examined were in good condition with no evidence of material degradation. Jacking studs showed no indication of movement.

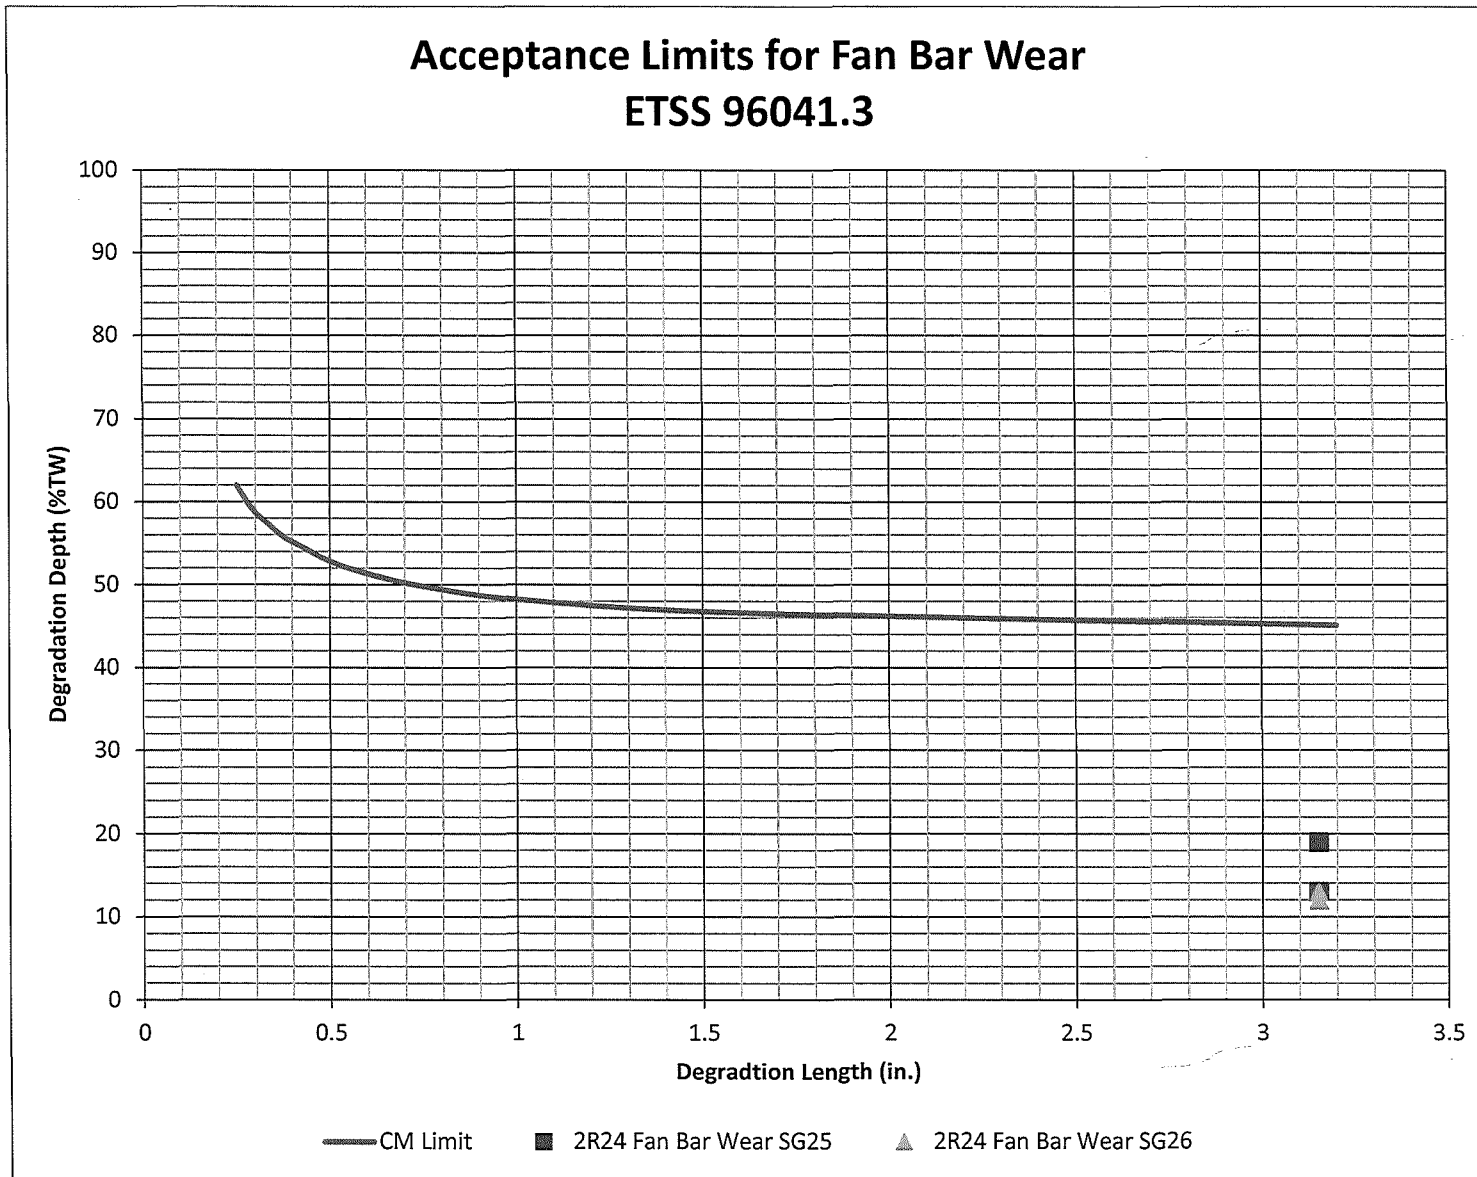
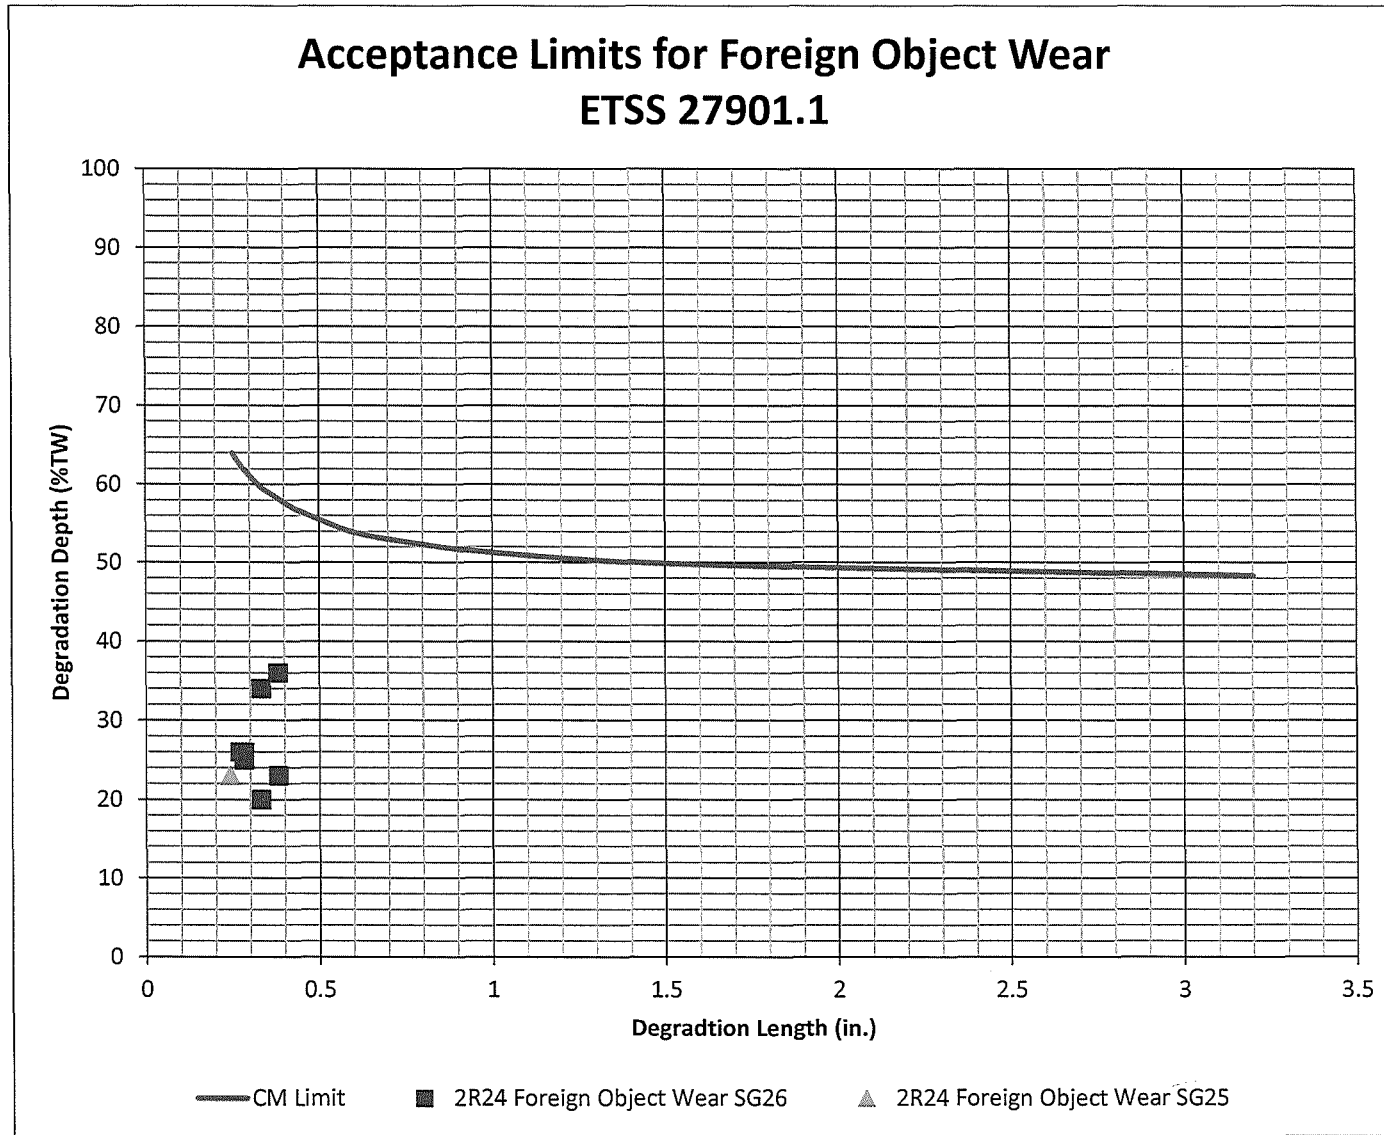
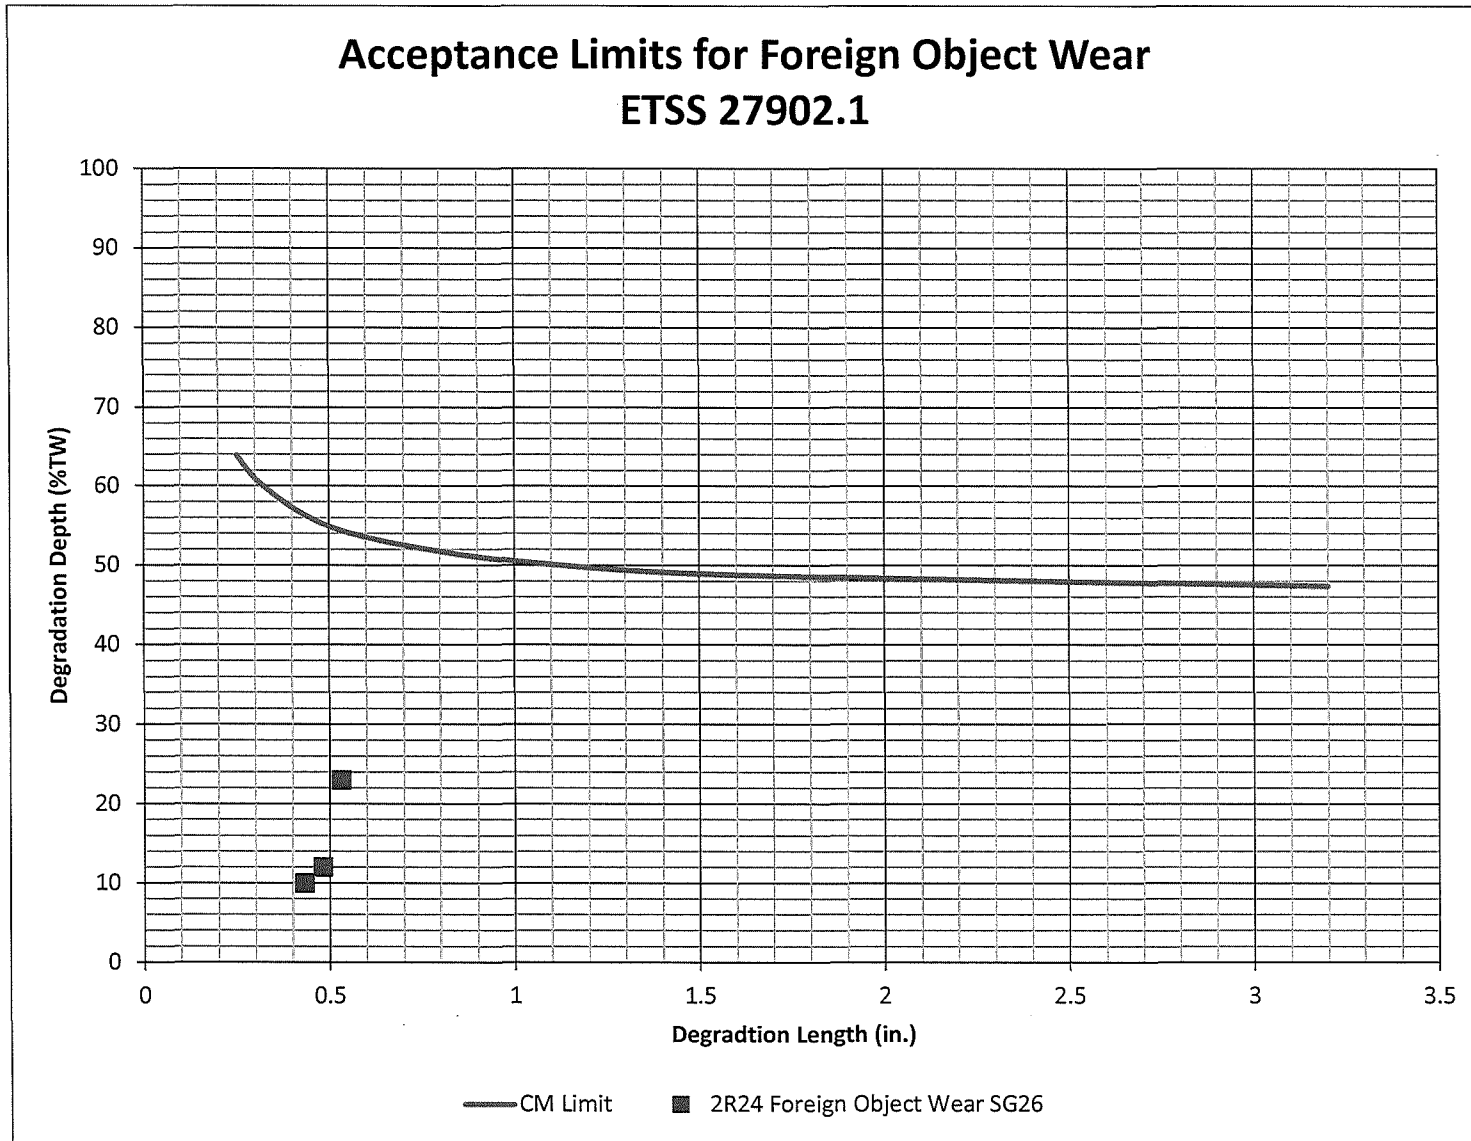
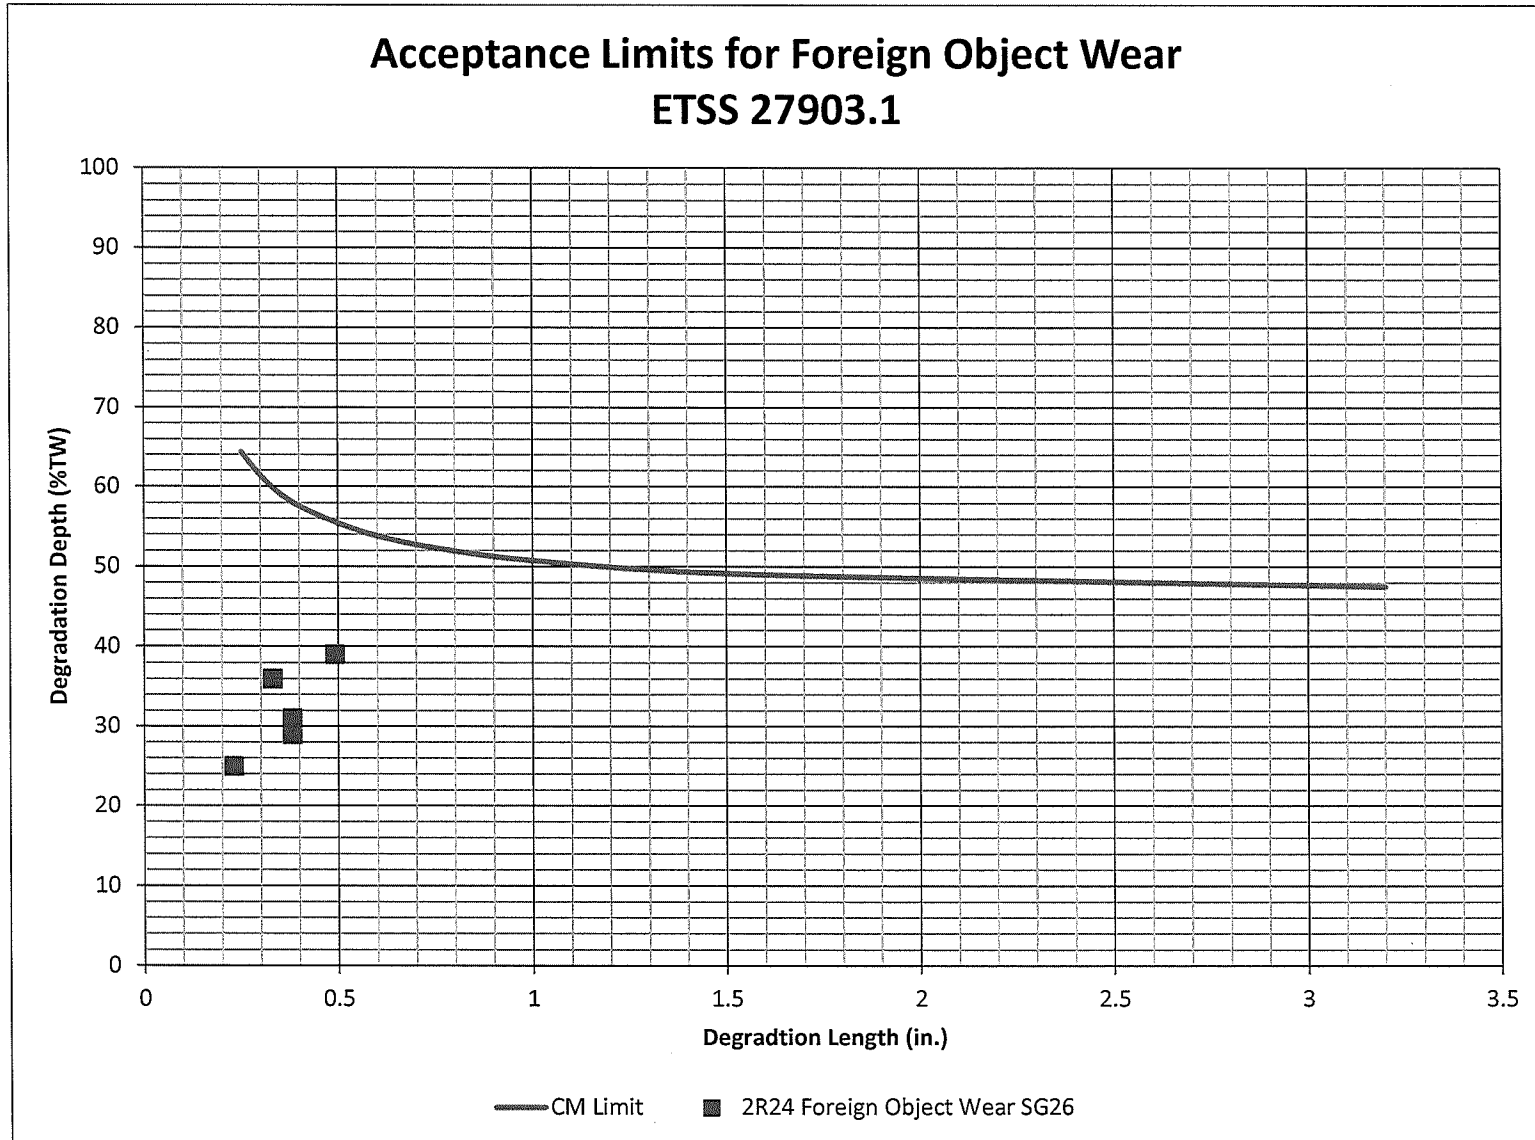
The figures also display the length and depth of each flaw. Because each flaw plotted in Figures 5-1 through 5-4 lies below the CM limit curve, it is concluded that the structural performance criteria set forth in the MPS2 Technical Specifications was not exceeded by any of the evaluated flaws. This also provides reasonable assurance that none of these flaws would have leaked under accident conditions.
