Donald C. Cook Nuclear Plant Unit 2  
License Amendment Request Regarding a Change to the Steam Generator (SG) Program to Allow  
for a One-Time Deferral of SG Inspections

Evaluation of Proposed Amendment to Revise Unit 2 Steam Generator (SG) Program to allow for a One-Time Deferral of SG Inspections for Donald C. Cook Nuclear Plant Unit 2

DC Cook Unit-2 SG Operational Assessment to Support Deferral of Planned Inspections at U2C26 (Spring 2021) and U2C27 (Fall 2022)

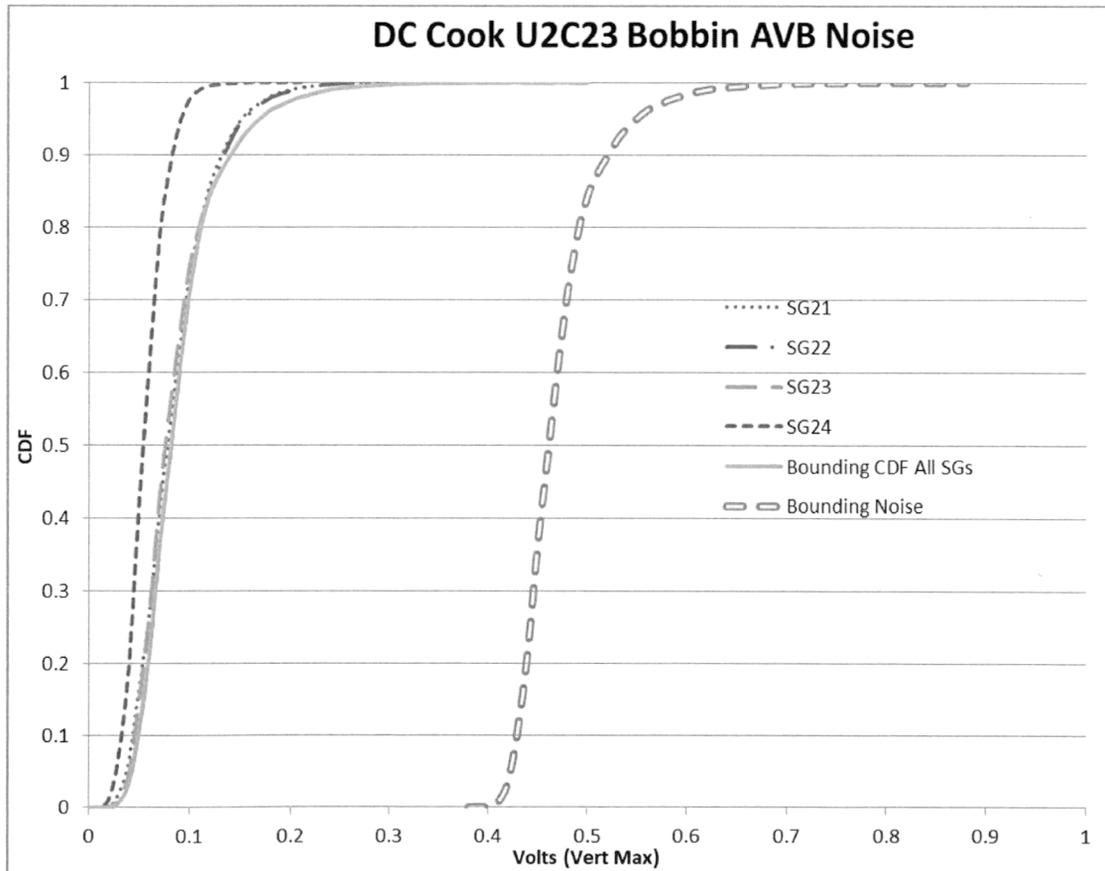
Figure 5-1: Comparison of AVB Noise to its Bounding Noise Distribution

To quantify the probability of detection (POD) for AVB wear, SG noise cumulative distribution functions (CDFs) were developed using the U2C23 bobbin data. Use of these CDFs also allowed the bounding CDF for all SGs to be determined. These distributions are illustrated on the left-hand side of Figure 5-1. The bounding noise distribution that coincides with a 95% POD for a 35%TW “must detect” depth was determined using the EPRI MAPOD (model assisted probability of detection) software [2.f]. The must detect depth of 35%TW was determined by subtracting the projected AVB wear growth ( $0.97\%TW/EPY \times 7.5\ EPY$ ) from the EOC high probability limit (41.7 %TW). This bounding noise distribution is illustrated in Figure 5-1. As the figure illustrates, ample margin exists between the bounding CDF for all SGs and the bounding noise distribution, thus providing reasonable assurance that growth of potentially undetected AVB wear over the 7.5 EPY operating period will not lead to a compromise in steam generator tube integrity.

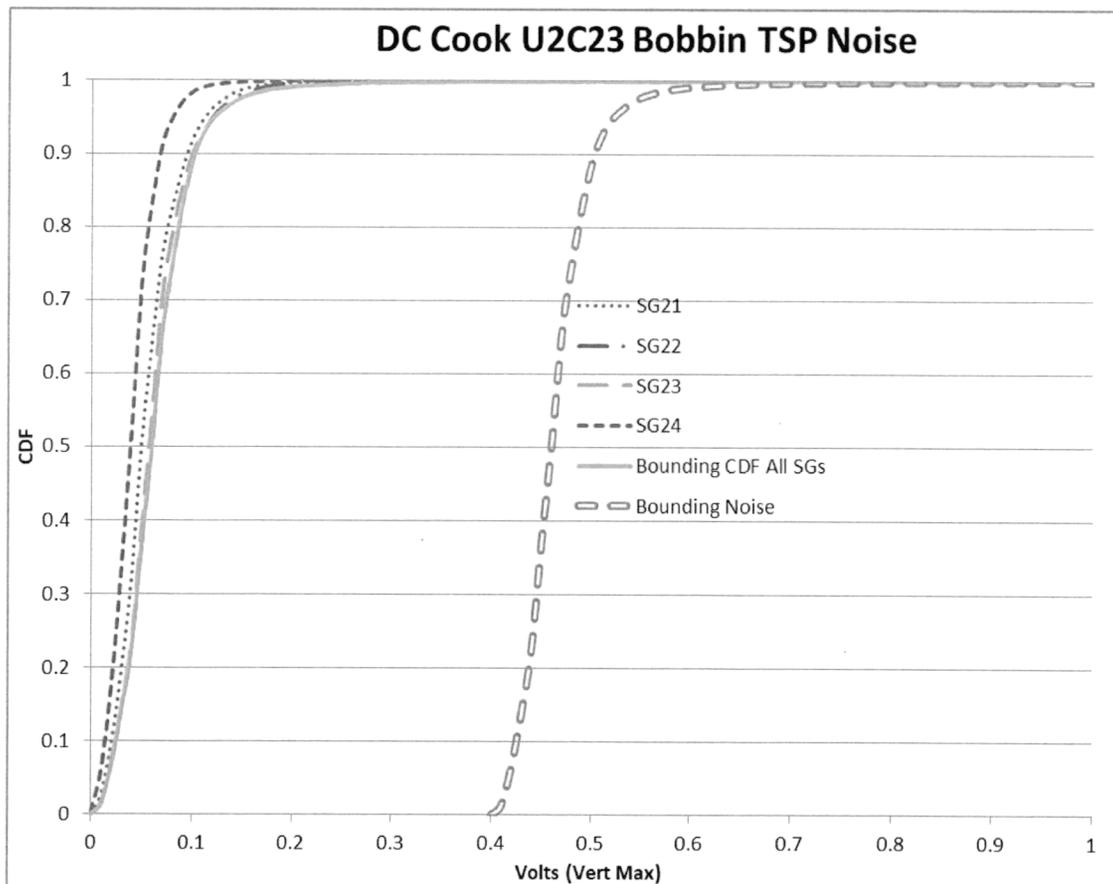
**Figure 5-2: Comparison of TSP Noise to its Bounding Noise Distribution**

Quantifying the probability of detection for TSP wear follows the same logic used above for AVB wear. Here, a 35%TW must detect depth was determined by subtracting the projected TSP wear growth ( $1.11\%TW/EPY * 7.5 EPY$ ) from the EOC high probability limit (43.2 %TW). The resulting CDFs are illustrated in Figure 5-2. Again, ample margin exists between the bounding CDF for all SGs and the bounding noise distribution, thus providing reasonable assurance that growth of potentially undetected TSP wear over the 7.5 EPY operating period will not lead to a compromise in steam generator tube integrity.

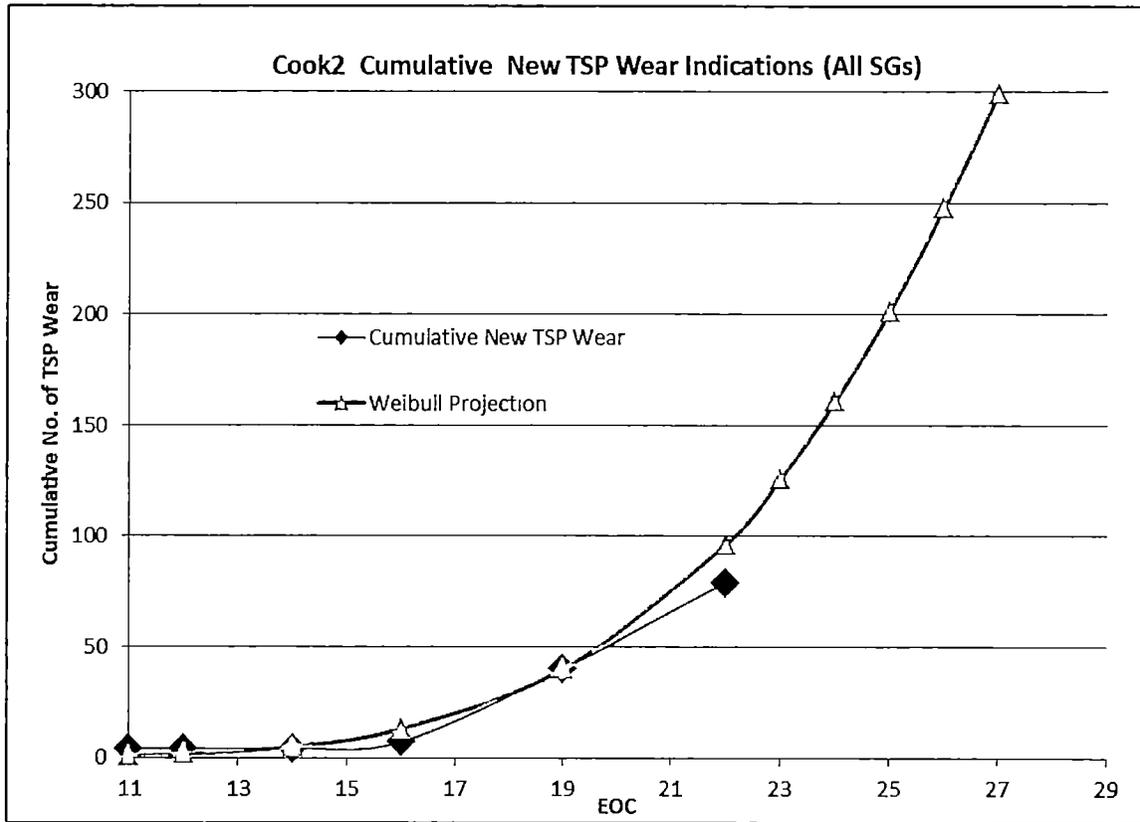
Figure 5-4: Cook-2 New TSP Wear and Weibull Projection

TSP wear was first detected in the Cook-2 steam generators during U2C12 after 5.868 EPFY of accumulated operation. The first indications were reported in SG21 of 4%TW, 6%TW, 7%TW, and 11%TW [4.b: Section 7.1.2]. During the U2C17 examination after 12.163 EPFY of operation three new indications were detected with the largest indication being 11%TW [4.e: Table 9-1]. During U2C20, 33 new indications were detected with the largest new indication being 9%TW [4.c: Sections 3.0 and 9.2.2].

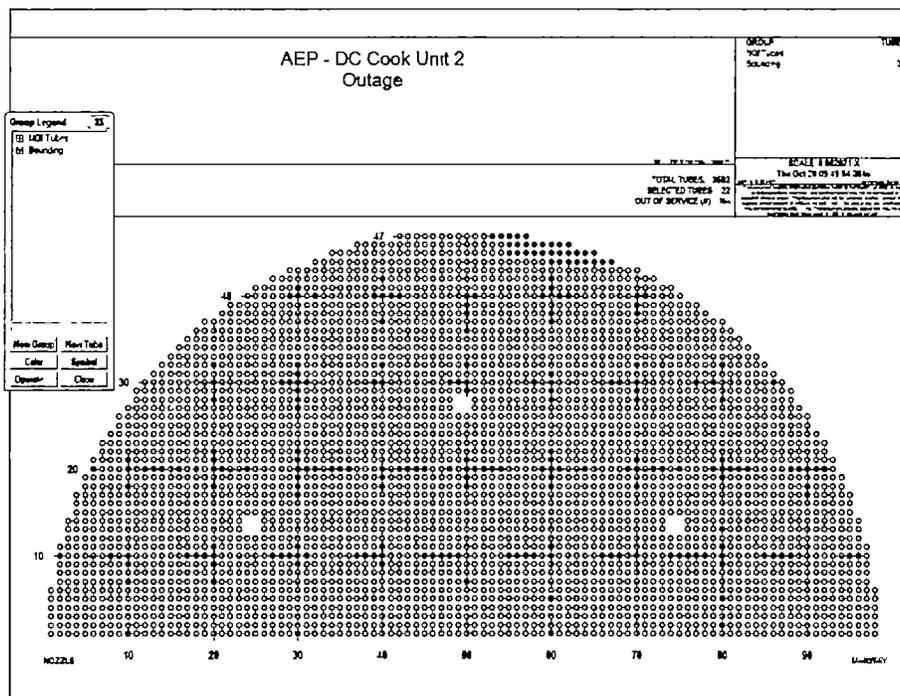
Figure 5-6: Cook-2 SG22 VOL Indications and 30 Bounding Tubes

part. The 30 bounding tubes plus the two bobbin tubes (32 tubes total) were also examined using the +Point™ probe. Based on these results, the two bobbin indications were dispositioned as VOLs and the 30 bounding tubes were reported as NDD (no degradation detected) with no associated loose part(s) presence. Both VOL indications were sized using +Point™ ETSS 27904.1. The largest VOL indication was sized by bobbin at 12%TW and at 39%TW using +Point™. The corresponding resulting upper 95/50 depth was calculated to be 43%TW as illustrated in Table 4-2. The VOL indications and bounding tubes are illustrated in Figure 5-6.

Based on the Cook-2 operating experience, it is unlikely that new foreign material introduced into the SGs since U2C23 would cause tube degradation. Recall that Cook-2 has proactively performed TTS lancing in parallel with ECT examinations. Since the lancing effort (performed at the end of every 3<sup>rd</sup> cycle) could have dislodged foreign objects in contact with SG tubes and prevented the occurrence of foreign object wear, it is recommended that Cook-2 consider performing TTS lancing in each SG prior to the U2C28 outage.
