SUBJECT: TRANSMITTAL OF FINAL NORTH ANNA POWER STATION, UNIT 1 –
ACCIDENT SEQUENCE PRECURSOR REPORT (LICENSEE EVENT
REPORT 338-20-001)

ASP Analysis for LER 338-20-001

Accident Sequence Precursor Program – Office of Nuclear Regulatory Research		
North Anna Power Station, Unit 1	Degraded Upper Cylinder Piston Pin Bushing Discovered during Maintenance Activities on Emergency Diesel Generator	
Event Date: 2/18/2020	LER: 338-20-001 IR: 05000338/2020003	$\Delta\text{CDP} = 5 \times 10^{-6}$
Plant Type:	Westinghouse Three-Loop Pressurized Water Reactor (PWR) with a Large, Dry Containment	
Plant Operating Mode (Reactor Power Level):	Mode 1 (100% Reactor Power)	
Analyst: Gary Wang	Reviewer: Chris Hunter	Completion Date: 3/2/2021

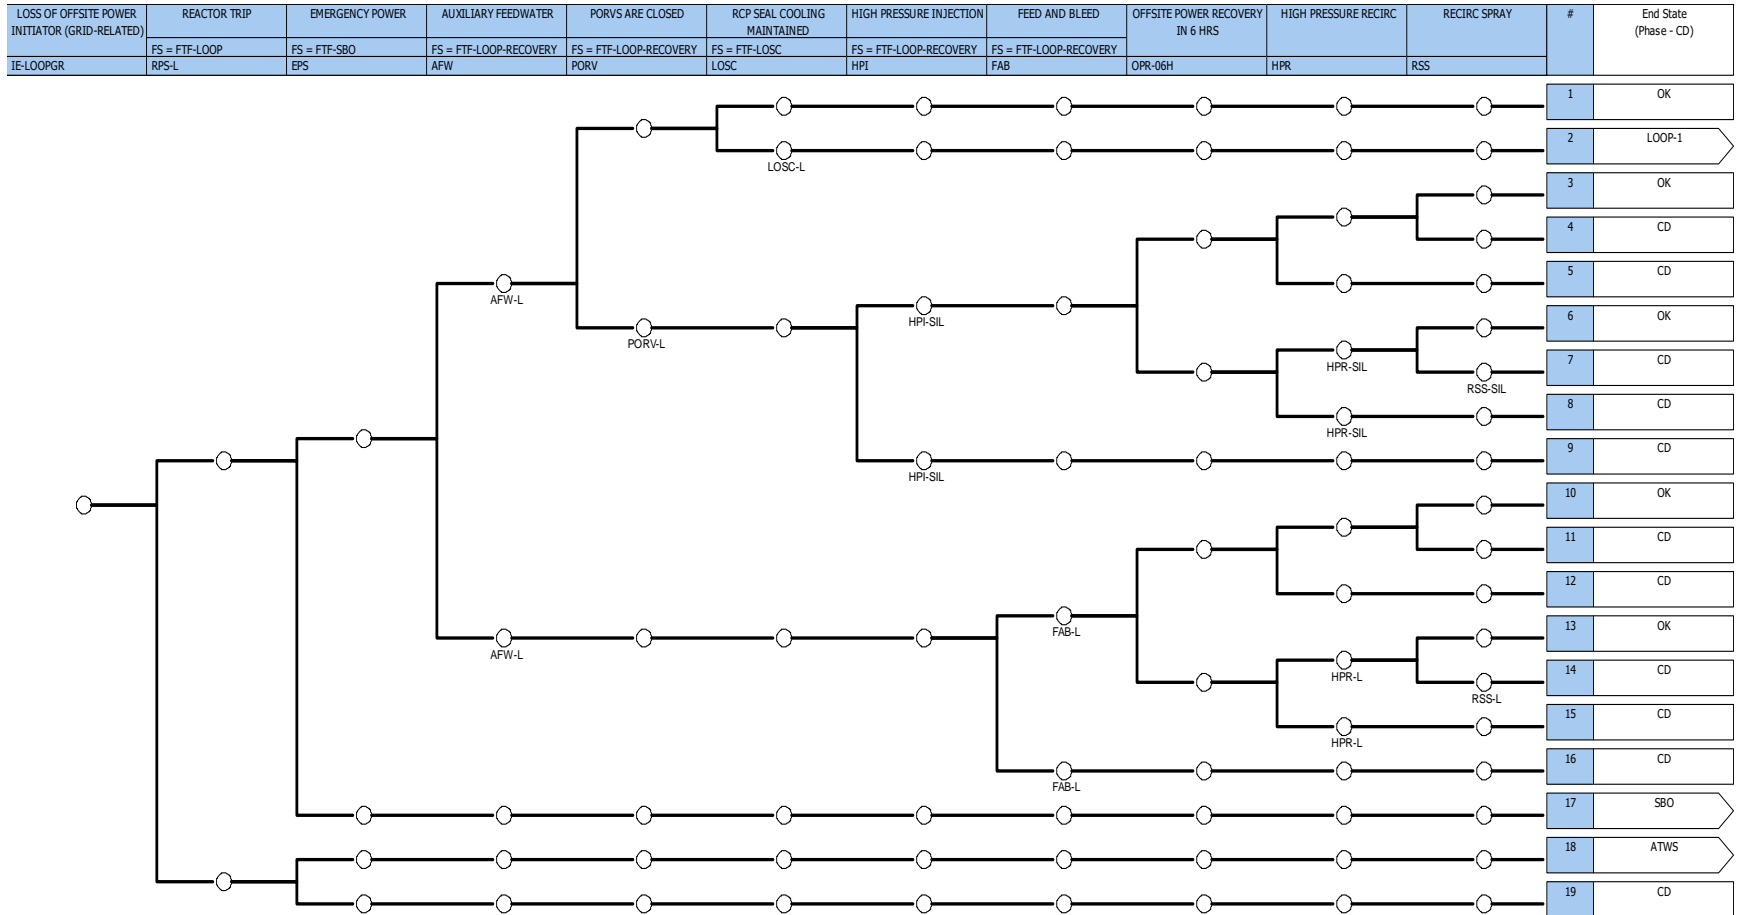
Figure A-1. North Anna LOOP Event Tree

The dominant accident sequence is LOOP sequence 17-12 ($\Delta\text{CDP} = 1.0 \times 10^{-6}$, which contribute approximately 31 percent of the total ΔCDP . The dominant sequences are shown in the table below and graphically in Figures A-1 and A-2 in [Appendix A](#). Accident sequences that contribute at least 5 percent of the total ΔCDP .

Sequence	ΔCDP	%	Description
LOOP 17-12	1.0×10^{-6}	31.0%	LOOP initiating event; emergency power system failure results in SBO; AFW fails; operators fail to restore AC power within 1 hour results in core damage.
LOOP 17-03-03	9.8×10^{-7}	30.5%	LOOP initiating event; emergency power system failure results in SBO; AFW successfully operates; operators fail to restore AC power prior to normal battery depletion (2 hours); operators declare ELAP; FLEX diesel generators successfully charge batteries; FLEX SG pumps successfully provide inventory makeup to the SGs; FLEX reactor coolant system (RCS) makeup pumps fail; core damage is assumed if operators fail to restore AC power within 24 hours.
LOOP 17-03-09	4.5×10^{-7}	14.0%	LOOP initiating event; emergency power system failure results in SBO; AFW successfully operates; operators fail to restore AC power prior to normal battery depletion (2 hours); operators declare ELAP; FLEX diesel generators fail to charge batteries is assumed to result in core damage (no credit for continued operation of AFW without DC power is provided).

LOOP 17-06	2.0×10^{-7}	6.3%	LOOP initiating event; emergency power system failure results in SBO; AFW successfully operates; reactor coolant pump (RCP) seal failure results in loss-of-coolant accident (LOCA); operators fail to restore AC power within 1 hour results in core damage.
