RS-21-042

LaSalle County Station, Unit 2
Renewed Facility Operating License No. NPF-18
NRC Docket No. 50-374

Subject: Relief Request I4R-12 Relief from Code Examinations for 2B33-F060A and 2B33-F060B Repairs, Revision 2

**Relief Request I4R-12 Associated with Alternative Examination Requirements for
Repair of Reactor Recirculation Flow Control Valves 2B33-F060A and 2B33-
F060B, Revision 2**

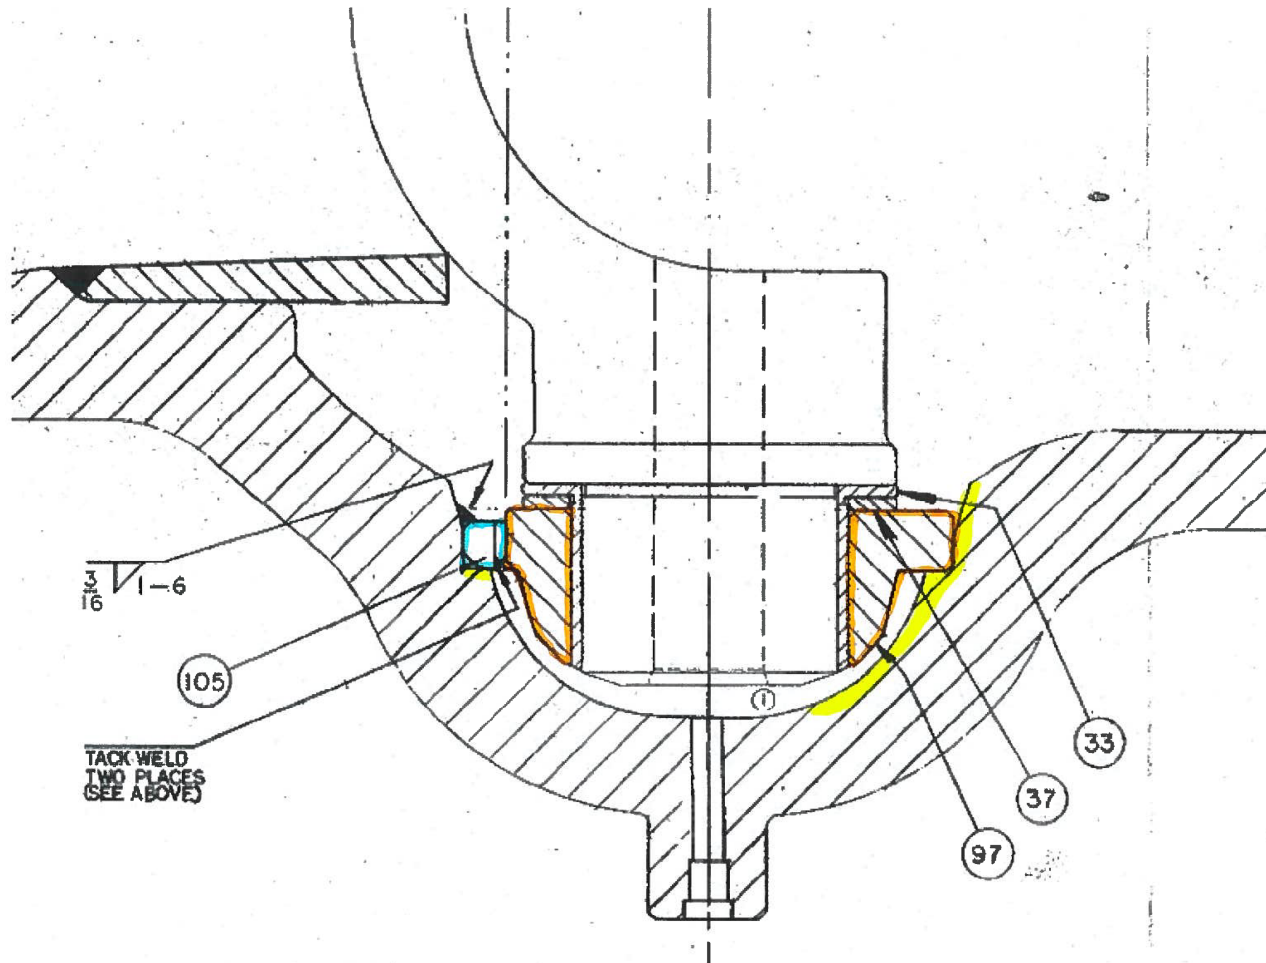
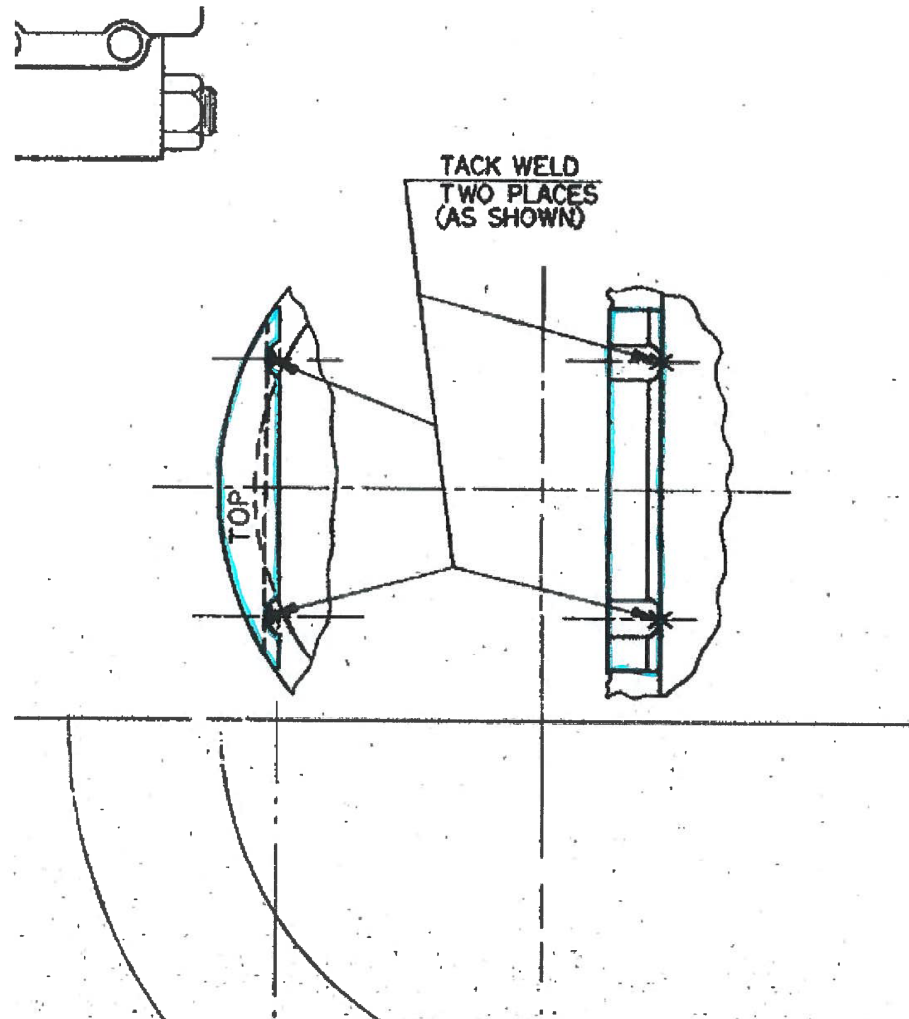
Figure I4R-12-2

anti-rotation segment, and yellow as the estimated area of wear in the valve body where material is missing due to the lower plug guide impact on the valve body. Figure I4R-12-4 is a close-up drawing of the area of the 2B33-F060A valve body in question. Figure I4R-12-4 is highlighted in yellow as the estimated area of wear in the valve body where material is missing due to the lower plug guide impact on the valve body.
