**From:** Ptasznik, Elizabeth M [<mailto:EPTasznik@ameren.com>]  
**Sent:** Monday, April 13, 2015 7:33 PM  
**To:** DL CAL NRC Resident Inspectors  
**Cc:** Ewens, Steve E  
**Subject:** Callaway ISFSI - Deluge test pictures

As requested, please find the attached photo's which were taken during the performance of last week's deluge test on the ISFSI.

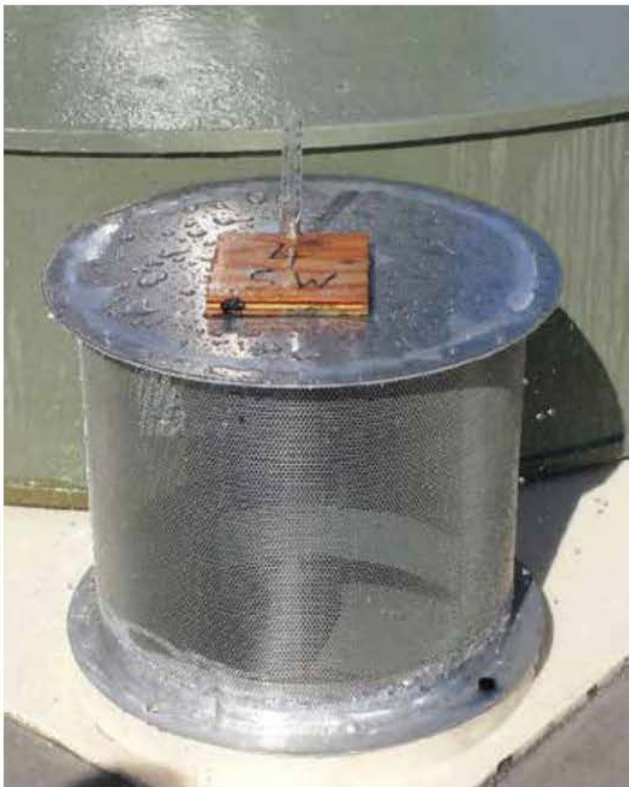
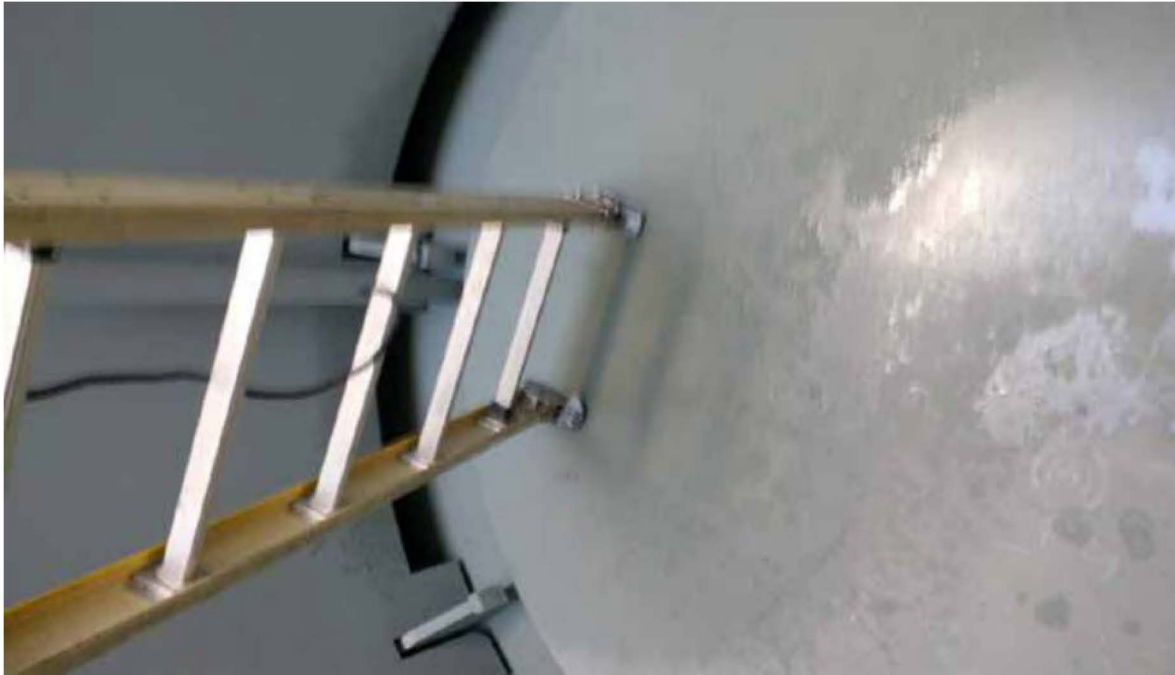
FYI. "Slight wetting" after the deluge test (last pic). It looks more than that to me.

Post-Deluge Test; Only slight wetting at the CEC baseplate
