NRC Informational Call

Potential Relief Request:
Reactor Vessel Head Nozzle #74 Examination
Catawba Nuclear Station Unit 2

April 15, 2021

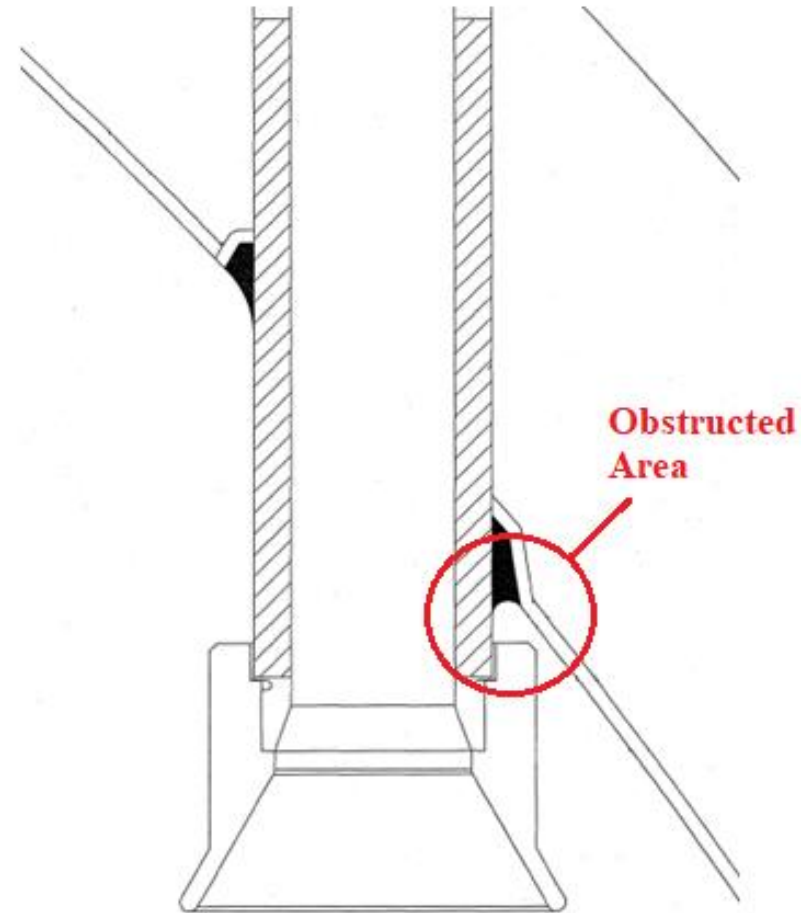
- ▶ The nozzle at penetration #74 is one of five core exit thermocouple (CET) locations on the outer periphery of the RVCH
- ▶ The CET nozzles have a threaded guide funnel attached with two anti-rotation dowel pins installed which are plug welded in place

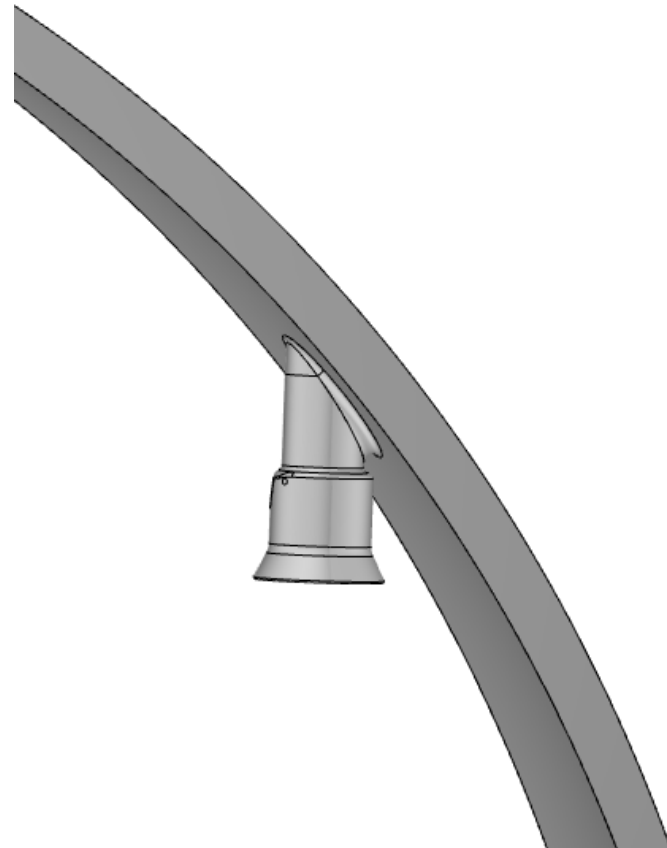
- ▶ Interference from the funnel welded to the end of the penetration nozzle (which functions as a thermocouple column) prevented completion of the ECT surface examination over 11% of the weld area
- ▶ NDE of the j-groove weld surface requires funnel removal to obtain full coverage

- ▶ One-time alternative will be requested in accordance with 10 CFR 50.55a(z)(2) – Hardship without a commensurate increase in quality and safety
- ▶ At the next refueling outage in Fall 2022 (C2R25):
 - ▶ The obstruction will be removed and the remaining portion of the weld surface will be examined
 - ▶ Bare metal visual will be performed
- ▶ The routine online leakage detection capability provides additional assurance and defense in depth until the time of the next refueling outage and beyond
