**AEP-NRC-2021-43**  
**10 CFR 50.55a**

**Donald C. Cook Nuclear Plant Units 1 and 2**  
**Response to Request for Additional Information Regarding Relief Request for**  
**Limited Coverage Examinations Performed In**  
**The Fourth 10-Year Inspection Interval**

### **Response to Request for Additional Information Regarding a Relief Request for Limited Coverage Examinations Performed in the Fourth 10-Year Inspection Interval**

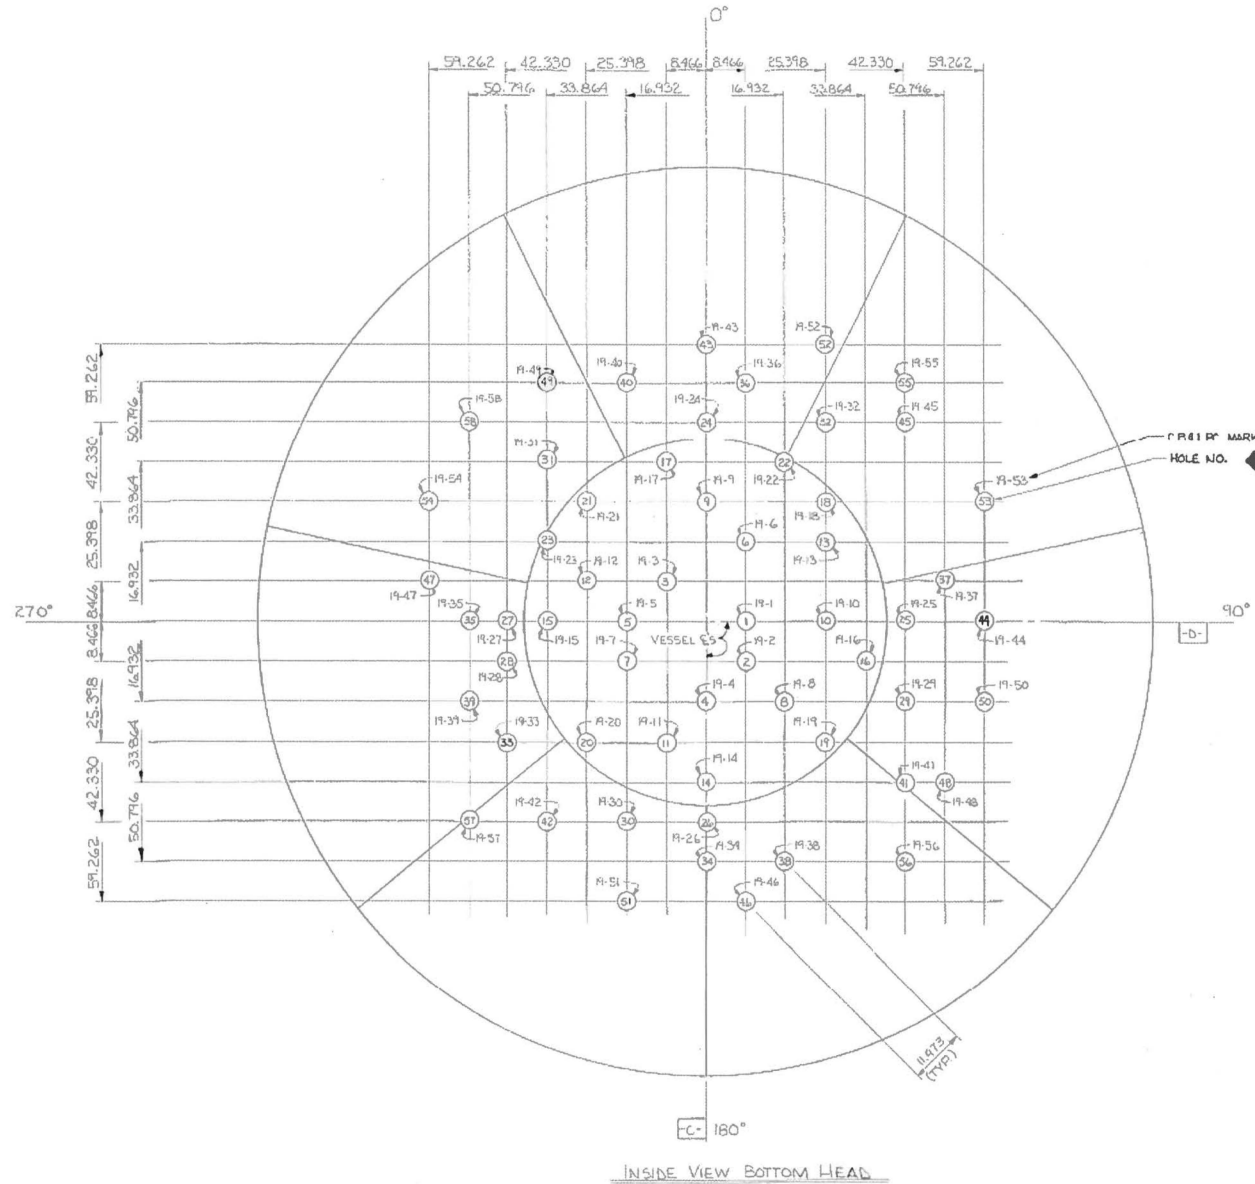
Figure 1: Layout of the BMI Tube Penetrations

A total of 58 BMI tubes penetrate the RPV lower head. Some of these BMI tubes are adjacent to the subject weld. A diagram excerpted from drawing DC-03137 provided in Figure 1 below shows the layout of the BMI tubes in relation to the subject weld:

Per drawing DC-03135, each BMI tube is approximately 1.50" in diameter with a collar located 6" from the inside RPV end making each BMI tube 1.75" at its widest point. Per drawing DC-03136, there is a quarter-inch throat fillet weld around the inside vessel penetration point of each BMI tube. This gives a footprint of approximately 2.00" for each BMI tube at the penetration. Per drawing DC-03136, the BMI tubes have a vertical height of approximately 12" above the inside of the bottom of the RPV.

The clearance needed for the examination sled to scan the subject weld is limited by the footprint of the BMI tubes. As seen in Figure 1, each square is 8.5", and there are 17 BMI tubes located within approximately 6" of the subject weld. Those BMI tubes limit the sled from scanning all or part of the adjacent portion of the subject weld. Additionally, there are 12 more BMI tubes that are located within approximately 12" of the subject weld. All of these BMI tubes either prevented scanning or reduced the scanning area in both the parallel and perpendicular direction adjacent to the associated BMI tubes.

The vertical component of the BMI tubes also limits the positioning options of the arm, end effector and examination sled when scanning the subject weld. The arm must be maneuvered so as to avoid damaging tooling or potentially snagging the cables. The vertical component of BMI tubes radially in line with the arm also limits the examination sled access to portions of the subject weld located on the far side of the BMI tubes.
