Subject: 10CFR21 Reporting of Defects and Non-Compliance -
Engine Systems, Inc. Report No. 10CFR21-0131, Rev. 0

Zinc Anode (installed in heat exchanger P/N 1335BEM2P)

Report No. **10CFR21-0131**
Rev. 0: 07/09/21

**10CFR21 REPORTING OF DEFECTS
AND NON-COMPLIANCE**

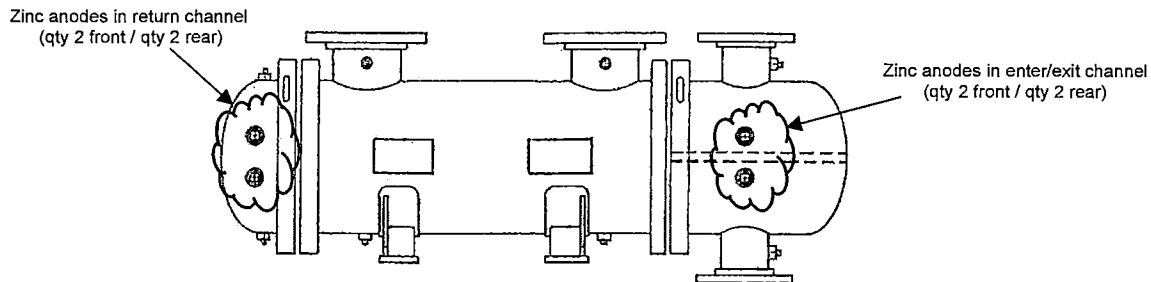
Figure 1: Heat Exchanger P/N 1335BEM2P

Two instances of a loose or dislodged zinc anode (protector) were discovered in heat exchangers supplied by ESI. The anodes are installed in the cooling water enter/exit and return channels of the heat exchanger as shown in Figure 1 below:

Each heat exchanger, P/N 1335BEM2P, contains qty 8 zinc anode assemblies that consist of a zinc rod threaded into a steel pipe plug. The zinc acts as a sacrificial anode to protect the pressure boundary metals from degradation due to galvanic corrosion. In the case of a loose or dislodged zinc anode, the zinc rod may become foreign material that remains trapped in the vessel, potentially impacting and damaging the tube ends where they project from the tube sheet. Alternatively, an anode located in the exit channel may be carried away from the heat exchanger and potentially damage downstream components.

It is recommended to perform an inspection to verify tightness at the zinc rod to pipe plug interface. The rod should be threaded into the pipe plug snug tight and, if required, may be tightened to a maximum of 15 ft-lbs.

If desired, the zinc rod may be removed and eliminated from the assembly leaving only the steel pipe plug. Inclusion of the zinc anode is not required for the EDG heat exchanger application at TVA-Browns Ferry.

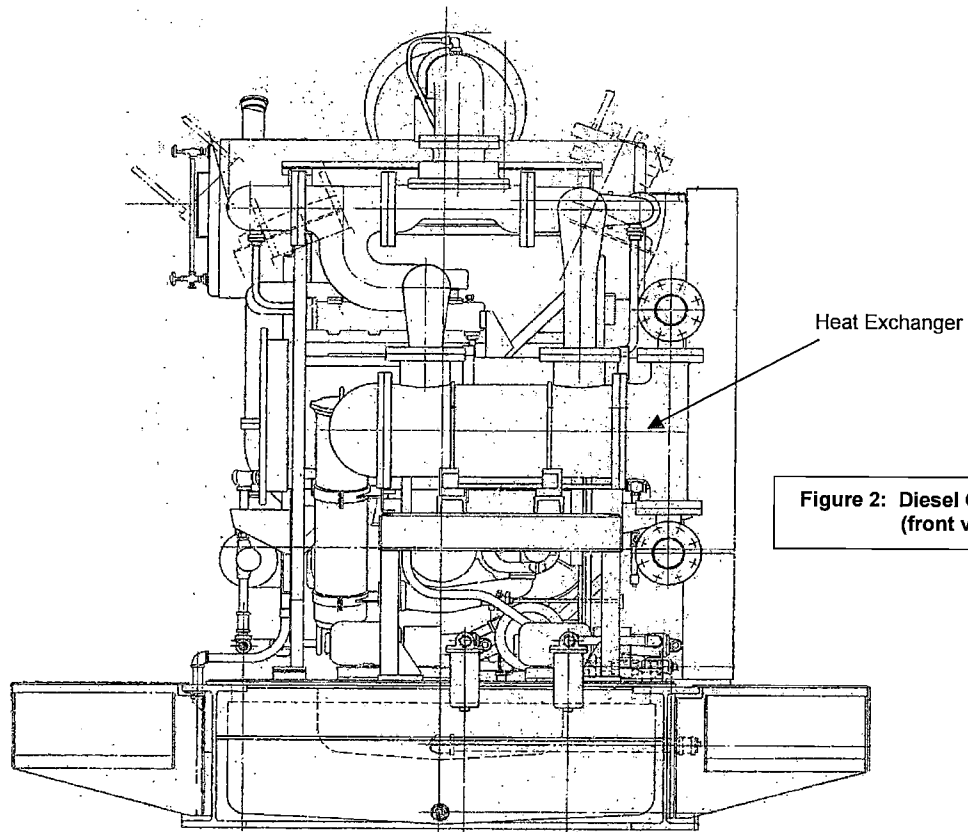
**Figure 2: Diesel Generator Skid
(front view)**

The heat exchanger provides cooling for the jacket water system of an EMD brand emergency diesel generator set (EDG), see Figures 2 and 3. Each EDG with uses qty 2 heat exchangers in parallel to transfer heat from the engine's jacket water to the station's raw water. Cooling of the jacket water is vital to operation of the EDG to maintain its safety-related function during an emergency event. While a dislodged anode is not expected to immediately impact operability of the heat exchanger, prolonged and repeated clattering within the vessel may damage tubes to the extent the tube-to-tubesheet pressure boundary is affected. This could impact ability to properly cool the EDG and result in failure of the EDG to perform during a safety-event.
