REFERENCE: Docket No. 50-186
University of Missouri-Columbia Research Reactor
Renewed Facility License Operating License No. R-103

SUBJECT: Reportable Event Report Pursuant to § 20.2203(a)(2)(iv)

The University of Missouri Research Reactor (MURR) submits this letter to report a condition pursuant to § 20.2203(a) regarding the dose limit for an individual member of the public as stated in § 20.1301(a)(2).

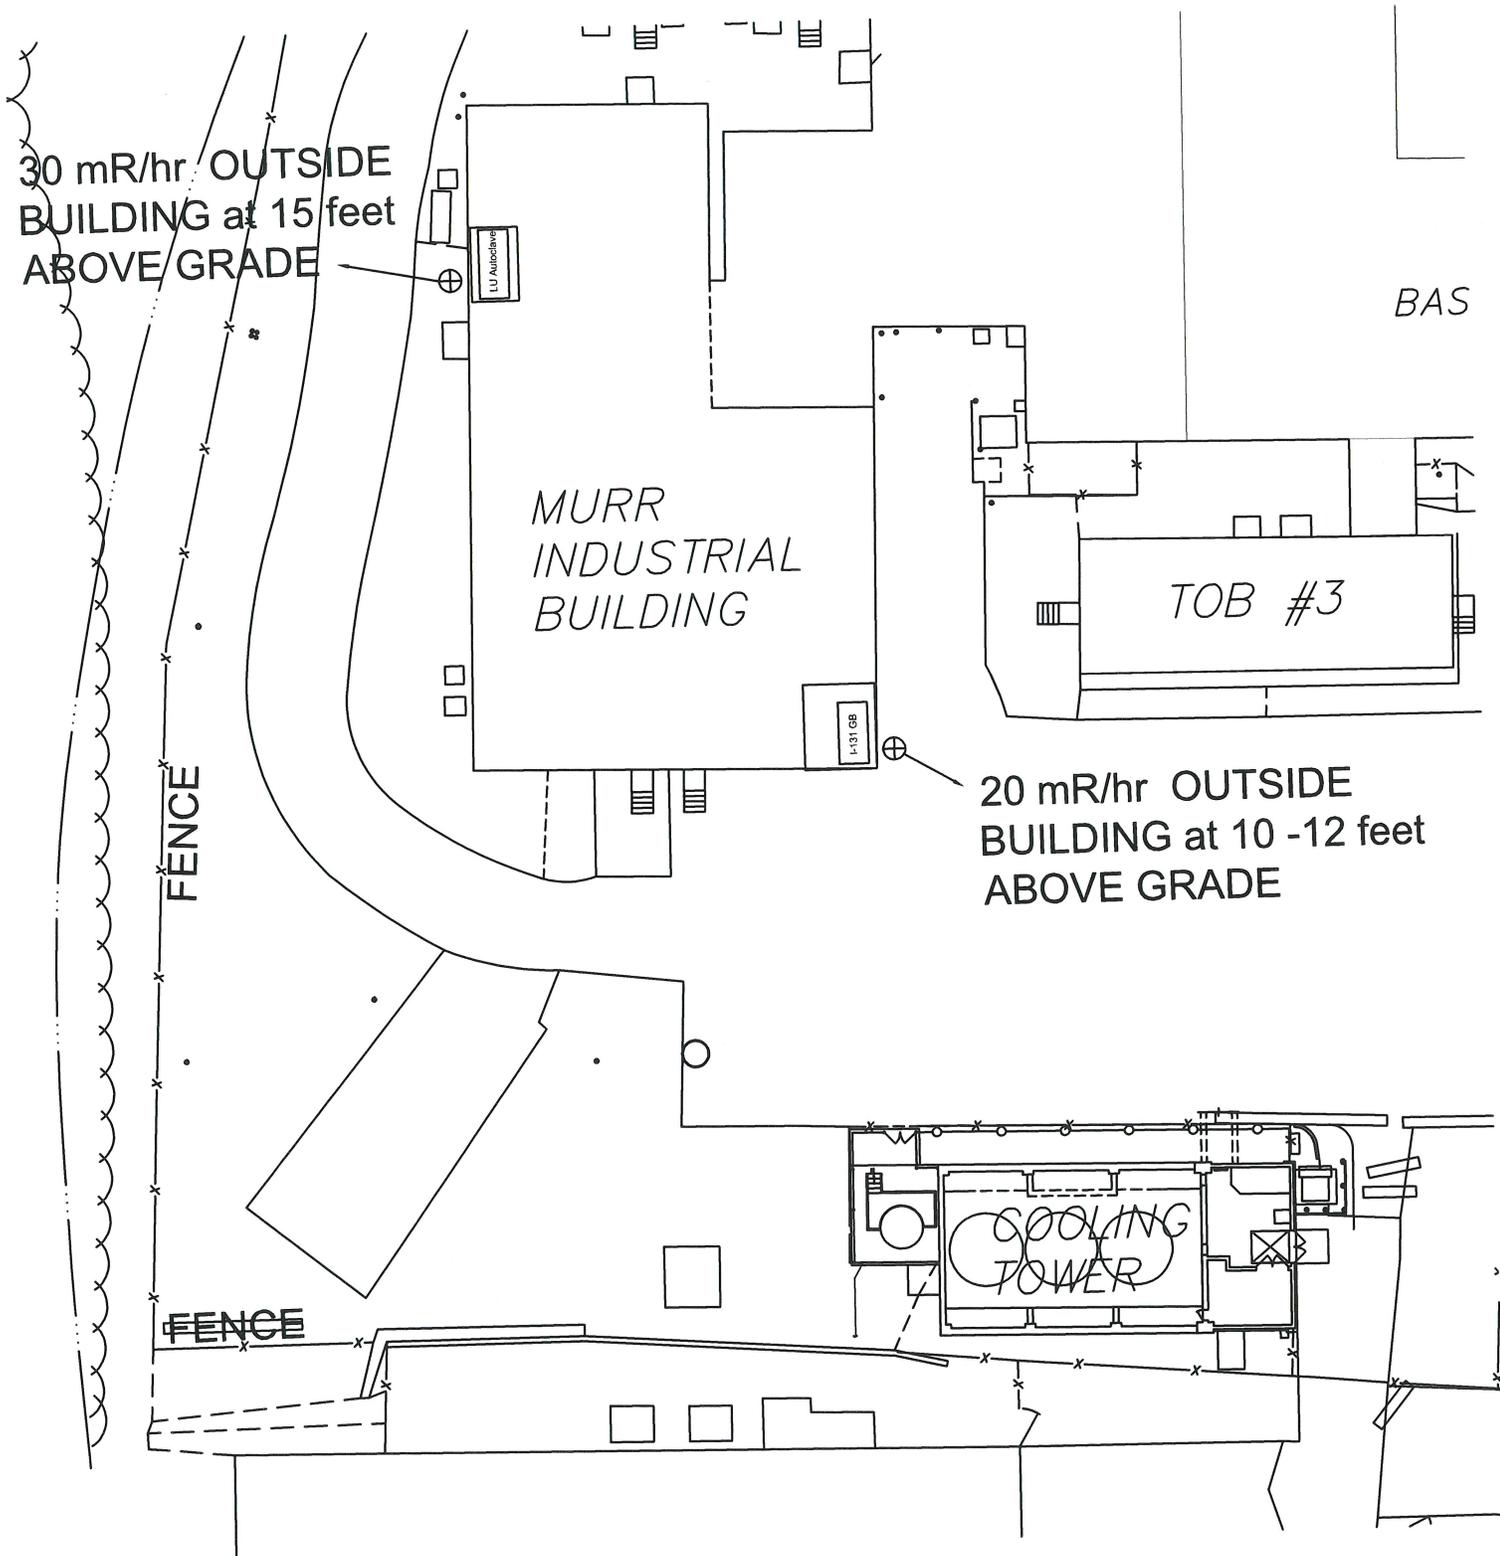
Attachment 1 - External Building Survey

On July 21, 2021 a survey external to the Lu-177 autoclave suite (MIB) was conducted during maximum activity use in the area. This survey also showed dose rates external to the building in excess of the 2 mrem/hr limit (See Attachment 1). The largest dose rate was found approximately 15 feet above ground level during the time vials were moved from “pigs” into the autoclave (~2 minutes). After the vials were loaded into the autoclave, the dose rate was reduced roughly in half. Upon noticing these dose rates, the Health Physics Manager was immediately contacted and assisted in further measurements. Dose rates were measured inside the building near the autoclave and it was discovered that a streaming path existed at the door of the autoclave shielding box at an approximately 45-degree angle out of the top front of the box. This streaming path created a high radiation area (HRA) at or above head level and does not occur at the designed working location in the room occupied by staff (behind lead glass wall). At the time the dose rates were recorded, no staff were working in the space and HP was always present. By procedure, Health Physics staff were present while staff worked in the space (~5 minutes during loading and ~10 minutes during unloading autoclave) to ensure that no elevated doses were received. All staff working in the room were wearing electronic dosimetry and no elevated dose rates were observed in the working spaces. Upon discovery of the elevated dose rate, the room was posted as an HRA and monitored by health physics until the dose rate was lowered at the end of the process.

The second event involved approximately 100 Ci of Lu-177 being autoclaved on 7/21/21. Measured dose rates were approximately 30 mrem/hr roughly 15 feet above ground level external to the building. The largest dose rates occurred during the time vials were removed from lead pigs and added to the autoclave. This period of time lasted approximately 1-2 minutes before the material was shielded by the lead autoclave enclosure. Once all vials were in the shielded autoclave enclosure, the dose rate external to the building at 15 feet above ground level dropped to approximately 15 mrem/hr. At the time of the incident, dose rates were taken within the posted radiation work area and were recorded as approximately 1000 mrem/hr on contact with the shielding box, and approximately 450 mrem/hr at 30 cm away. These dose rates were coming out of the front of the shielded box at an angle putting the dose rate at or above head height.

A contributing factor to the elevated dose rates of the second event on 7/21/21 was that the shielding was not being used in its designed configuration. The lead door was not able to physically close all the way based on the positioning of the autoclave itself. This was being done based on ease of operation and reducing manipulator use time. However, this inadvertently led to the door being cracked approximately one inch allowing for a larger than designed streaming path. Also, a lack of communication/training by radiation workers in this part of the facility led to a misunderstanding of the true design function of the shielding.

- The autoclave was reconfigured back to its original shielding design behind the shielding door. This allowed for proper closure of the shielding door and lowered the dose rate from streaming paths external to the building. Continual evaluations are underway to determine where additional shielding can be added to reduce dose and remove the high radiation area inside the room. The room will continue to be posted and monitored/secured as a high radiation area until the dose rate is no longer in this range.
