# Turkey Point Unit 3 ICW Pipe Leak Repair Plan Potential Relief Request

NRC NRR Turkey Point PM and Tech Staff Briefing  
August 25, 2021

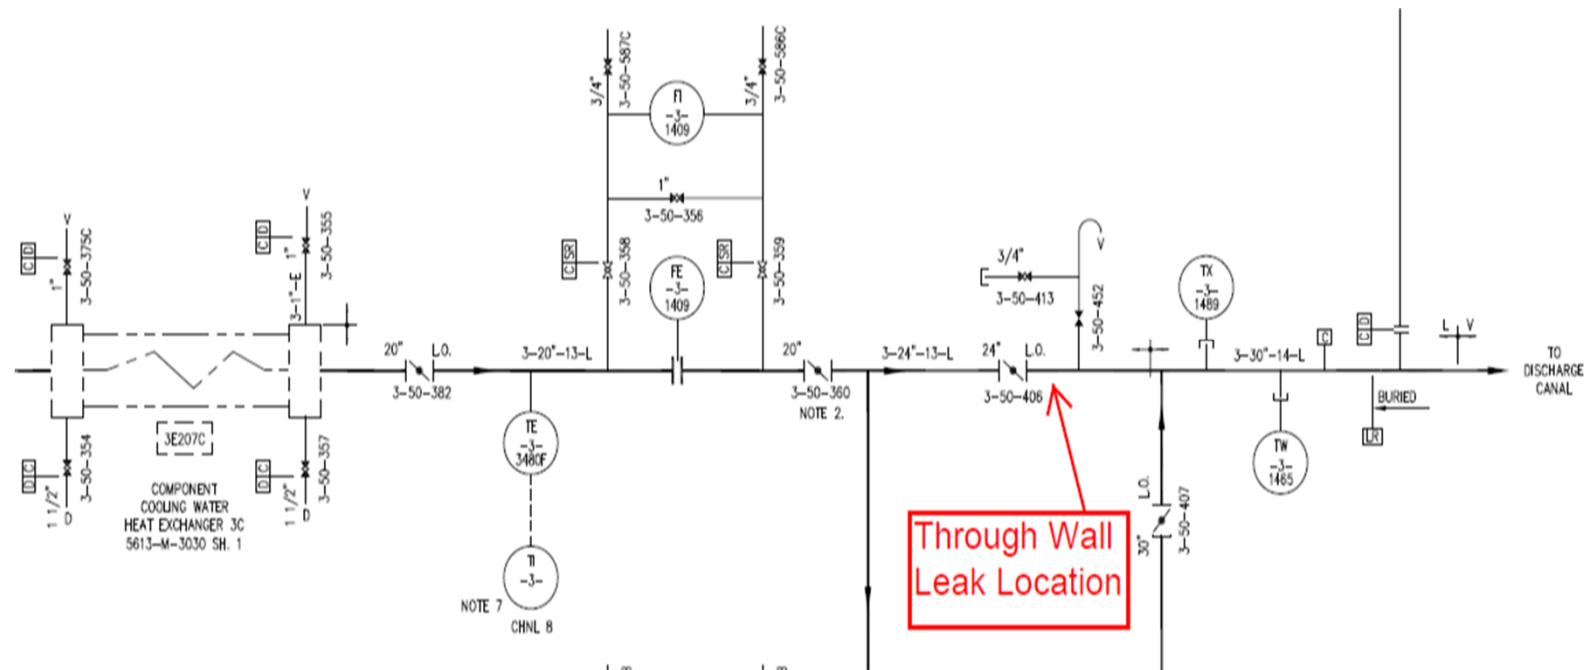
# ICW Leak Location

- On 3/5/2020, during surface preparation for metalizing / coatings applications, a through-wall leak was discovered on a 24" diameter Intake Cooling Water (ICW) safety related piping.
- The non-planar wall loss was identified under the pipe coatings, downstream of valve 3-50-406, the ICW manual isolation valve from the CCW heat exchangers.
- The flaw is approximately 12 feet from the underground piping directed to the discharge canal and is located in the Unit 3 CCW heat exchanger room.

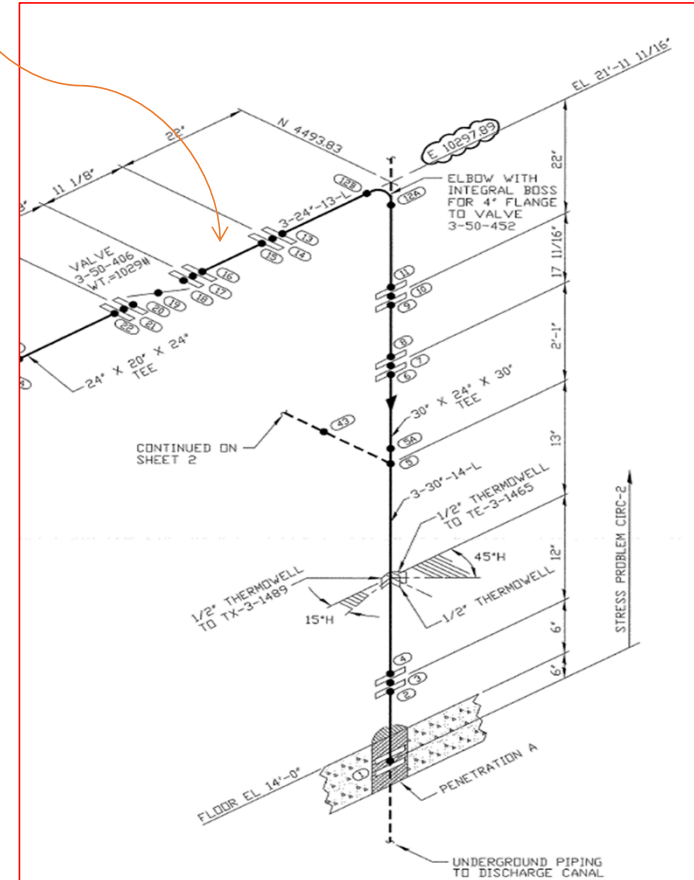
See 11-1/8 inch-Long spool piece Directly Downstream of Valve 3-50-406 (5613-P-820-S, Sheet 1 of 2)

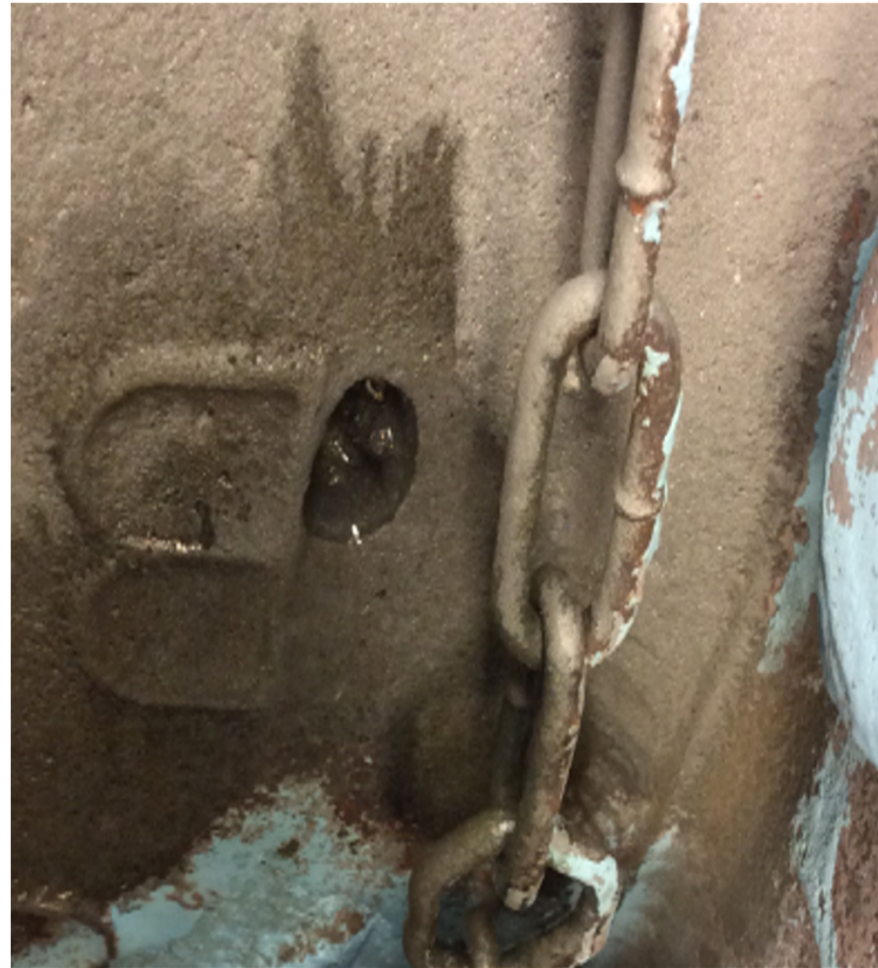
- The leakage is captured and routed to a nearby floor drain
- There is no nearby safety related equipment that could be impacted with the leakage condition or should leakage capture be challenged.
- No FME effects are probable as a result of this leak condition.
- Should any lining material disassociate from the pipe, negligible flow restriction is expected since the piping downstream is 30 inches in diameter.
