SUBJECT: American Nuclear Corporation Gas Hills Project Site Inspection  
Report 040-04492/2021-001

AMERICAN NUCLEAR CORPORATION GAS HILLS PROJECT SITE INSPECTION REPORT  
040-04492/2021-001, DATED – SEPTEMBER 2, 2021

Report No.: 040-04492/2021-001

### American Nuclear Corporation Gas Hills Project Site NRC Inspection Report 040-04492/2021-001

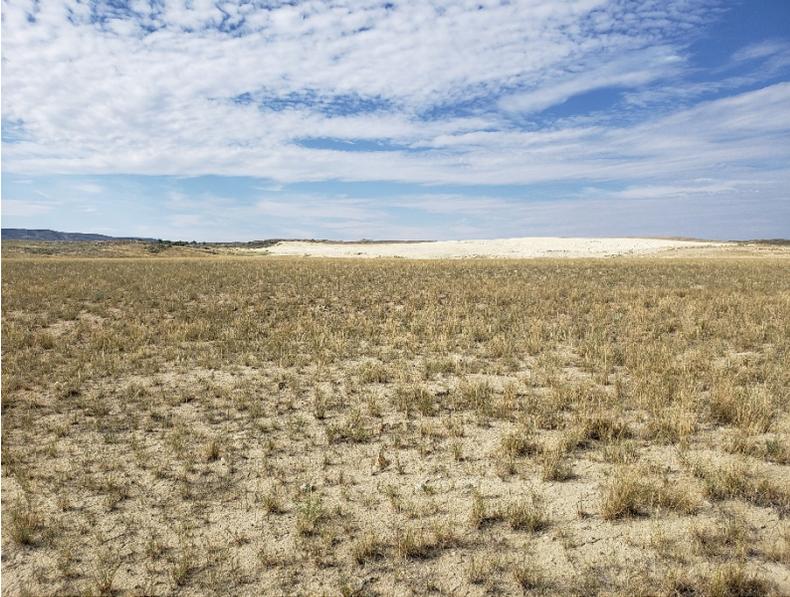
Figure 1 – looking across TSP-1 with spoils in background

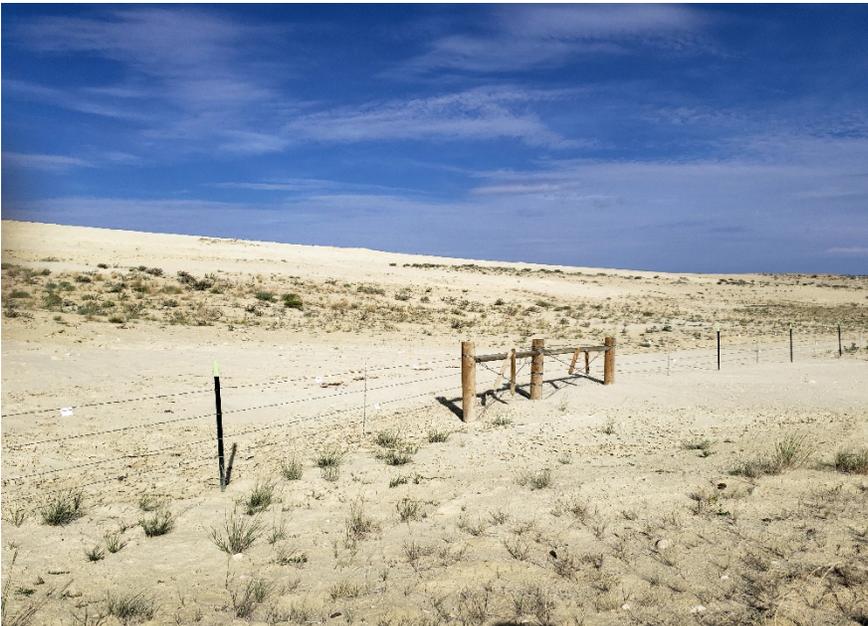
minimal signs of erosion. Washdown from the spoils pile previously identified along one side of the TP-1 area just inside the fence line has increased since the inspection in CY2019, but the tailings pile has not been impacted, the trench along that side has just been filled along that side. The Wyoming Department of Environmental Quality, Abandoned Mine Land Program, is spending approximately \$80,000 per year in attempts to mitigate this washdown issue onsite. Portions of the TP-2 tailings pile were not accessible due to deep trenching along the access road but areas that were accessible were found in good condition.

Figure 2 – Spoils washout at fence line on TSP-1

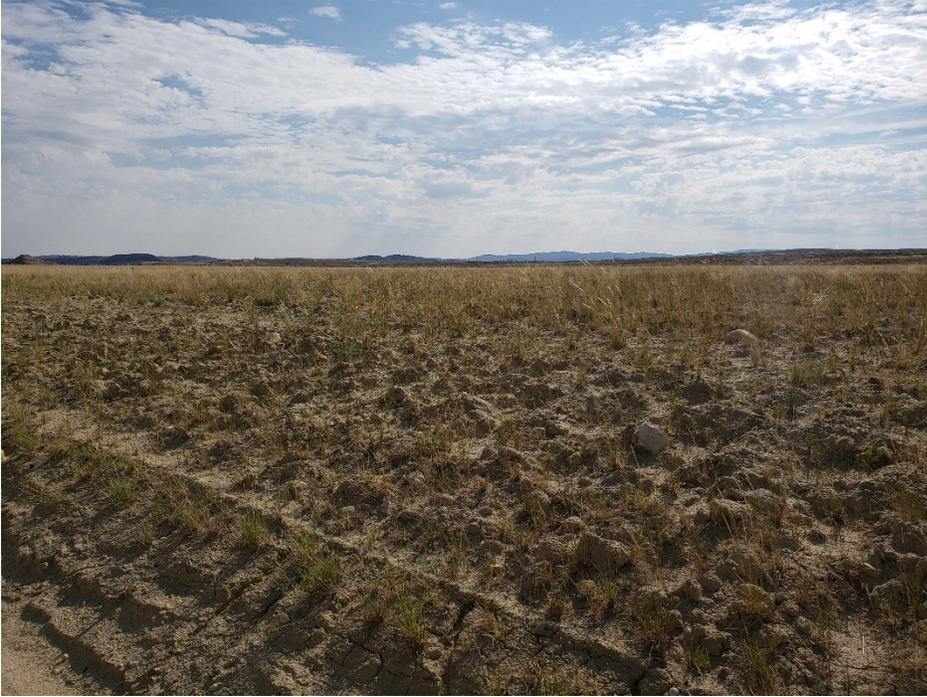
Both tailings piles (TP-1 and TP-2) are stabilized. TP-2 was considered complete by the State, but a recent assessment by the U.S. Department of Energy - Office of Legacy Management indicates that additional cover may be required. During the inspection in 2019, TP-1 had just been seeded for a vegetative cover. During this inspection, the inspector noted that the vegetative cover has grown in appropriately for the region.

Figure 3 – TSP-1 showing vegetative cover and side slopes

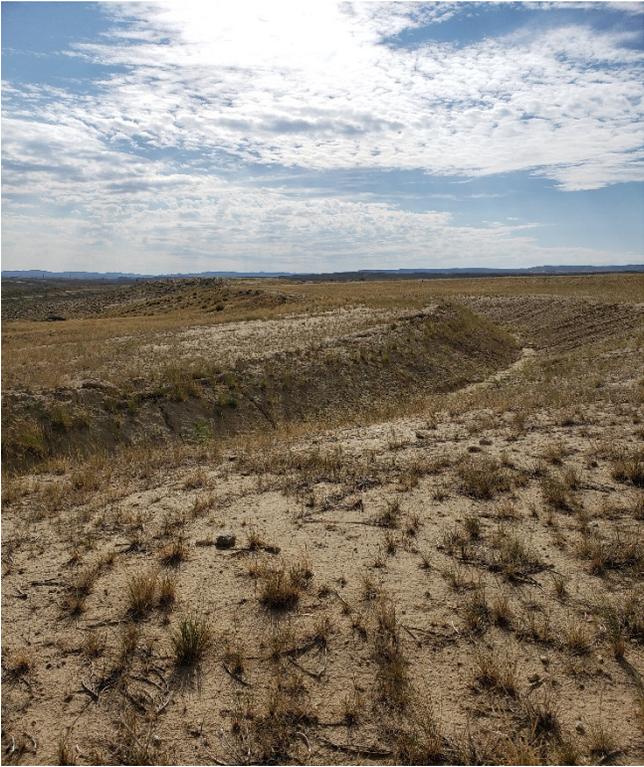
Figure 4 – showing trench not impacted by washout

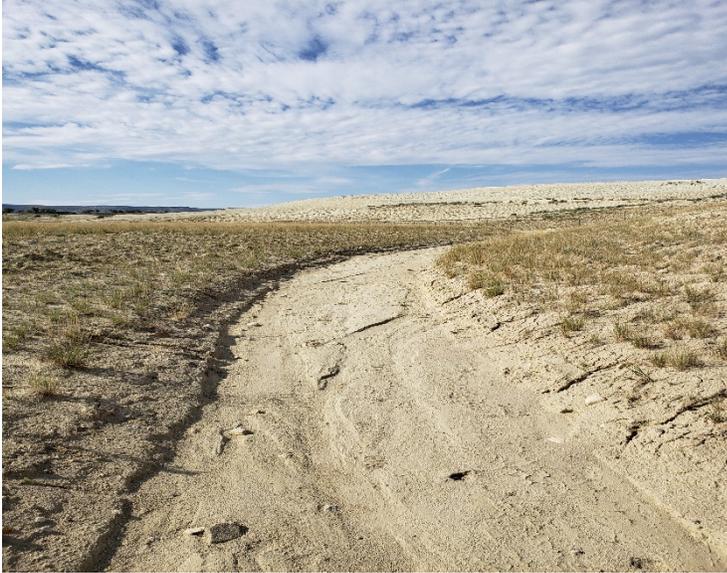
Figure 5 – showing trench filled in by washout

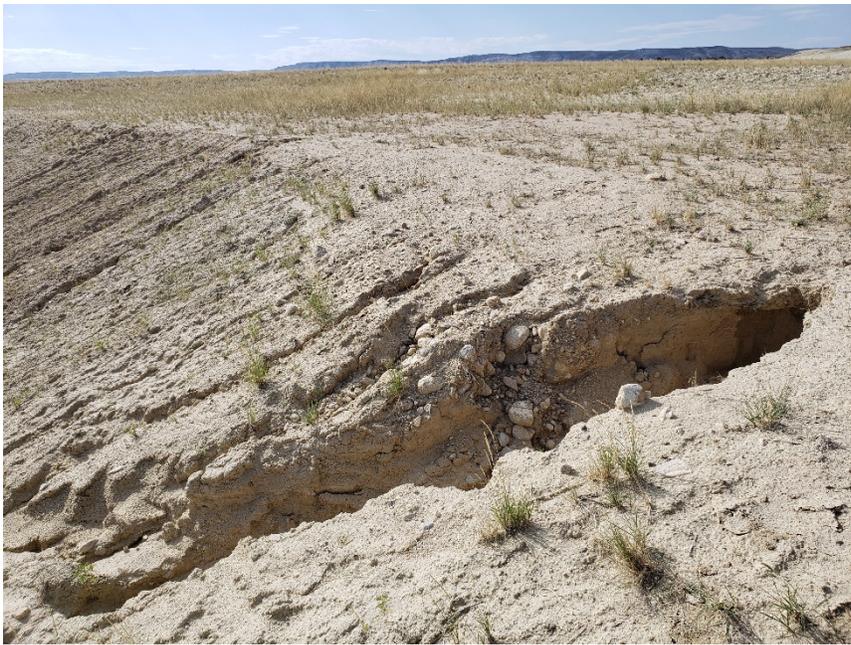
Figure 6 Rill and Gully erosion TSP-1 trench side (not tailings pile side) suspected to be a result of channeled rain flow from washout
