Re: Turkey Point Unit 3
Docket Nos. 50-250
Fifth Ten-Year Inservice Inspection Interval Relief Request No. 10

TURKEY POINT UNIT 3

RELIEF REQUEST No. 10

Turkey Point, Unit 3
Fifth 10-Year Interval Relief Request No. 10
Intake Cooling Water Pipe Spool Repairs for Through Wall Defect
L-2021-183, Enclosure 1

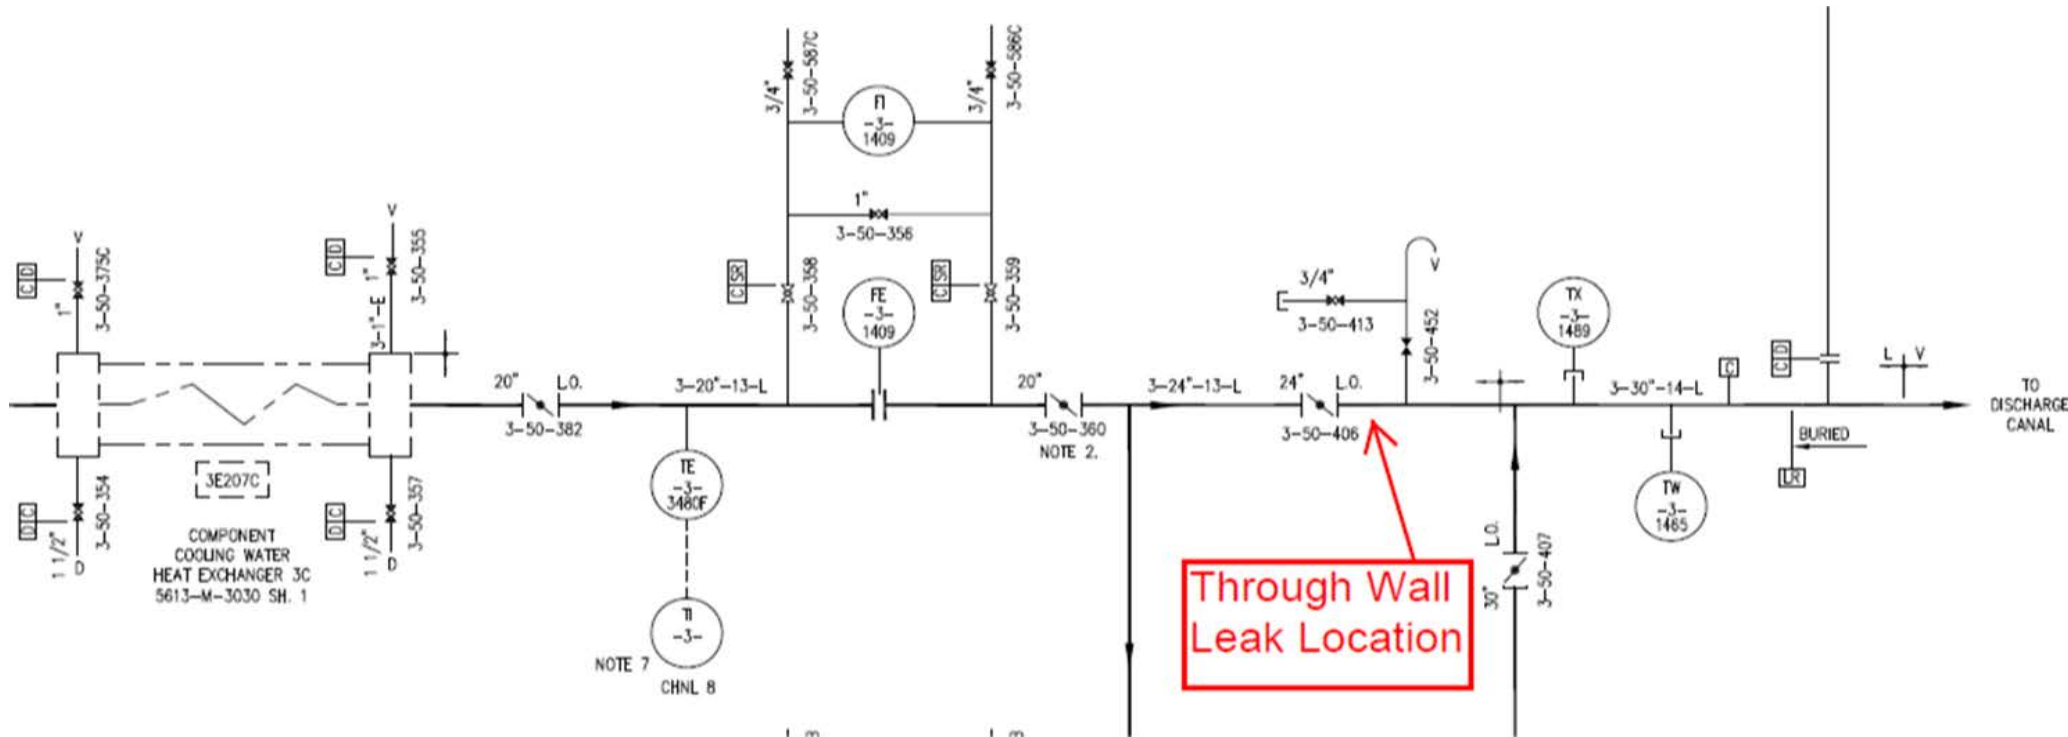
Turkey Point, Unit 3
Fifth 10-Year Interval Relief Request No. 10
Intake Cooling Water Pipe Spool Repairs for Through Wall Defect
Location of Through Wall Leak
L-2021-183, Enclosure 1

The non-planar flaw was identified under the pipe coatings downstream of the ICW manual isolation valve 3-50-406 from the CCW heat exchangers (See attached drawings). The flawed pipe section is located in the Turkey Point Unit 3 CCW heat exchanger room, approximately 12 feet from where the piping turns underground directing the water exiting the CCW heat exchangers back to the discharge structure and the ultimate heat sink. It does not include any downstream valves or any other active components that could fail and prevent delivery of the ICW fluid back to the discharge location. The safety significance of this section of the pipe is considered low

The subject ICW pipe has been confirmed as being an original installation in operation since the initial plant start up. The flaw size is shaped like a crater with two small wall weep holes inside. The size of the flaw longitudinal OD is 9/16 inches with a diameter of 13/16 inches. The average measured leakage is approximately 5 GPH with the subject ICW line pressurized. Leakage fluctuates between 0-10 GPH (depending on the system cleanliness and line up).

The likely cause of the defect is ID corrosion due to localized degradation of the concrete liner. The latest prompt operability determination concluded that this section of piping is classified as “Operable but Degraded” with no compensatory measures required. Both leakage rate and flaw size are monitored in accordance with ASME XI code case N-513-4 and have not grown since the initial identification in March 2020.

In lieu of the requirement of IWA-4421 to remove the defective portion of the ICW component prior to performing repair/replacement activities, unacceptable localized through wall corrosion, shall be corrected by installation of a Code compliant replacement pressure retaining parts, Restoration Clamp Assembly, that fully restore the degraded pipe spool.
